**To:** Eoanna Goodwin - Project Manager, RPD Capital and Planning Division

**From:** John Romaidis - Disability Access Coordinator, RPD Capital & Planning Division

**Date:** July 7, 2025

**Subject:** Embarcadero Plaza - Accessibility Assessment

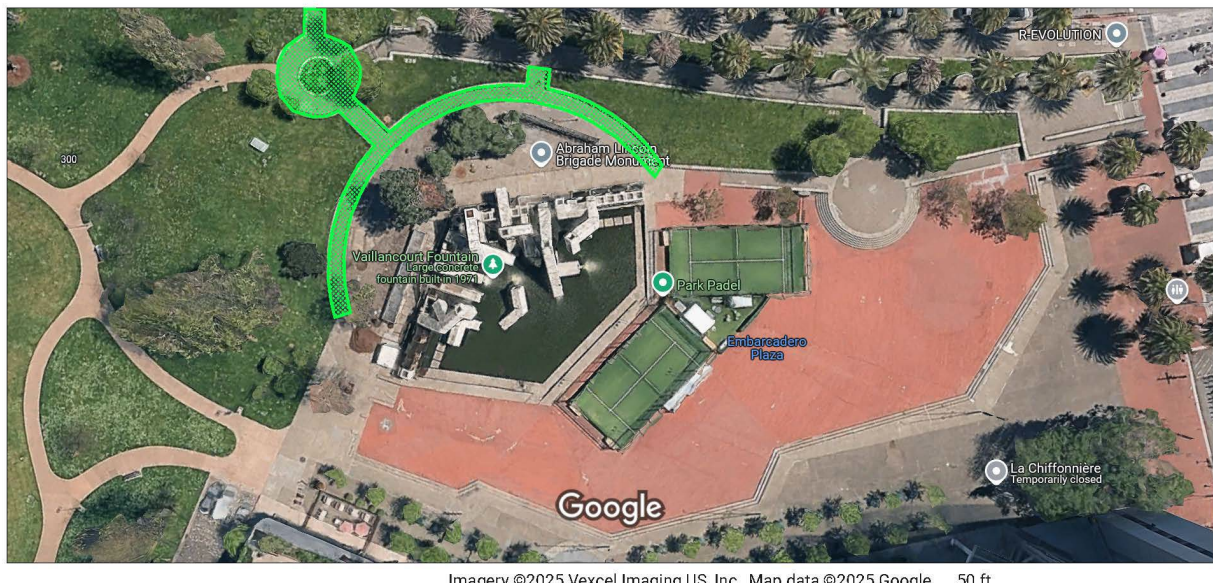
Figure 2. NE Walk

From The Embarcadero, a roundabout section of concrete path leads to a bifurcation point, where the walkway splits, one leg heading west and the other south, both providing access to the plaza. In the roundabout section, several locations exhibit cross slopes exceeding the 2% maximum, with measurements up to 3.6%. Similar excessive cross slopes up to 3% were observed at both split paths. Running slopes were found to be compliant (not exceeding 5%).

Additionally, a short connector path links the NE walk to the elevated SE section. At this location, a depressed manhole cover creates a vertical change in the surface exceeding  $\frac{1}{2}$ -inch.

Repair concrete paving as necessary to correct noncompliant cross slopes. Repair the area surrounding the manhole to eliminate the vertical surface deviation.

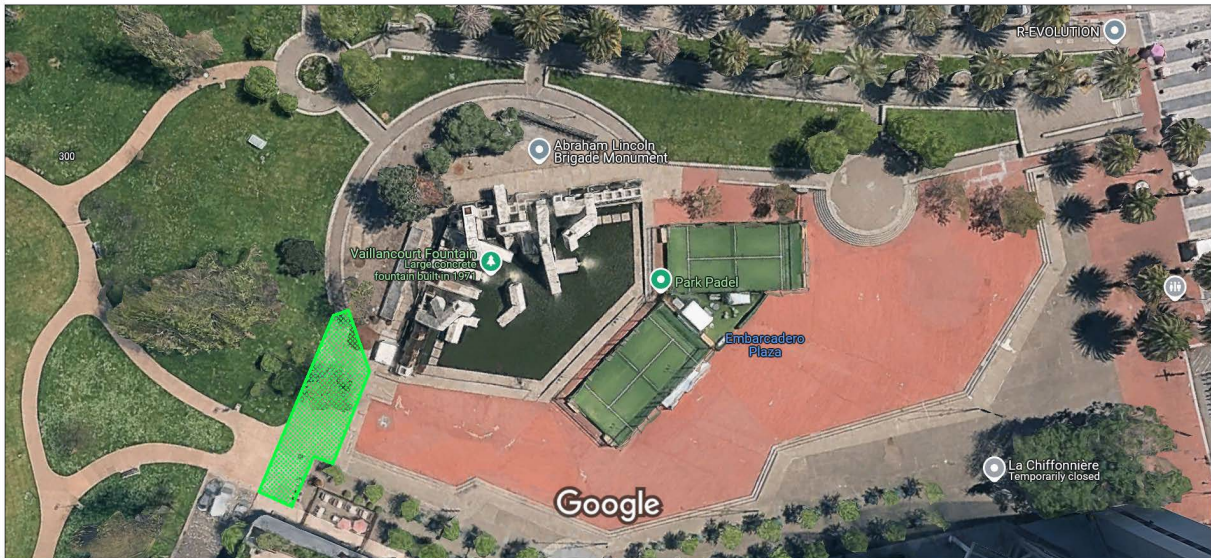
Figure 3. NW Walk

The NW walk is a primary access route connecting Clay Street and Sue Bierman Park to the plaza. This area is in severe disrepair. Significant concrete upheaval has resulted in extreme cross slope conditions and vertical level changes, creating major accessibility barriers.

Repair concrete walkways to correct excessive cross slopes and vertical displacements. Provide compliant transitions throughout.

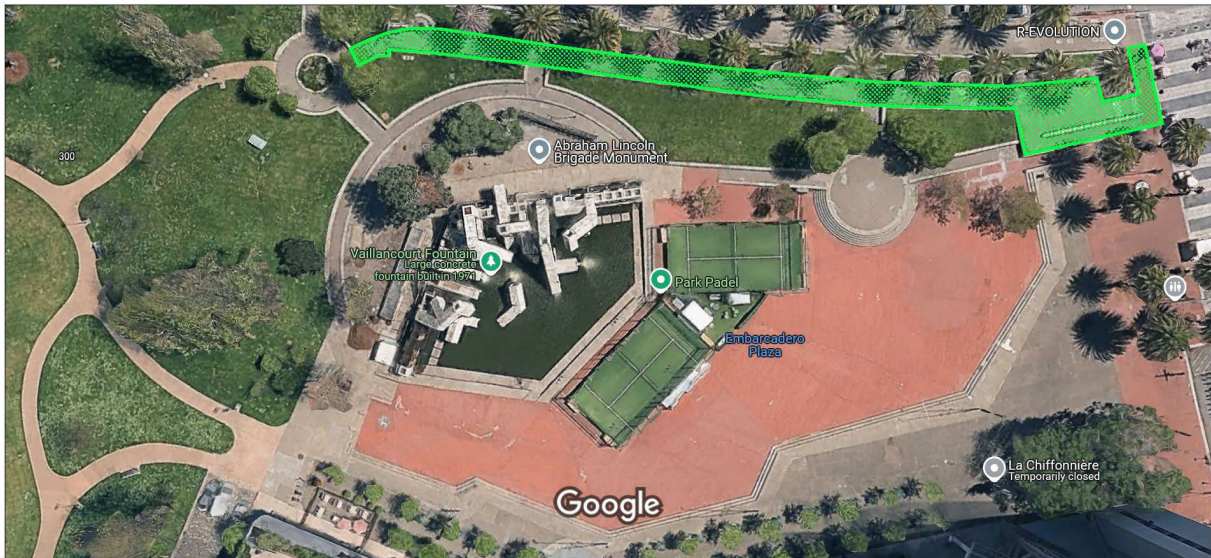
Figure 4. SE Walk

The SE walk, located on the elevated edge of the plaza, is generally flat and accessible. It can be accessed via stairs and a sloped walkway from Market Street at the south, and by a set of stairs connecting to the NE walk at the north end. While the running slopes were within compliant limits, two issues were observed:

- The lower handrails at the south entry do not include the required 12-inch horizontal extensions.
- The intermediate stair landing has a slope of approximately 3.6%, which exceeds the maximum allowed for a level landing.

Repair stair landings to ensure compliance. Modify handrails to meet the 12-inch horizontal extension requirement.

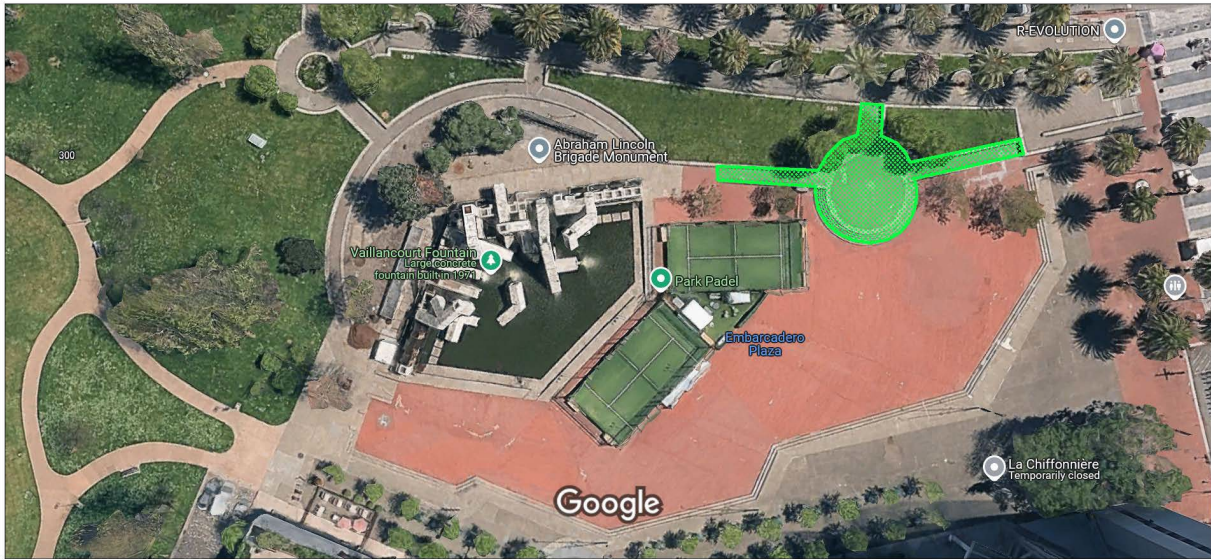
Figure 5. SW Walk

The SW walk consists of two sloped paths that descend from a semi-circular stair and raised platform area overlooking the plaza. Portions of the walk exhibit running slopes exceeding the 5% maximum (up to 6%). No cross-slope issues were noted. At the north end of the stairway, an electrical cabinet or device encroaches into the required 48-inch stair landing depth

Repair walkway segments with excessive running slope. Relocate the electrical equipment or reposition the handrail to maintain the required landing depth.

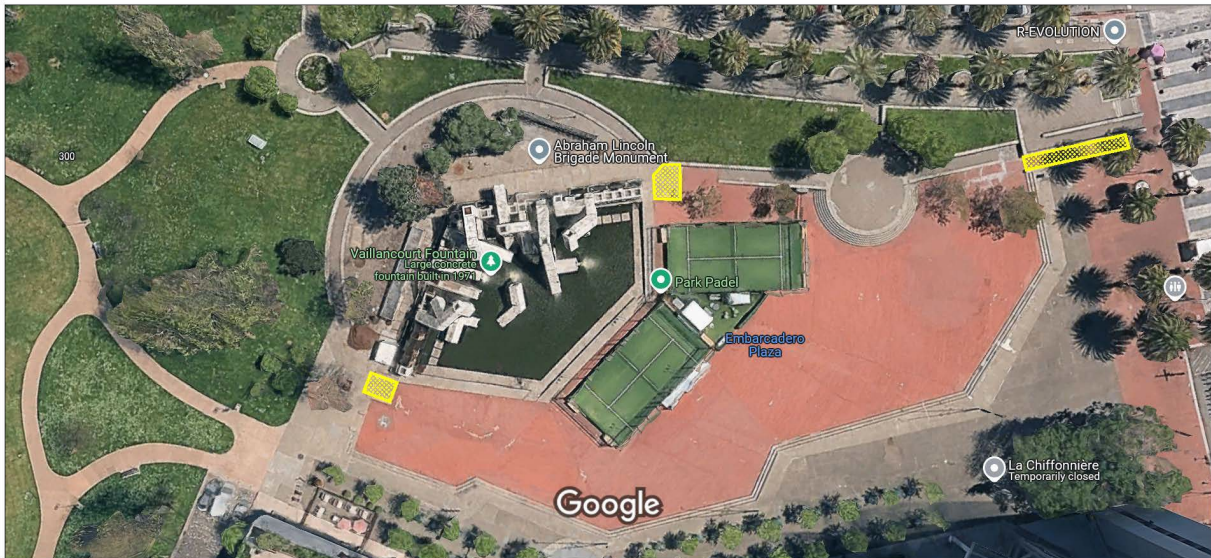
Figure 6. Sloped Walks

Three sloped walkways provide the main accessible routes into the plaza.

- The north sloped walk is in poor condition, with significant cross slope issues and deteriorated surface conditions.
- The east sloped walk has a running slope measured at 9.9%, which exceeds the maximum allowable 5%.
- The south sloped walk, which connects from Market Street, was observed to be compliant in both slope and surface condition.

Repair sloped walk entries as necessary to correct excessive cross-slopes and running slopes.

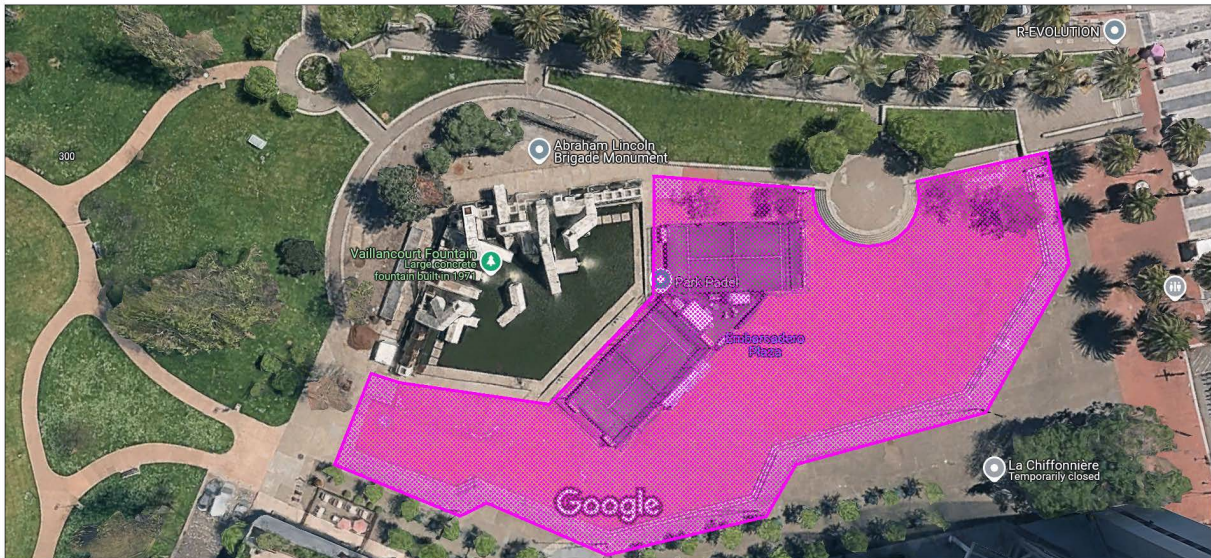
Figure 7. Plaza

The brick plaza is accessed via three primary sloped entries, as well as a continuous set of steps along the south and west edges. Overall, the plaza gently slopes downward toward the Vaillancourt Fountain. While much of the area appears relatively flat, approximately half of the surface exhibits accessibility issues due to localized non-compliant cross-slopes and irregularities caused by brick displacement and settlement.

- Cross slopes ranging from 2.9% to 10%, primarily concentrated on the western portion of the plaza.
- Cross slope issues at fountain border
- Surface undulation and unevenness at the top and bottom approaches to the steps.
- Missing handrails at the stairways.
- Lack of visual contrast (striping) at stair treads

Repair brick plaza surfaces as needed to correct excessive cross slopes. Repair approach areas at stairways. Install compliant handrails and provide visual contrast (e.g., contrasting stripes) on stair treads.

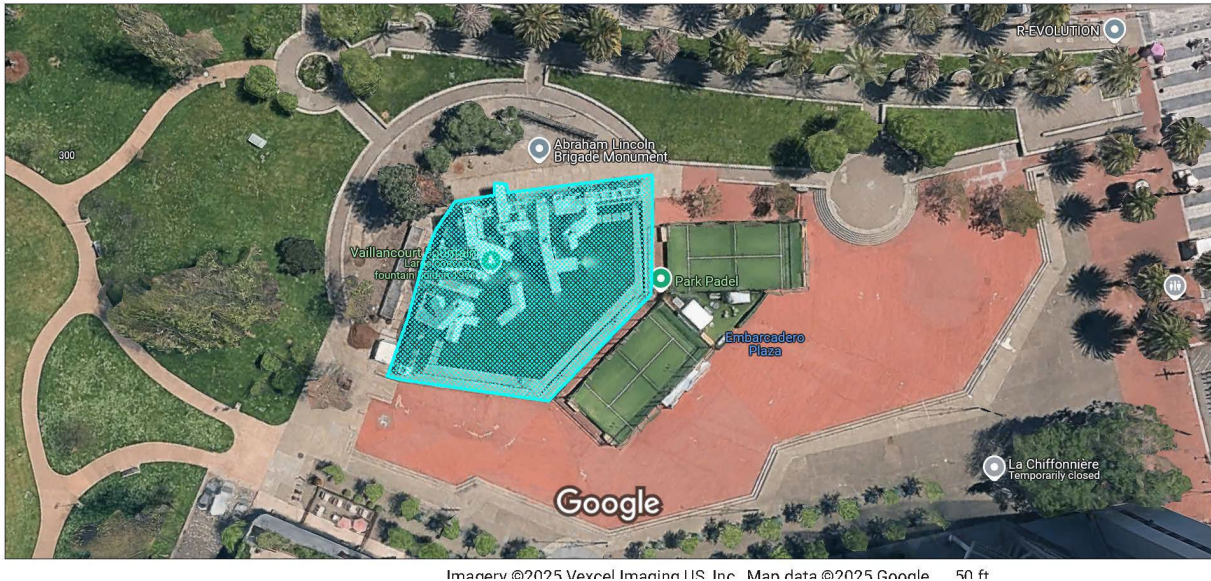
Figure 8. Vaillancourt Fountain

The Vaillancourt Fountain is located at the northeast corner of Embarcadero Plaza. It is bordered by a raised concrete block, approximately 6 to 8 inches above the main plaza level, which separates the main plaza from a lower-level walkway surrounding the fountain. This surrounding walk is only accessible via two sets of stairs, effectively precluding wheelchair users or others with mobility aids from reaching the fountain's edge.

- No accessible route to the edge of the fountain; access is only via stairs.
- Excessive gaps between concrete lily pads.
- No edge protection at the lily pads or along the fountain's water edge.

- No edge protection at the raised concrete block. Though it may function as a seating area, it connects to the plaza by a short ramp, making it a walkway under accessibility standards.

- Cross slope conditions along the walkway at the back of the fountain exceeds 2% (observed up to 2.5%).
- Raised path and cobblestone walking surface at the rear of fountain.

- Observation decks are not accessible, due to:
  - Open risers on stairs
  - Lack of handrail extensions
  - Absence of contrasting tread markings
  - Excessive openings in drainage grates on stair landings

- Surface irregularities on deck platforms
  - Guardrail openings exceeding 4 inches
  - Non-compliant guardrails on the rear side of the fountain

*Provide an accessible route to the fountain perimeter by modifying or reconstructing approaches. Install edge protection where required along raised walking surfaces and water features. Modify or restrict access to the lily pad area unless fully compliant which could include filling the gaps between the pads as well as adding edge protection or another barrier such as a guardrail. Restrict access to or redesign the observation decks to eliminate barriers and ensure accessible use, including compliant handrails, stair treads, guardrails, walking surfaces and the addition of an alternate means of access. Repair the walkway behind the fountain including adding curb ramps at the raised walkway and reposition the cobblestones to provide a compliant path throughout the area.*
