***Regular Meeting of the
Abatement Appeals Board***

Statement to the San Francisco Abatement Appeals Board Regarding

NOV202424763 at 4757 19th Street

Scott Guerin, 46 Eagle Street

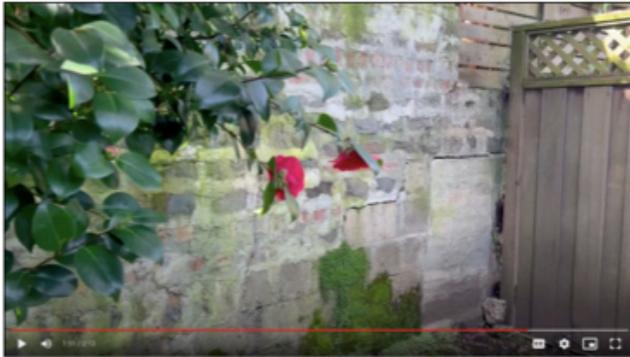
30-32 Eagle Facing North Towards 4741 19th

Exhibit 4 shows photographs of the property line between 30-32 Eagle St. and 4741 19th St. There is an abrupt change in the age and composition of the building materials at the property line. Importantly, this property line does not involve 46 Eagle St.

Exhibit 4: Photographs of the property line between 30-32 Eagle St. and 4741 19th St., showing an abrupt change in the age and composition of building materials.

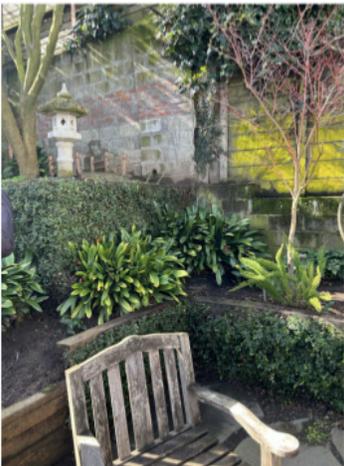
There is also an abrupt change in the composition and configuration of the materials between 4757 19th St. and 4741 19th St. ([Exhibit 5](#))

Exhibit 5: Photographs showing an abrupt change in the composition and configuration of materials between 4757 19th St. and 4741 19th St. Photos show the eastern (middle picture) and central (right picture) buttresses on the 4757 19th St. property. The western buttress is also 4757 19th St. property but is obscured by ivy.

4741 19th Street facing west towards
4757 19th Street.
Photo taken 2/5/23

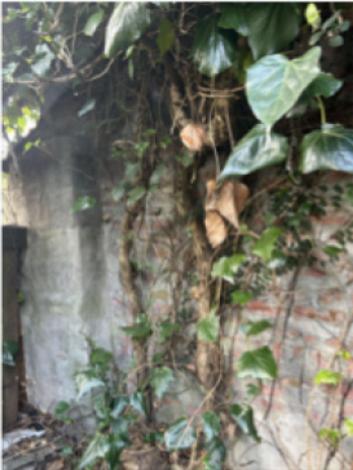
4757 19th Street facing east towards
4741 19th Street.
Photo taken 1/25/25

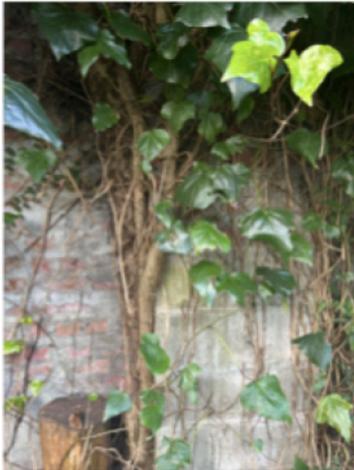
4757 19th Street facing south towards
46 Eagle Street.
Photo taken 1/25/25

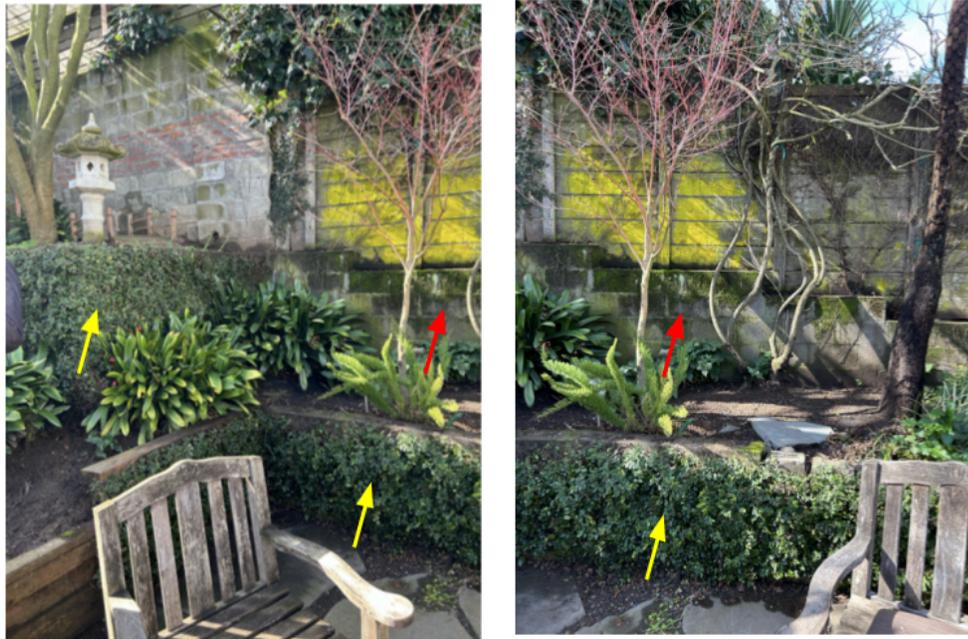
Exhibit 9 shows a retaining wall adjoining 4741 19th St and 4757 19th Street and also shows retaining walls built entirely within 4741 19th St. The style of the walls match the wall with the large vertical crack.

Exhibit 9: Photograph taken in rear yard of 4741 19th St. showing a retaining wall adjoining 4741 19th St. and 4757 19th St. (red arrows), and also retaining walls built entirely within 4741 19th St. (yellow arrows).

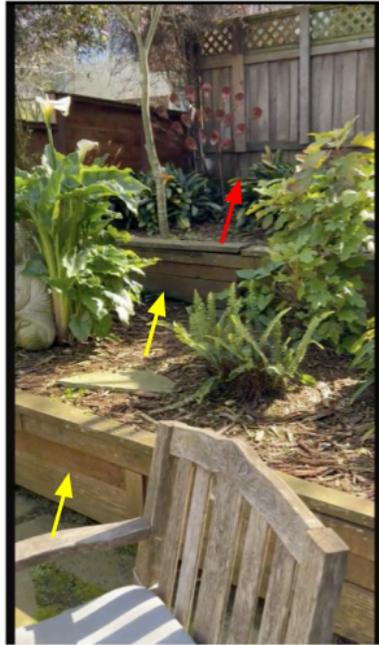
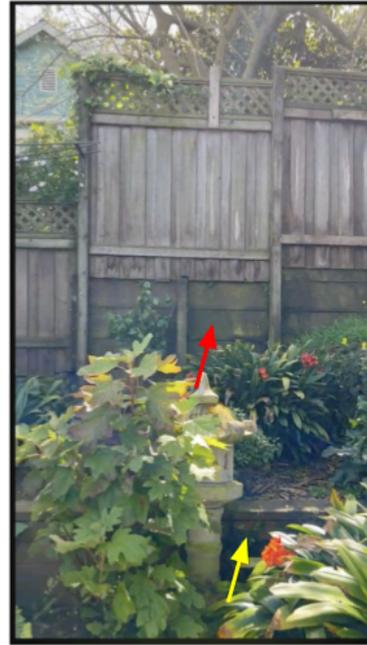
Exhibit 10: : Photograph taken in rear yard of 4741 19th St. showing a retaining wall adjoining 4741 19th St. and 30 Eagle St. (red arrows), and also retaining walls built entirely within 4741 19th St (yellow arrows).

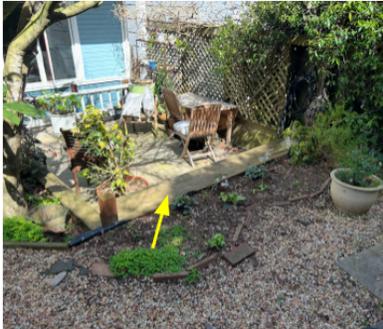
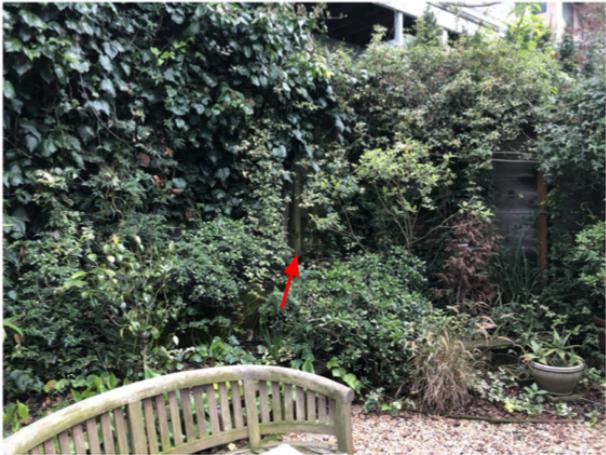
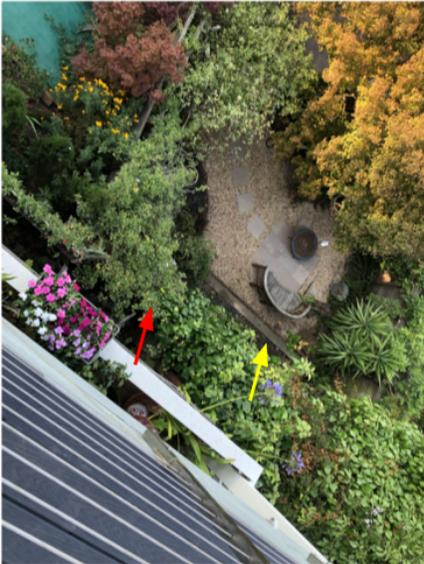
Exhibit 11: Photographs of the rear yard of 4757 19th St. showing retaining walls adjoining 50 Eagle St. (red arrows), and also retaining walls built entirely within 4757 19th St (yellow arrows).
