***Regular Meeting of the
Abatement Appeals Board***

APPELLANT STATEMENT TO THE ABATEMENT APPEALS BOARD

4757 19th Street – Request for Removal of Notice of Violation #202424763-A

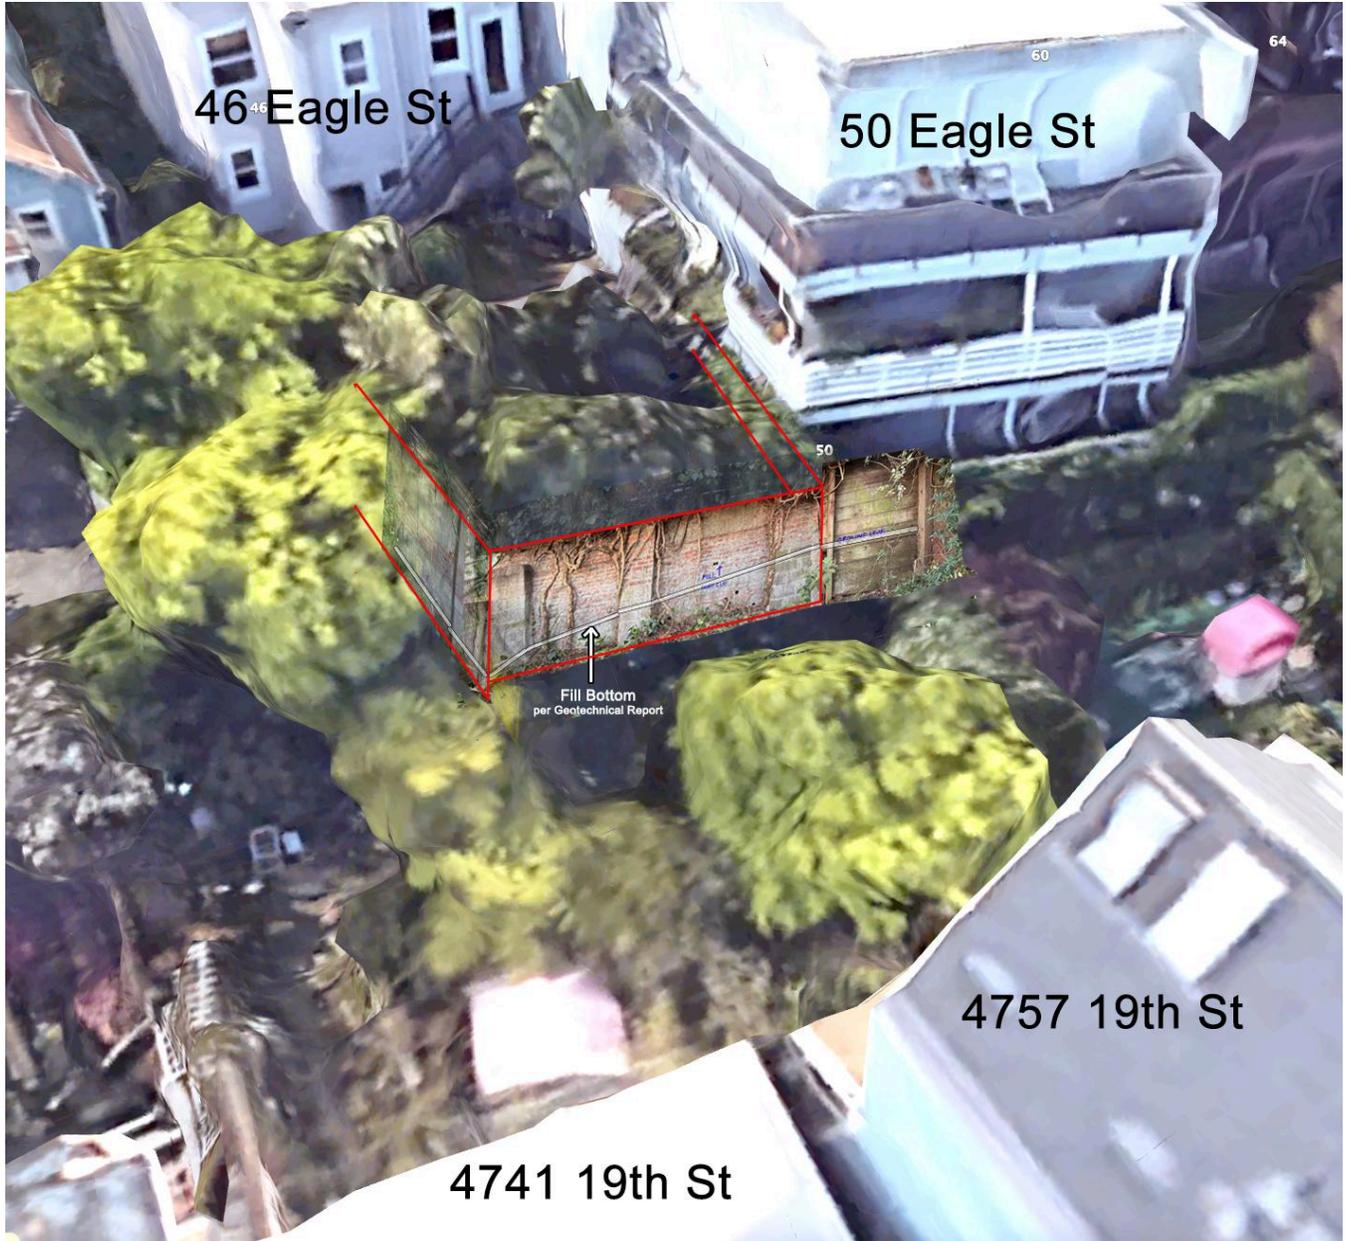
Exhibit B: Aerial 2025

Shows site with wall photos superimposed. The white superimposed line represents the approximate bottom of the fill on the 46 Eagle side.

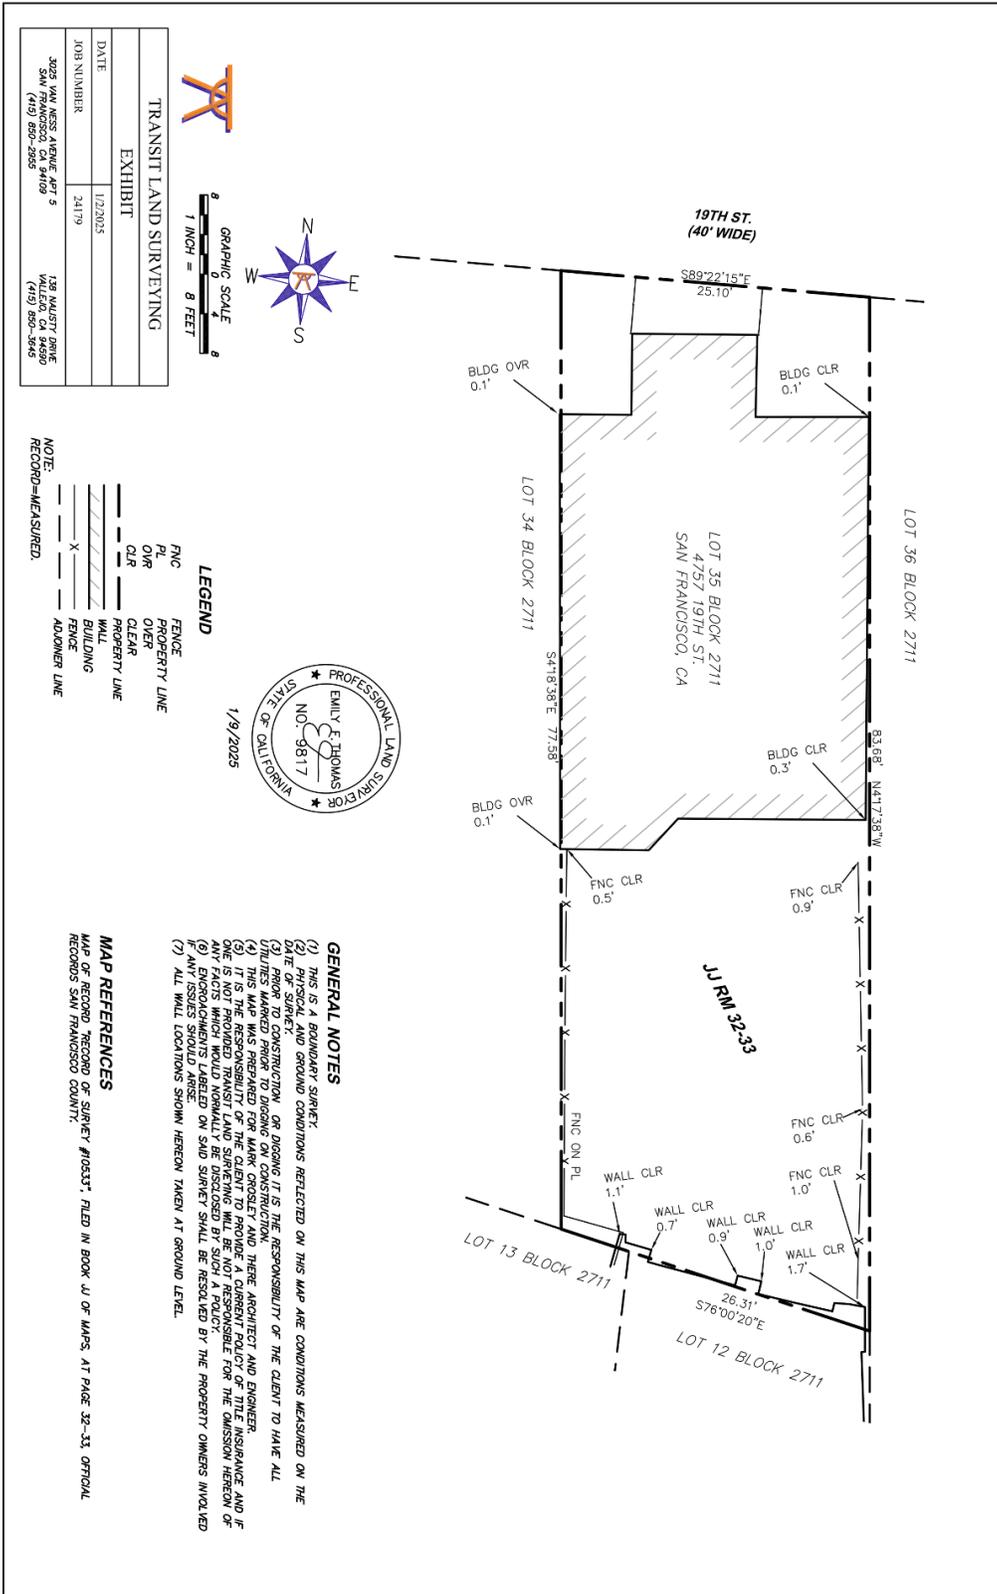
Exhibit C: Site survey 2025

Establishes geometry and encroachment.

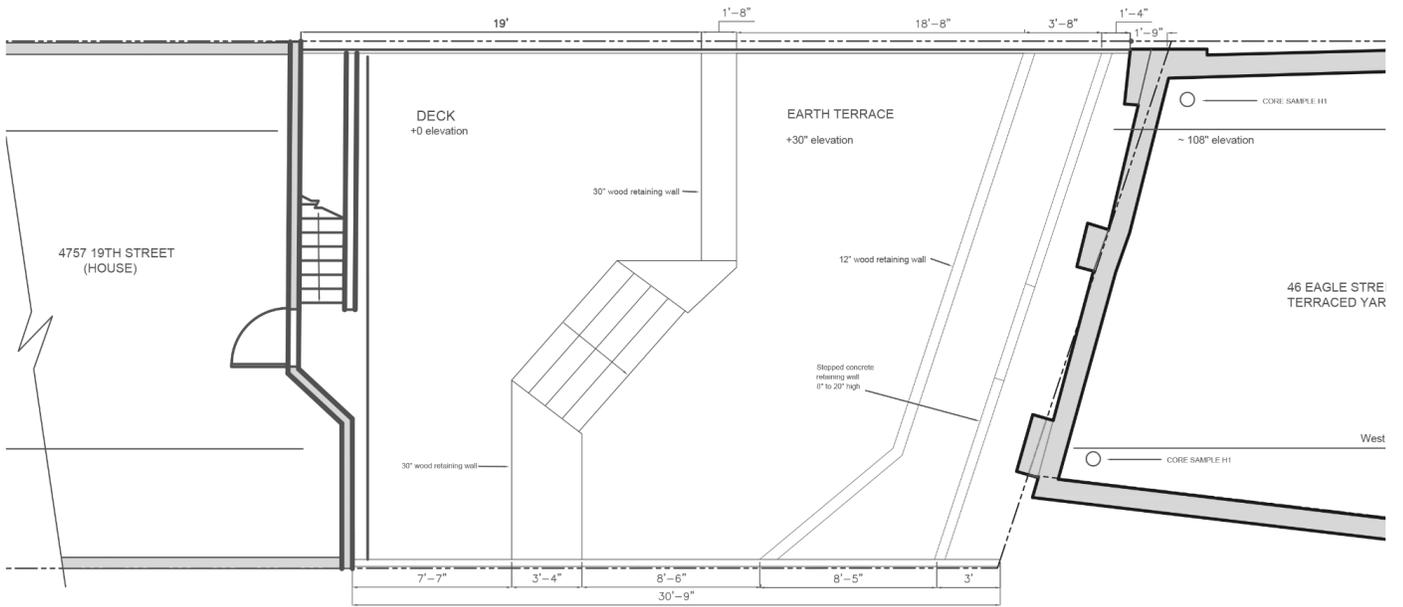
Exhibit D: Site plan - current

Shows relationship of parcels and wall.

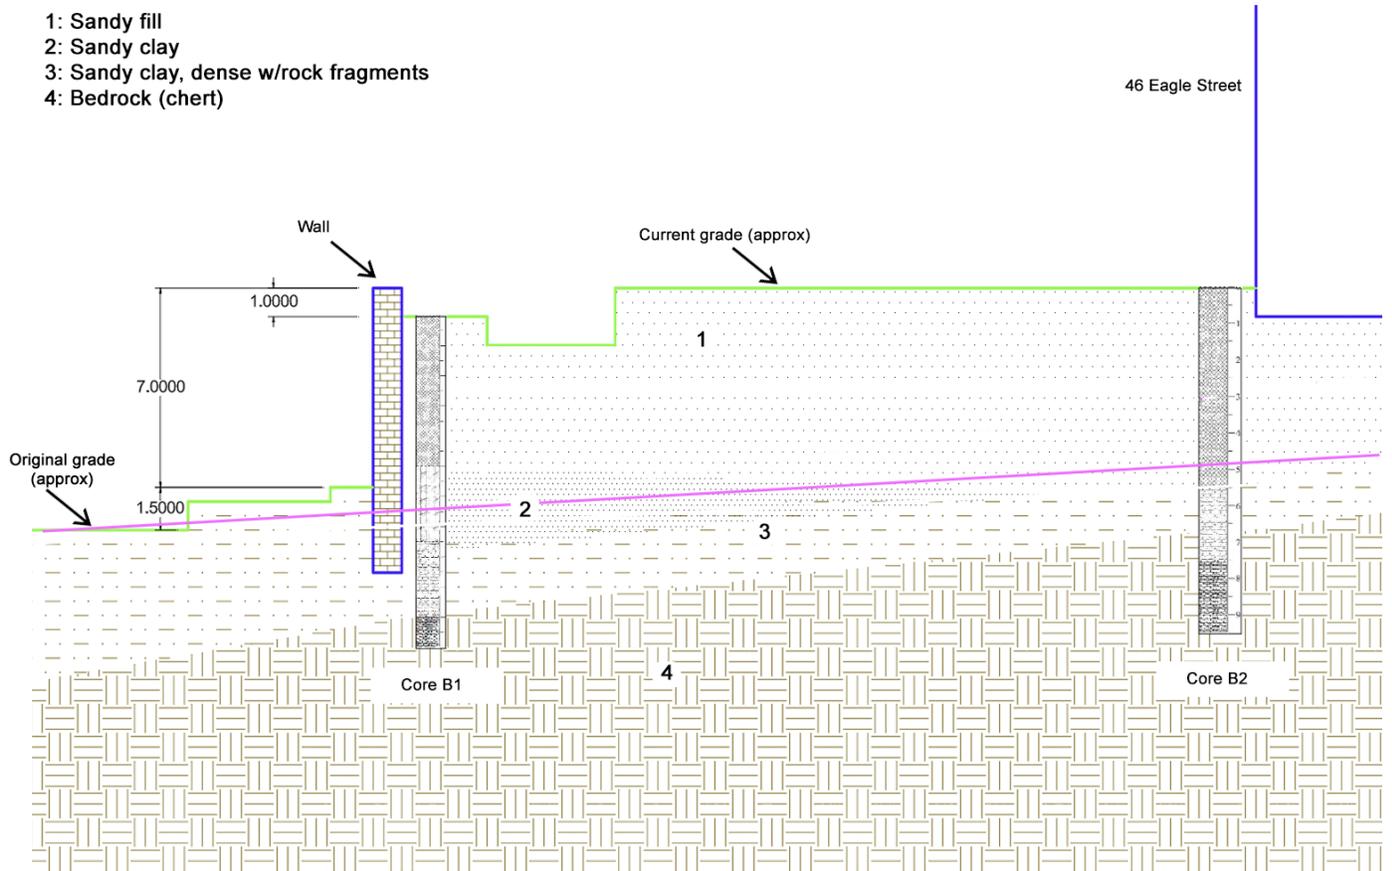
Exhibit E: East Section

- 1: Sandy fill
- 2: Sandy clay
- 3: Sandy clay, dense w/rock fragments
- 4: Bedrock (chert)

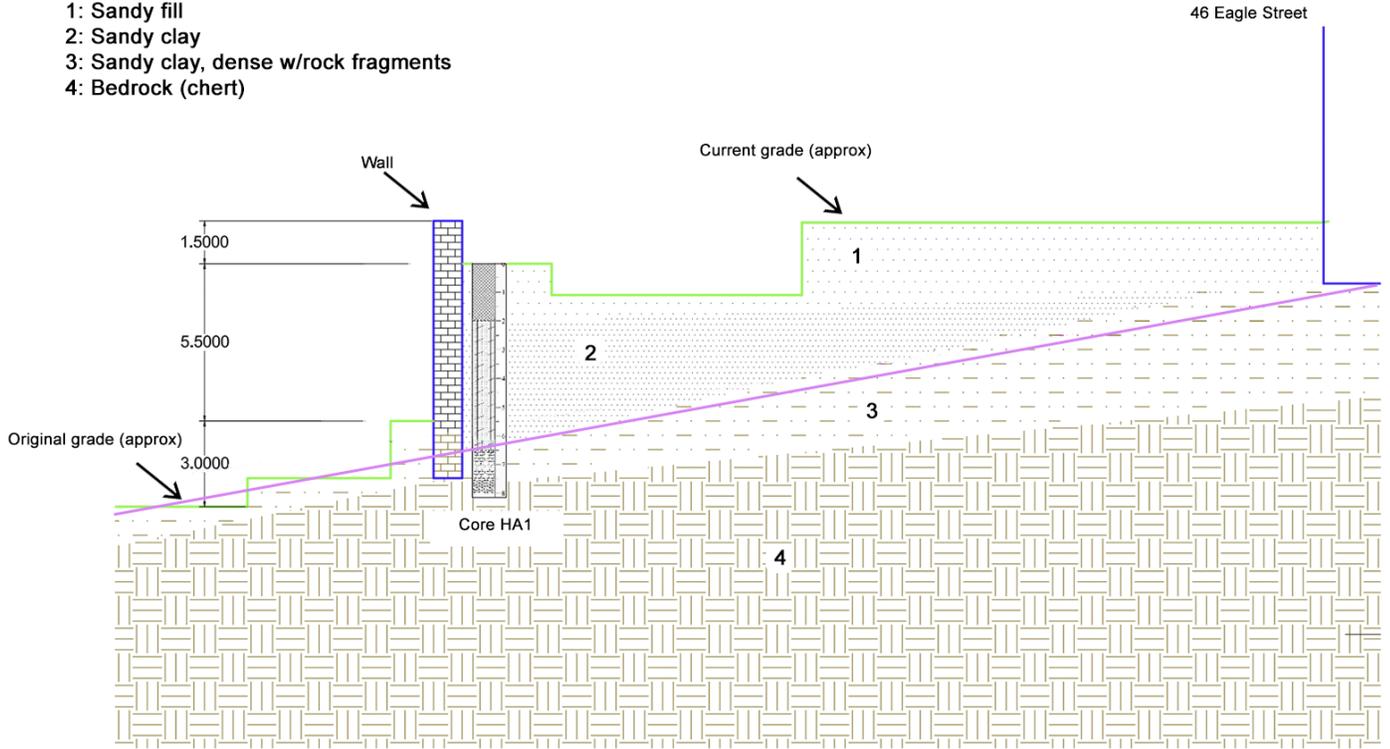
Exhibit F: West Section

- 1: Sandy fill
- 2: Sandy clay
- 3: Sandy clay, dense w/rock fragments
- 4: Bedrock (chert)

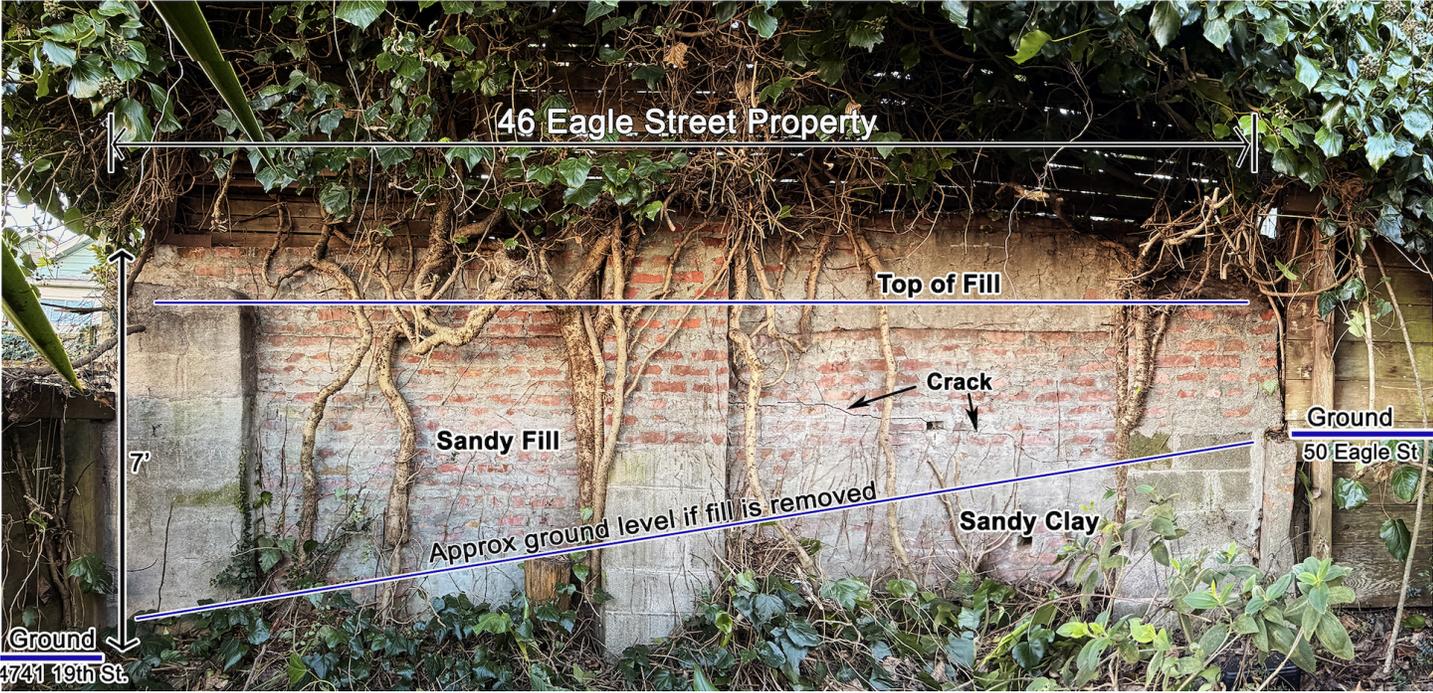
Exhibit H1: Annotated wall photo, North Wall from Appellent's backyard
Cracking and fill height.

Based on the field observations, the brick retaining wall between 4757 19th Street and 46 Eagle Street is significantly tilted and there are horizontal cracks along its length. The south-west corner of the wall has a very significant crack, and the wall is almost detached at that corner from the transverse wall. Based on our engineering judgment, the buttresses are mainly holding the subject wall in its place.

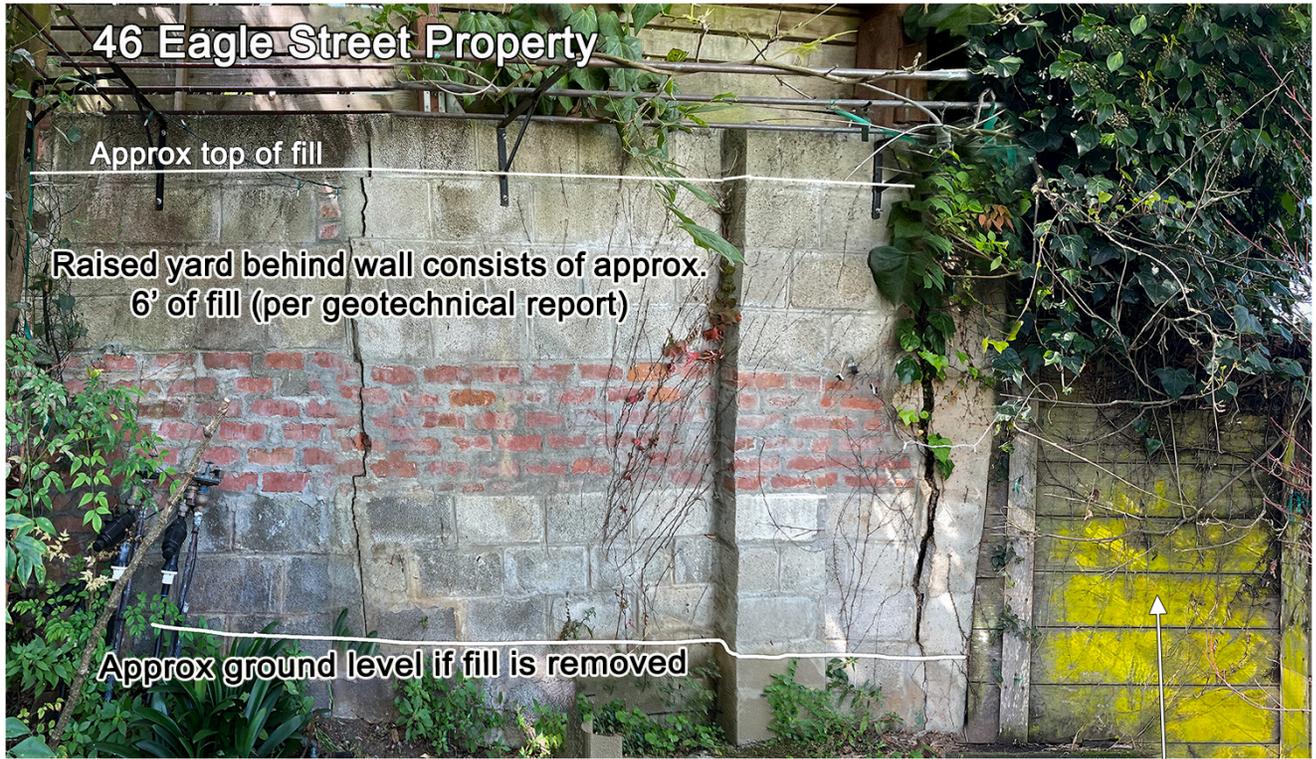
Exhibit H2

Failing Retaining Wall Holding Uphill Fill

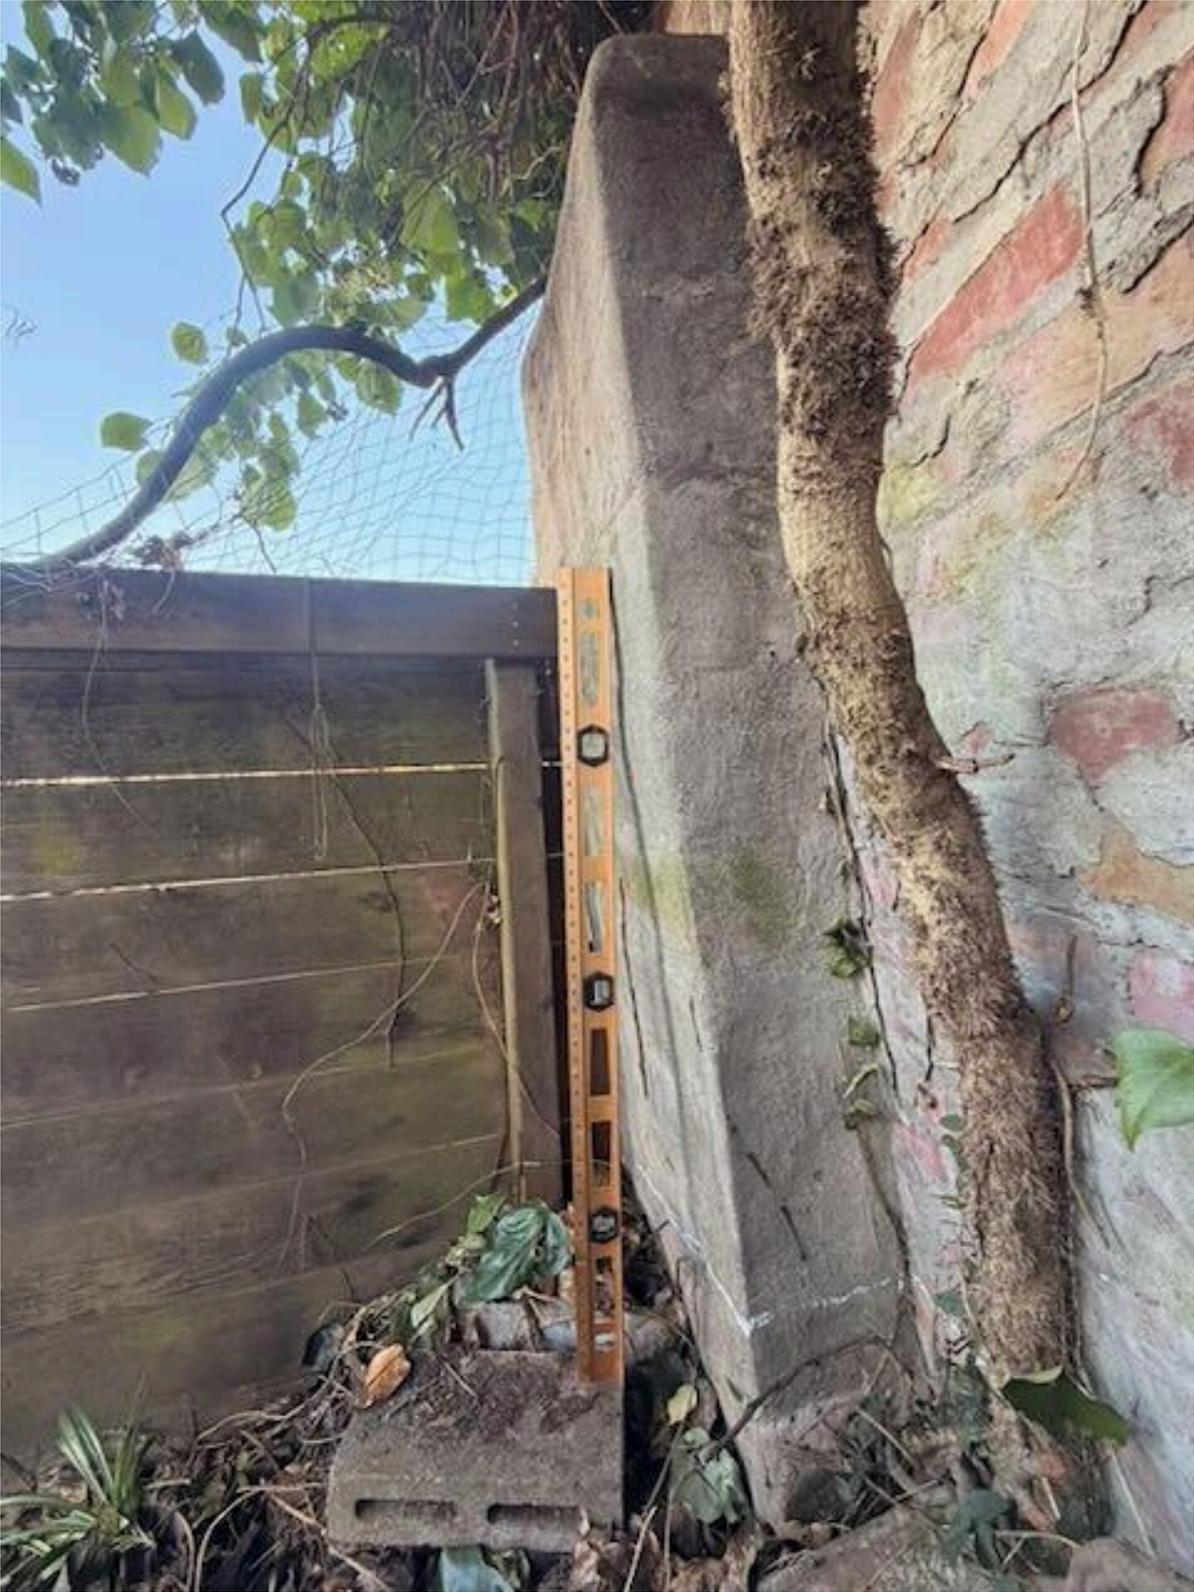
Exhibit I: Lean photo

Movement toward downhill.

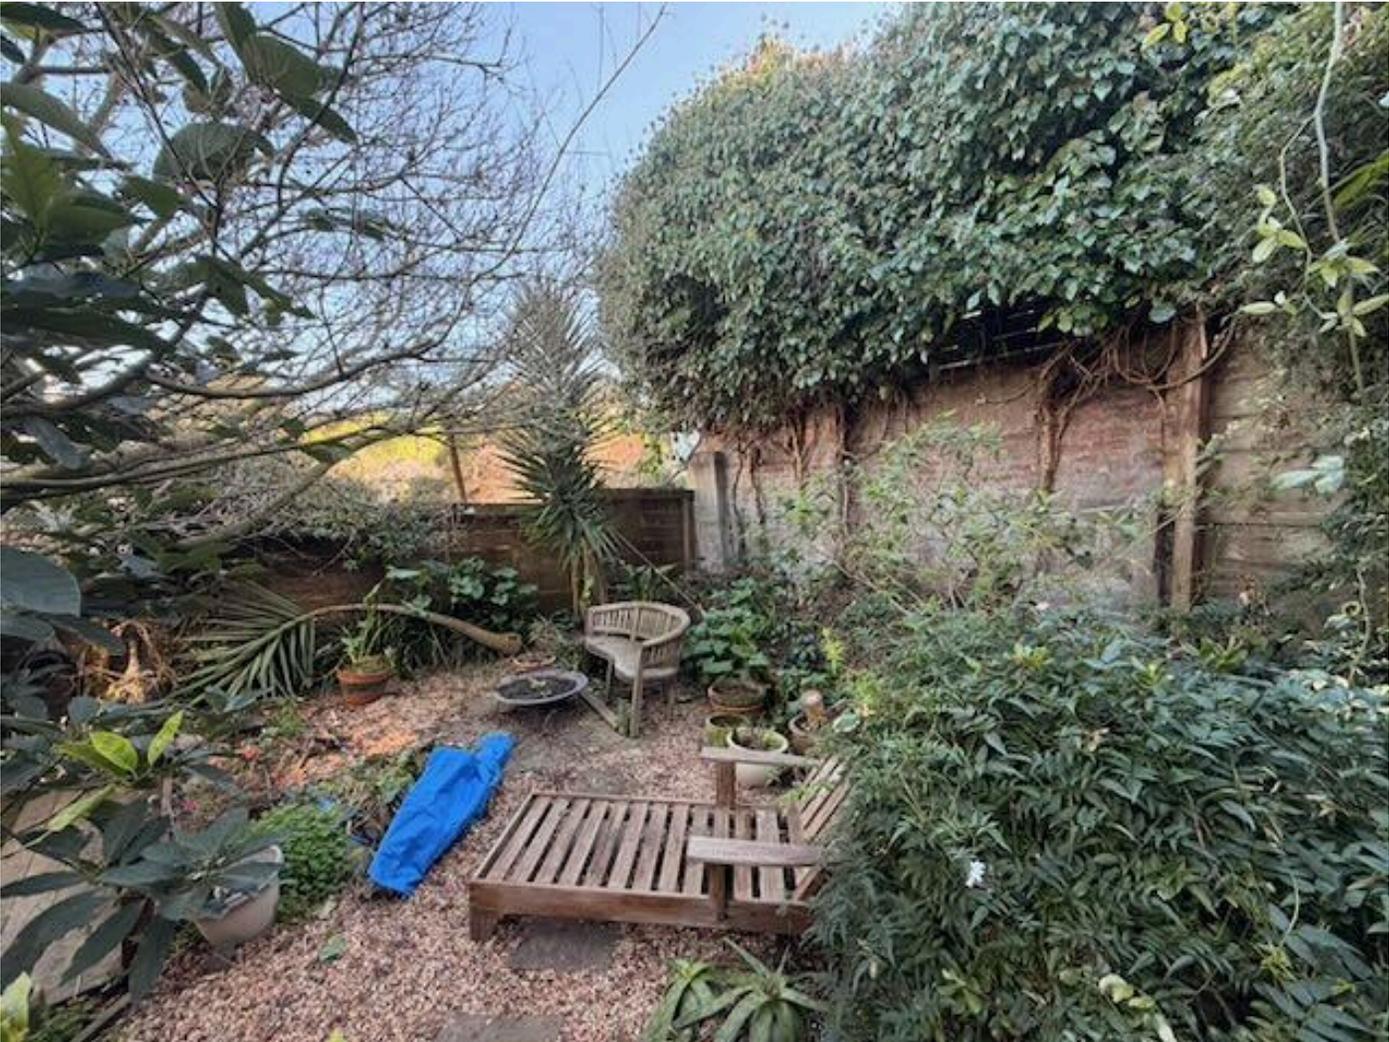
Appellant's residence is located approximately thirty-five feet downhill from the wall. Even in the event of wall failure, the residence and its occupants would not be impacted. The potential impact would be limited to garden areas within Appellant's yard. No public sidewalk, street, or right-of-way lies below the wall or within any potential fall zone.

Exhibit J: Yard distance photo Shows 35 ft to house.

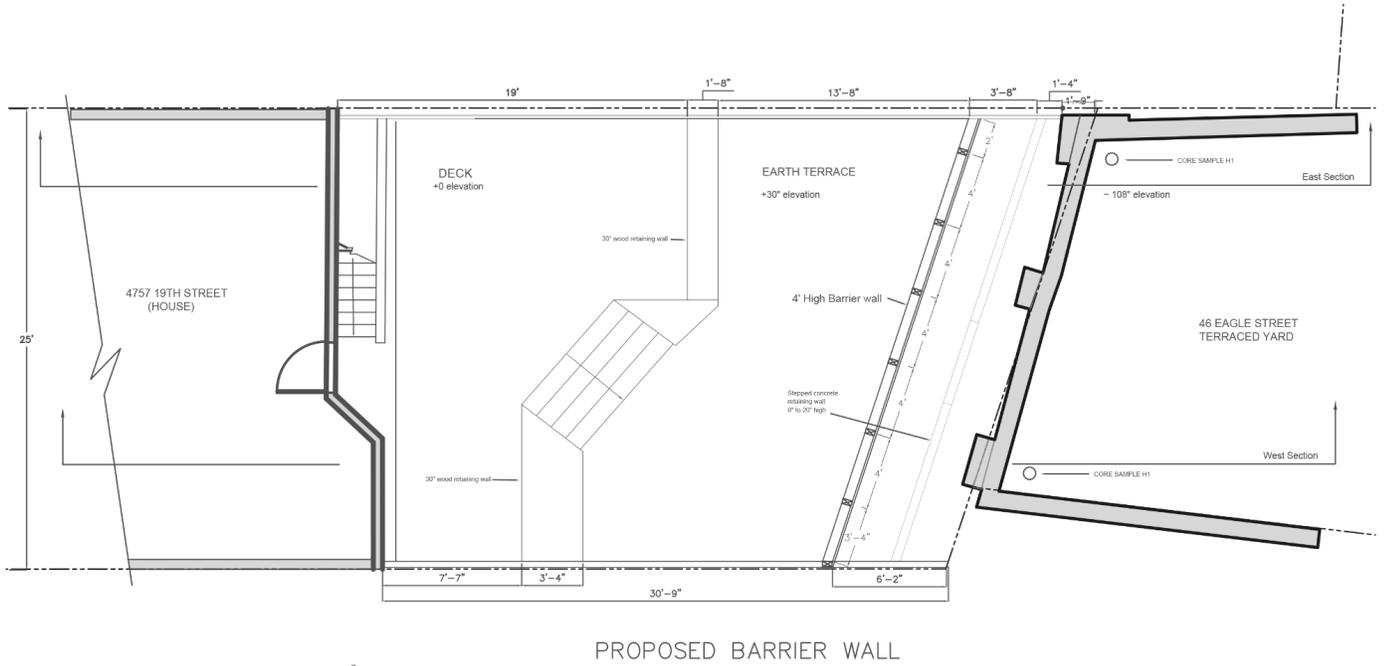
Exhibit K: Site plan with proposed barrier

Shows possible barrier to protect 4757 19th yard.

The owner of 4757 19th Street proposes building a 4-ft high fence approximately 6-ft away from the brick wall for safety reasons. Any fence less than 6-ft in height does not require engineering plans. It is recommended to keep the height less than 6-ft due to the slope at the site and 4-ft is considered adequate height to build without engineering plans. A fence is still considered to provide limited life safety in the area since it prevents someone getting too close to the wall in the event of a collapse.

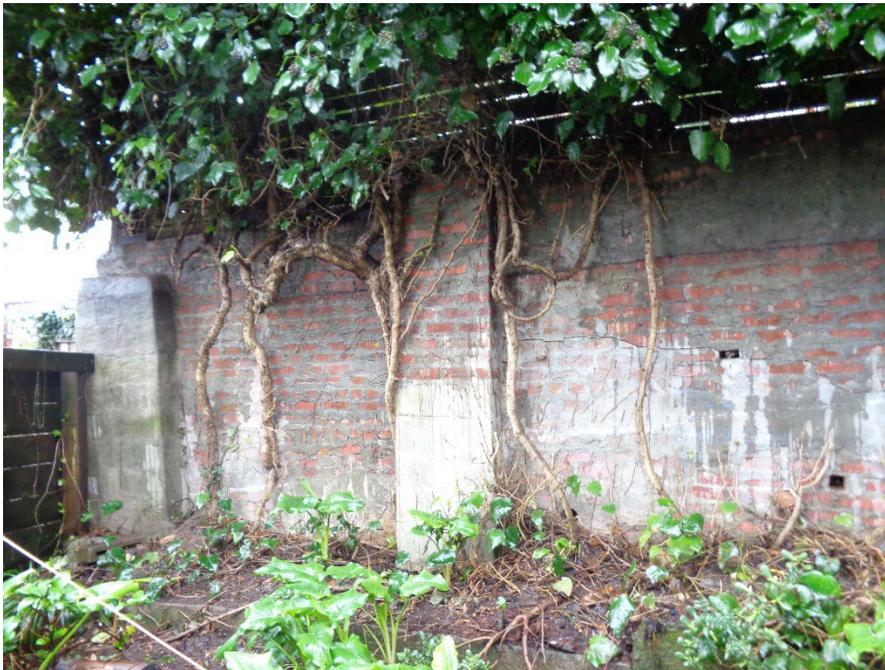
2. The existing brick retaining wall at the rear (south) side of the building

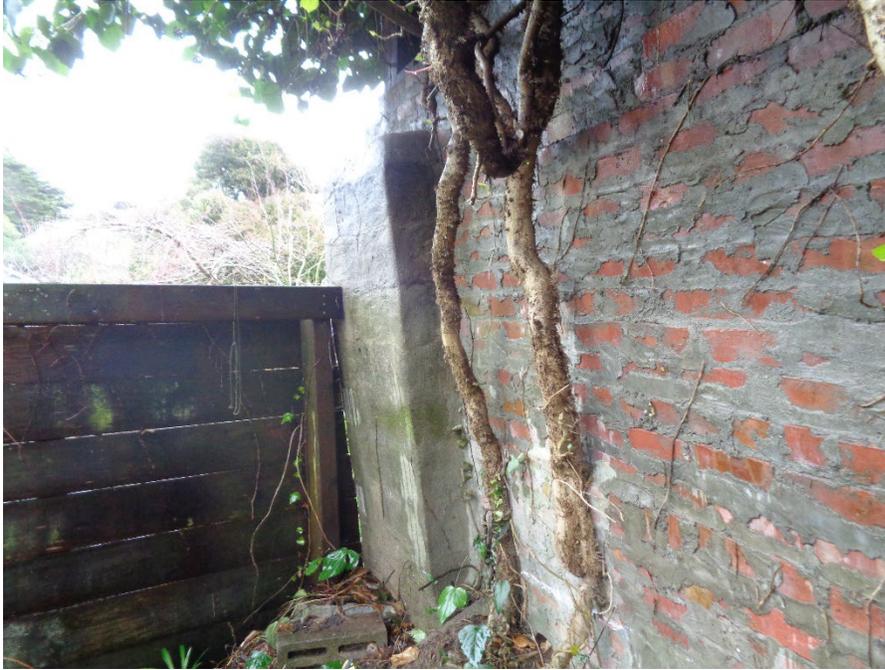
3. Tilting of the subject retaining wall

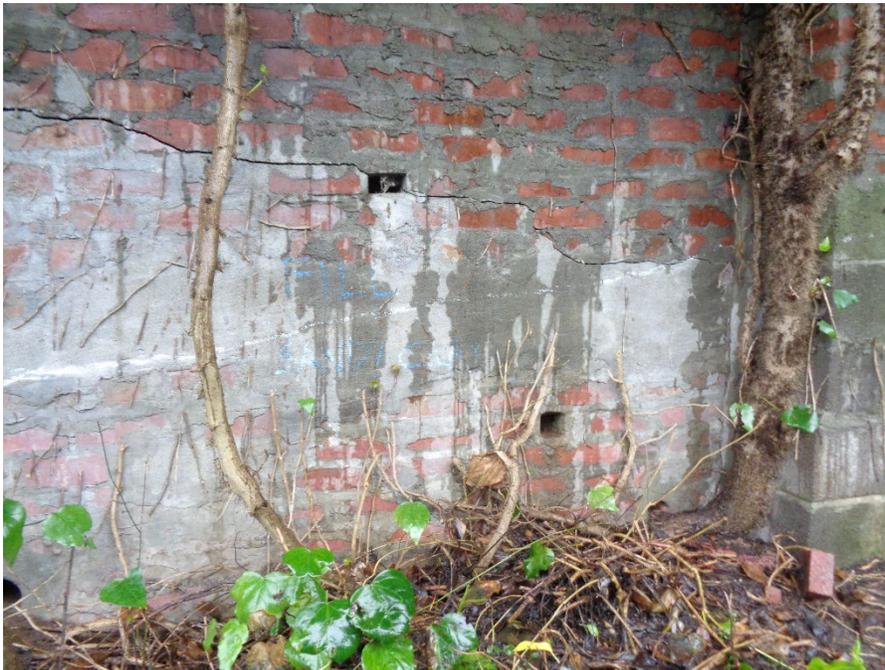
4. The horizontal and diagonal crack along the length of the existing brick retaining wall

The 7-ft high brick retaining wall can also be replaced with a shorter wall in height if the fill in the backyard of 46 Eagle Street is removed or regraded...The height of the new wall may be reduced to 3-ft to 4-ft above the ground, which will reduce the construction cost of the wall significantly.
