Date: July 25, 2025 Project Number: 23-018-01

Subject: 301 Mission Retrofit Monitoring Report 139: Results as of July 23, 2025

Millennium Tower Perimeter Pile Upgrade: Instrumentation Monitoring Data City and County of San Francisco, California

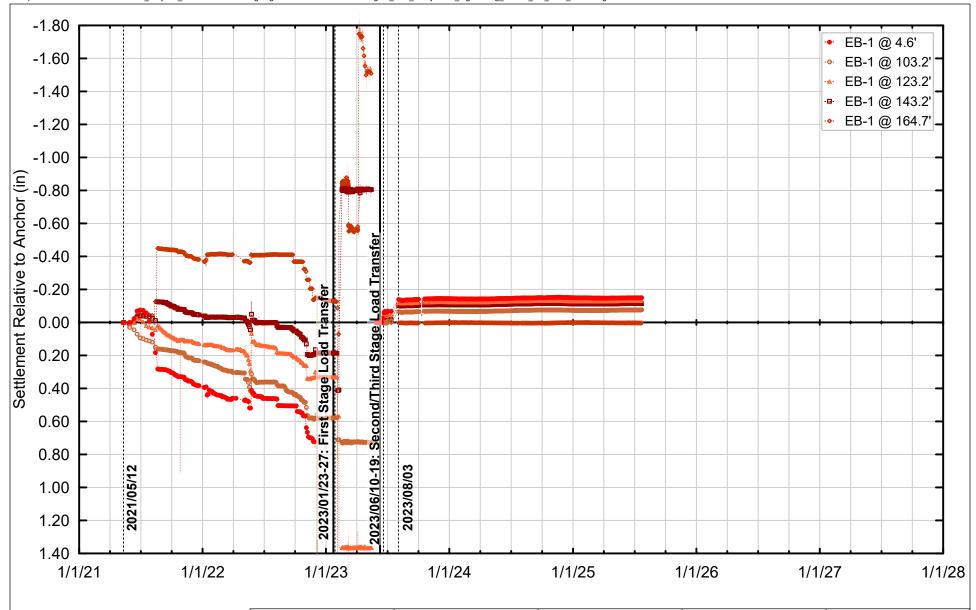
Figure No: **139-11**

Note: EB-1 was repaired and reset on 2023/05/30

EXTENSOMETER DATA FROM FREMONT STREET SINCE 05/10/2021 THROUGH 05/16/2023 SINCE 05/30/2023 THROUGH 7/23/2025

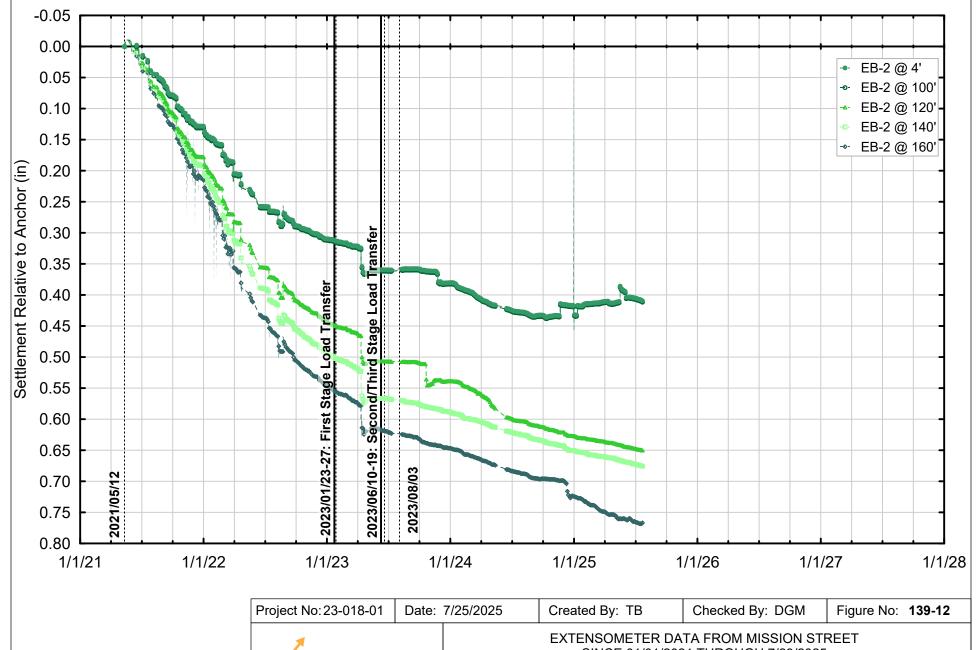
Figure 12 – Extensometer Data from Mission Street since 01/01/2021 through 7/23/2025
