To: Millennium Tower Association

Project Number: 23-018-01

Subject: 301 Mission Retrofit Monitoring Report 141: Results as of January 23, 2026

Millennium Tower Perimeter Pile Upgrade: Instrumentation Monitoring Data
City and County of San Francisco, California

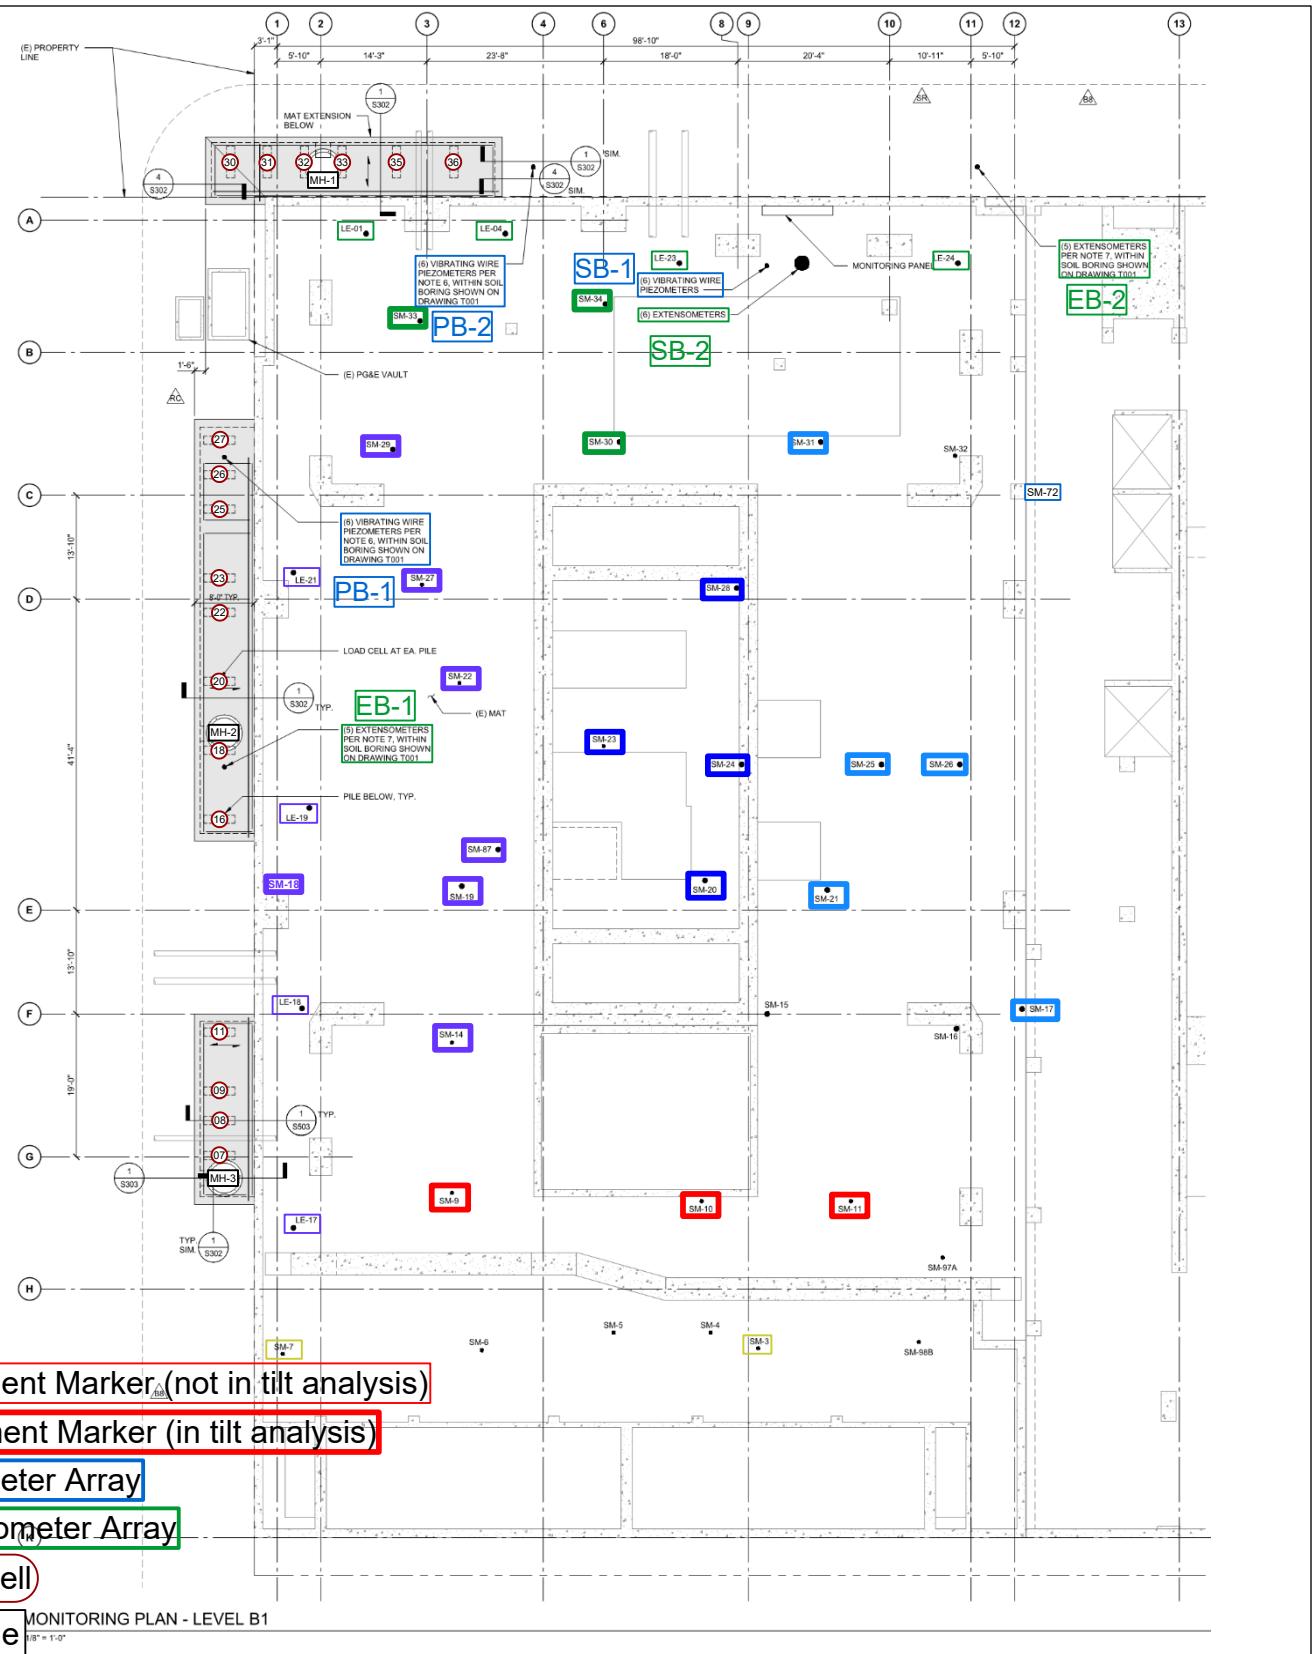
Project No: 23-018-01	Date: 8/22/2023	Created By: NBW	Checked By: DGM	Figure No: 141-01A
-----------------------	-----------------	-----------------	-----------------	--------------------

Figure 01 presents the instrument locations as referenced in later figures.

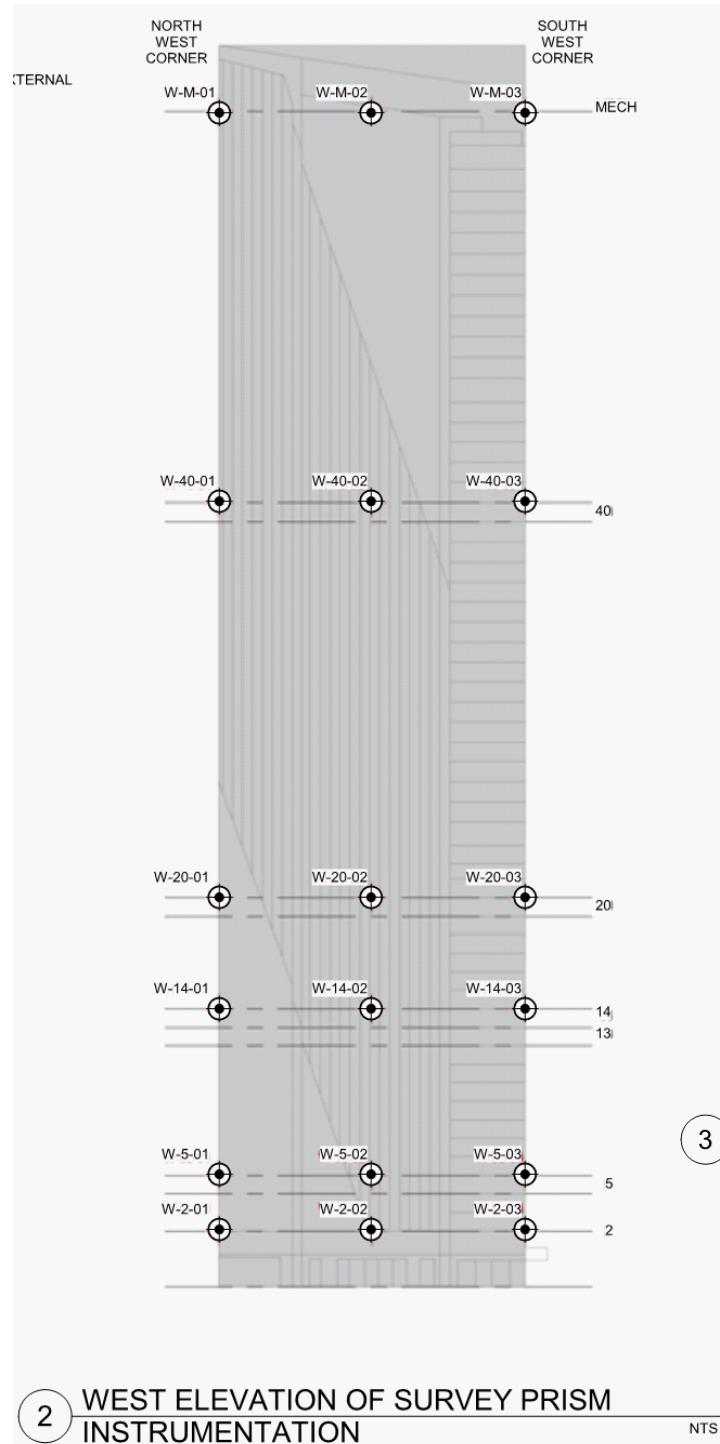
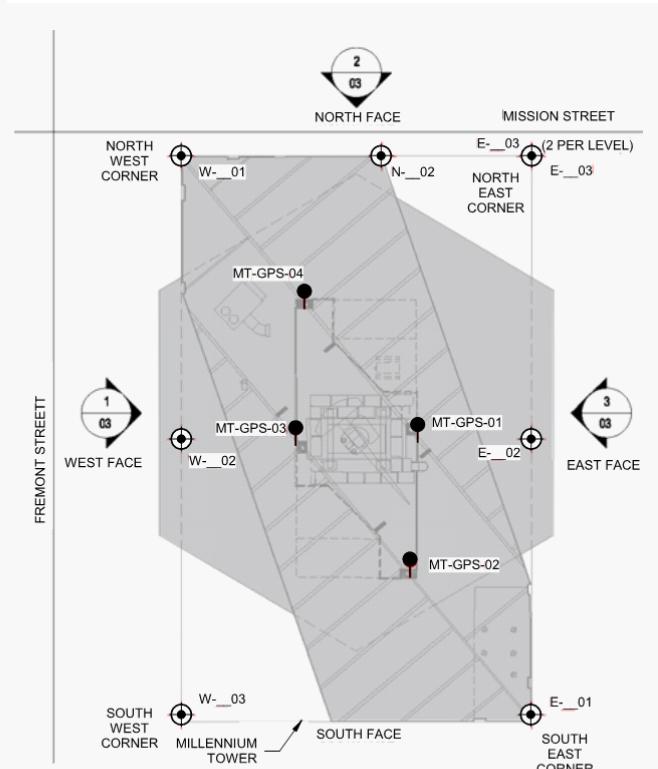
Project No:23-018-01	Date: 7/26/2021	Created By: NBW	Checked By: DGM	Figure No: 141-01B
----------------------	-----------------	-----------------	-----------------	---------------------------

3 ROOF PLAN OF SURVEY PRISM INSTRUMENTATION NTS

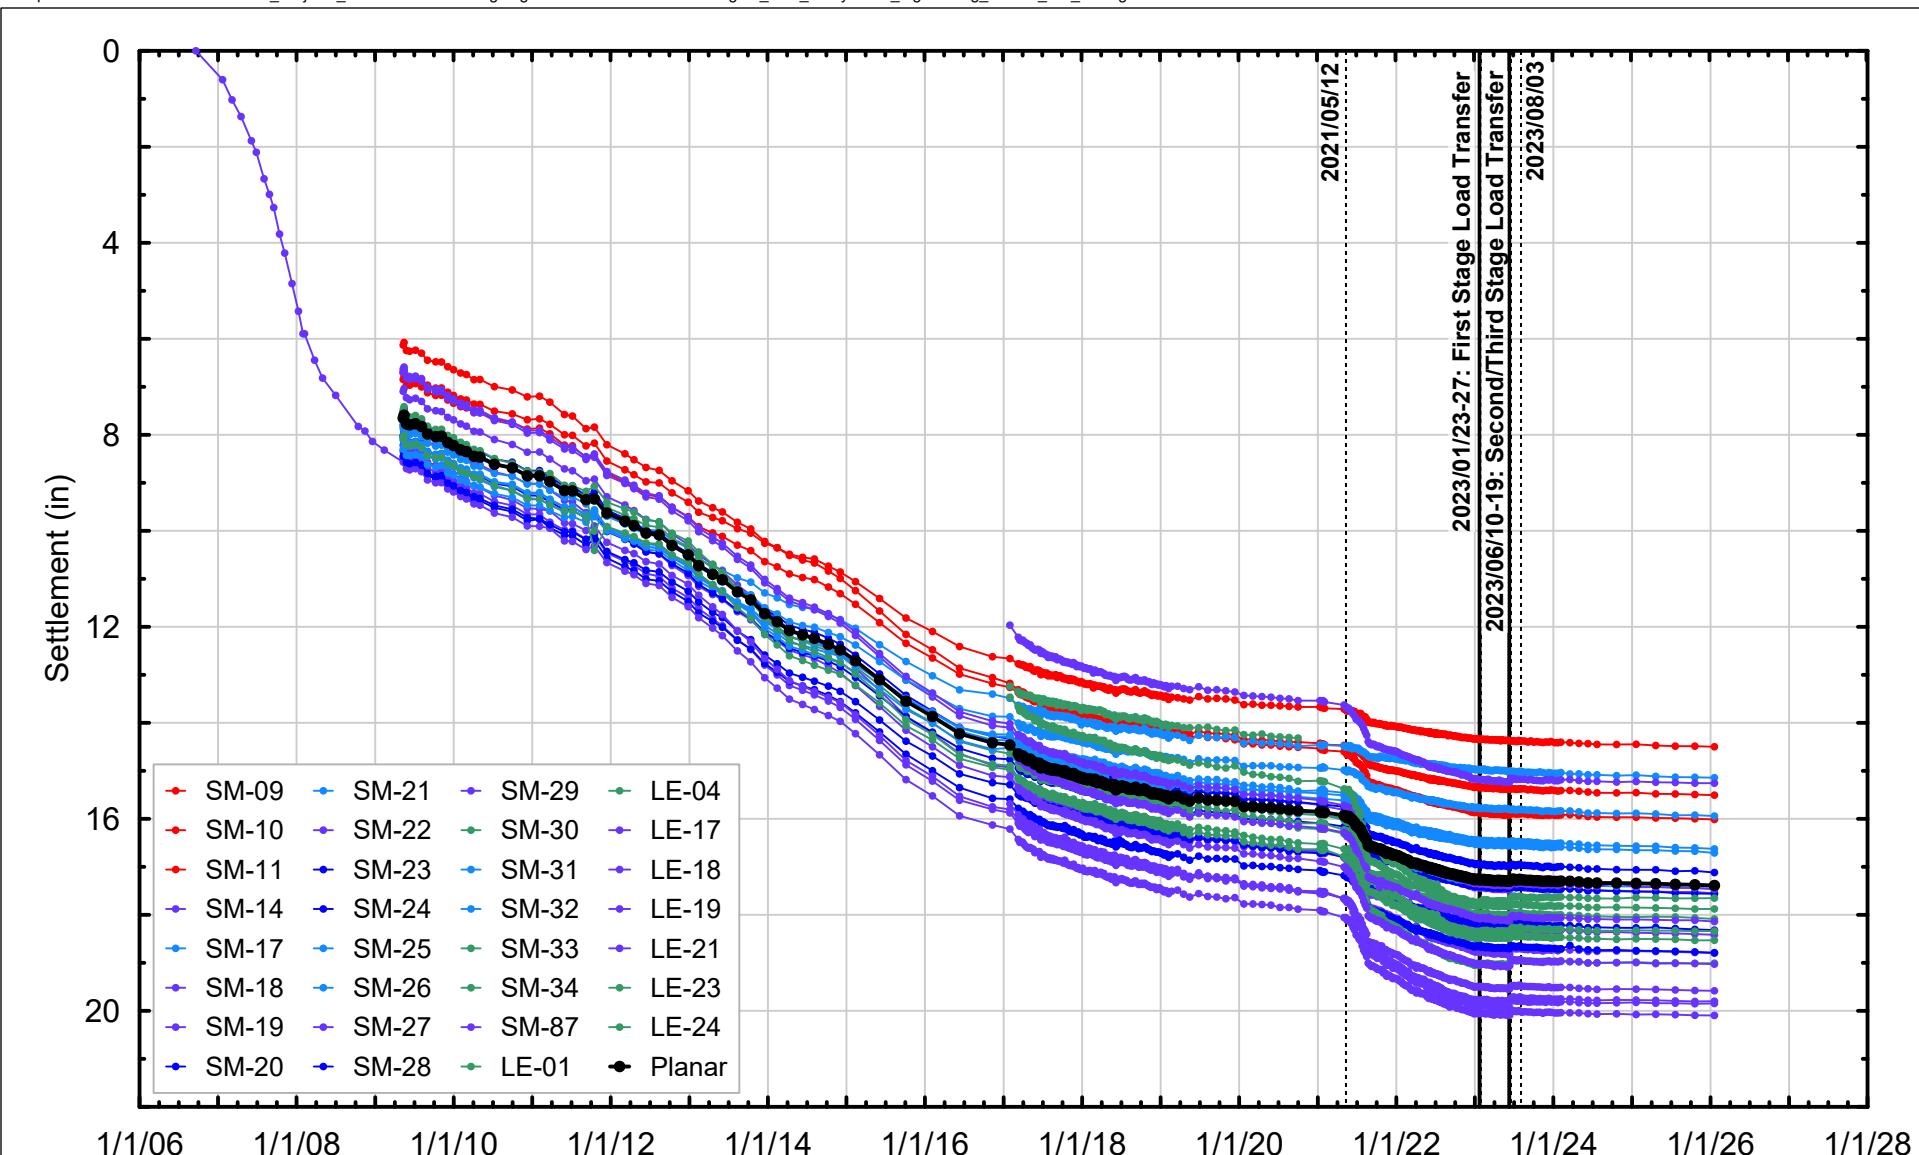
Figure No: 141-02

Figure 02 presents the historical settlement data interpreted from settlement markers installed on the B-1 Level of 301 Mission Tower. In addition, data from surveys performed during the retrofit are included. Figure 03 presents settlement data since the start of production pile installation (May 12, 2021; baseline readings on May 10, 2021) through January 19, 2026. Figure 04 presents current settlement contours (in inches) on January 19, 2026.

HISTORICAL SETTLEMENT MARKER DATA

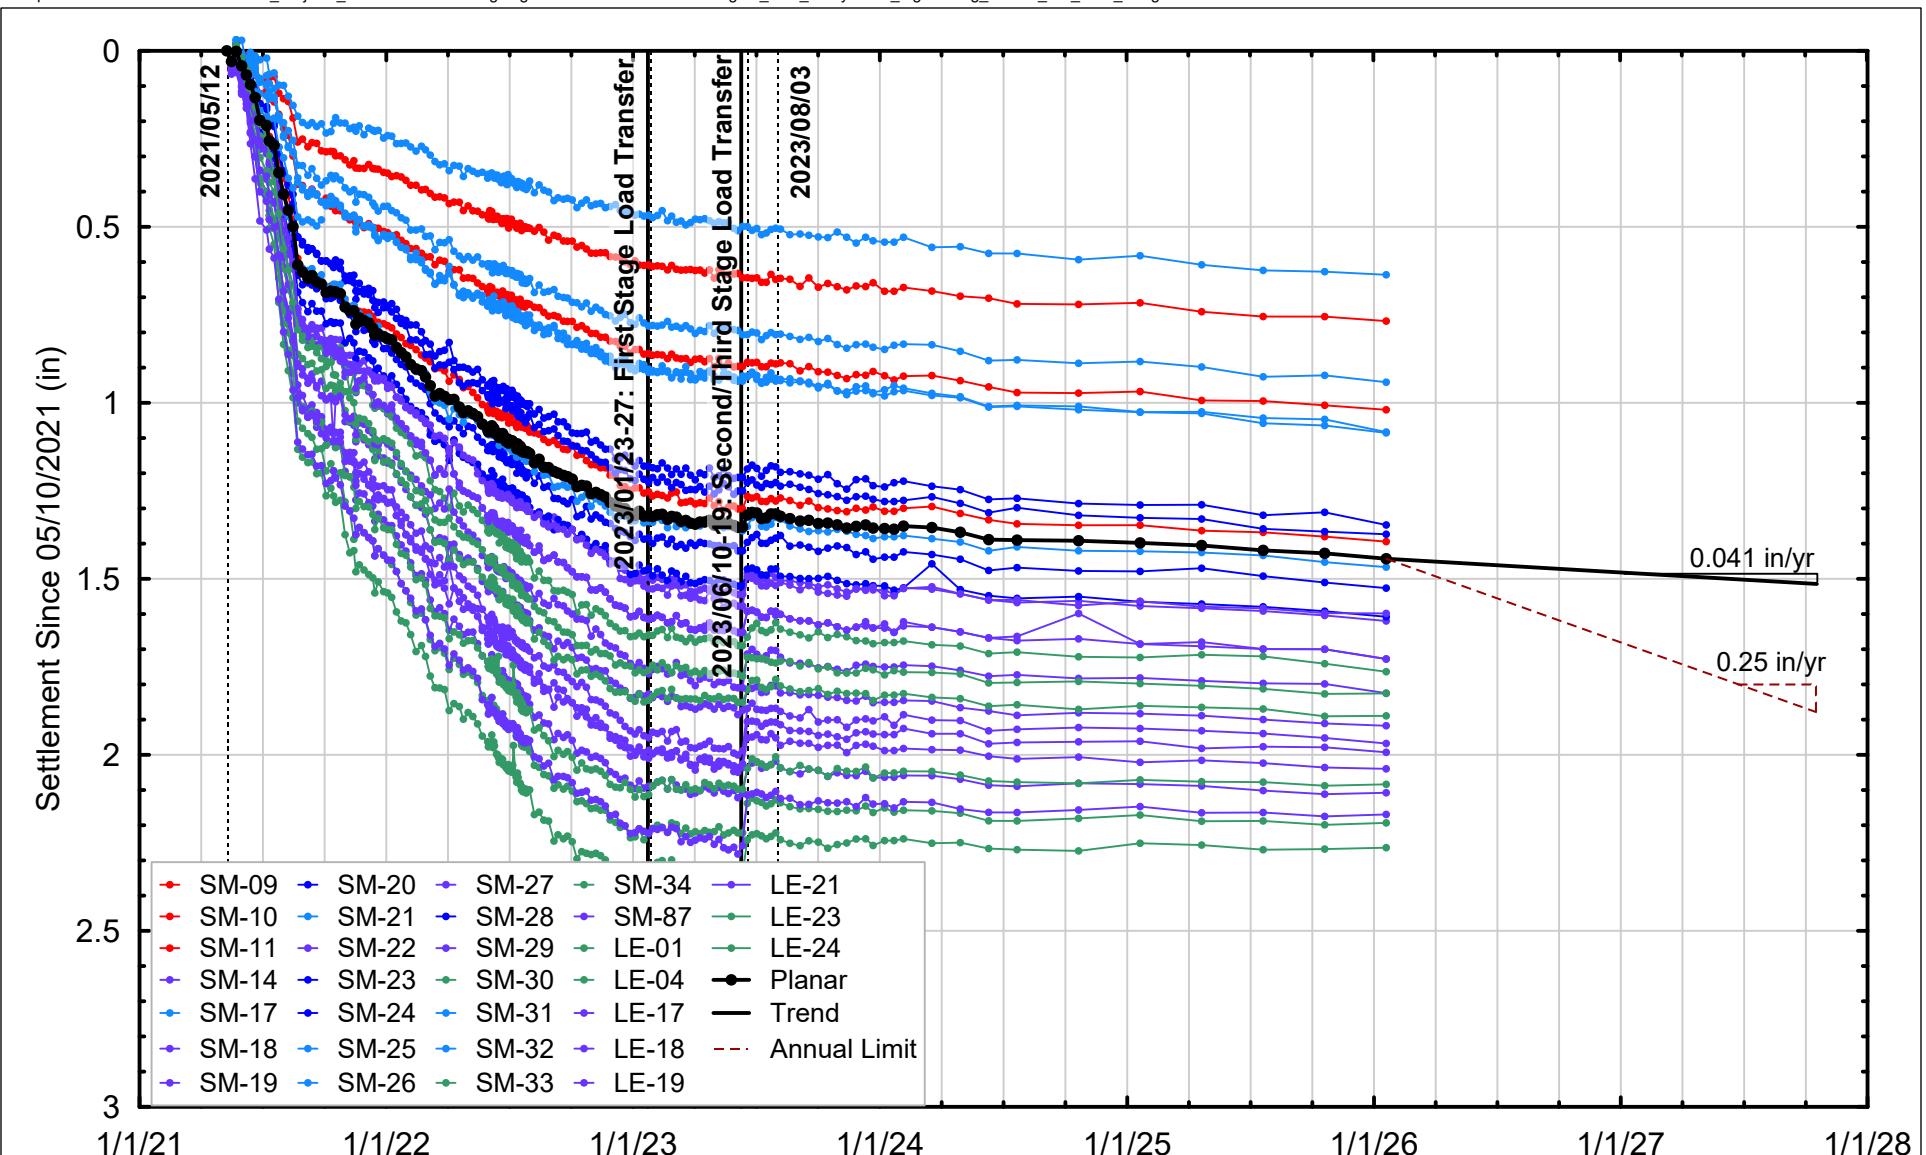
Figure No: 141-03

SETTLEMENT MARKER DATA
SINCE 05/10/2021 THROUGH 01/19/2026

⁵ As plotted on Figure 03. The annual rate is calculated starting on the settlement monitoring date closest to one year prior to the current date or on June 19, 2023 (the settlement monitoring date corresponding to the last day of jacking load application), whichever is later, and ending on the current date.

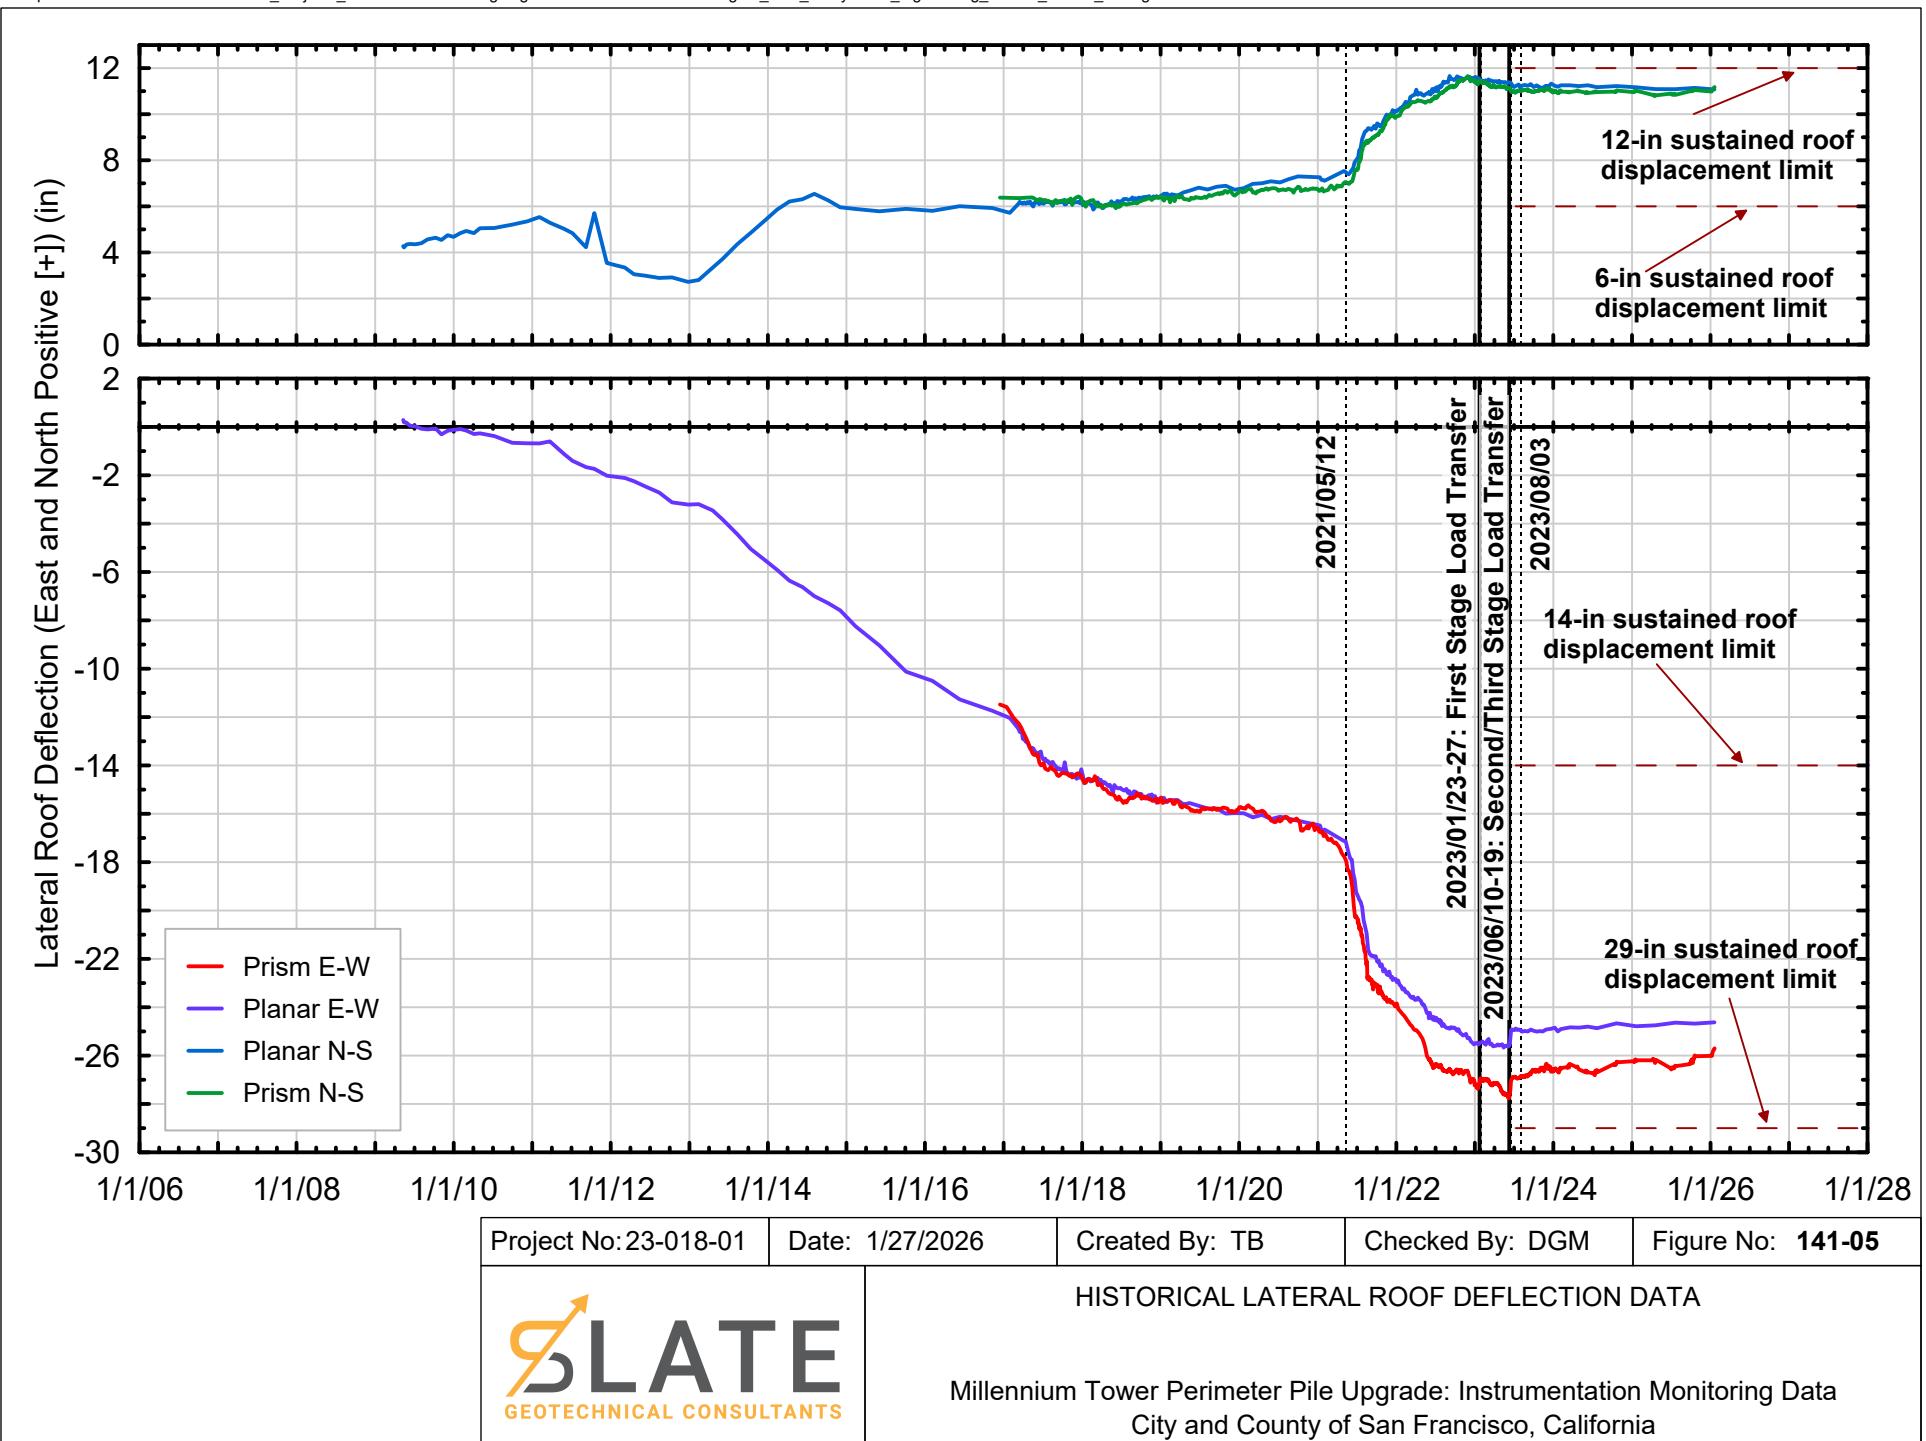
Figure 05 presents historical lateral roof deflections in the project north-south and project east-west directions interpreted from survey prisms mounted on the exterior of the Tower, from InSAR data, and from a planar fit of the settlement marker data. In addition, data from surveys performed during the retrofit are included. Figure 06 presents lateral roof deflection data from a planar fit of the settlement marker data and from survey prisms mounted on the exterior of the Tower since the start of production pile installation (May 12, 2021; baseline readings on May 10 and 13, 2021, respectively) through January 20, 2026.

⁶ As plotted on Figure 05, relative to a plumb condition.

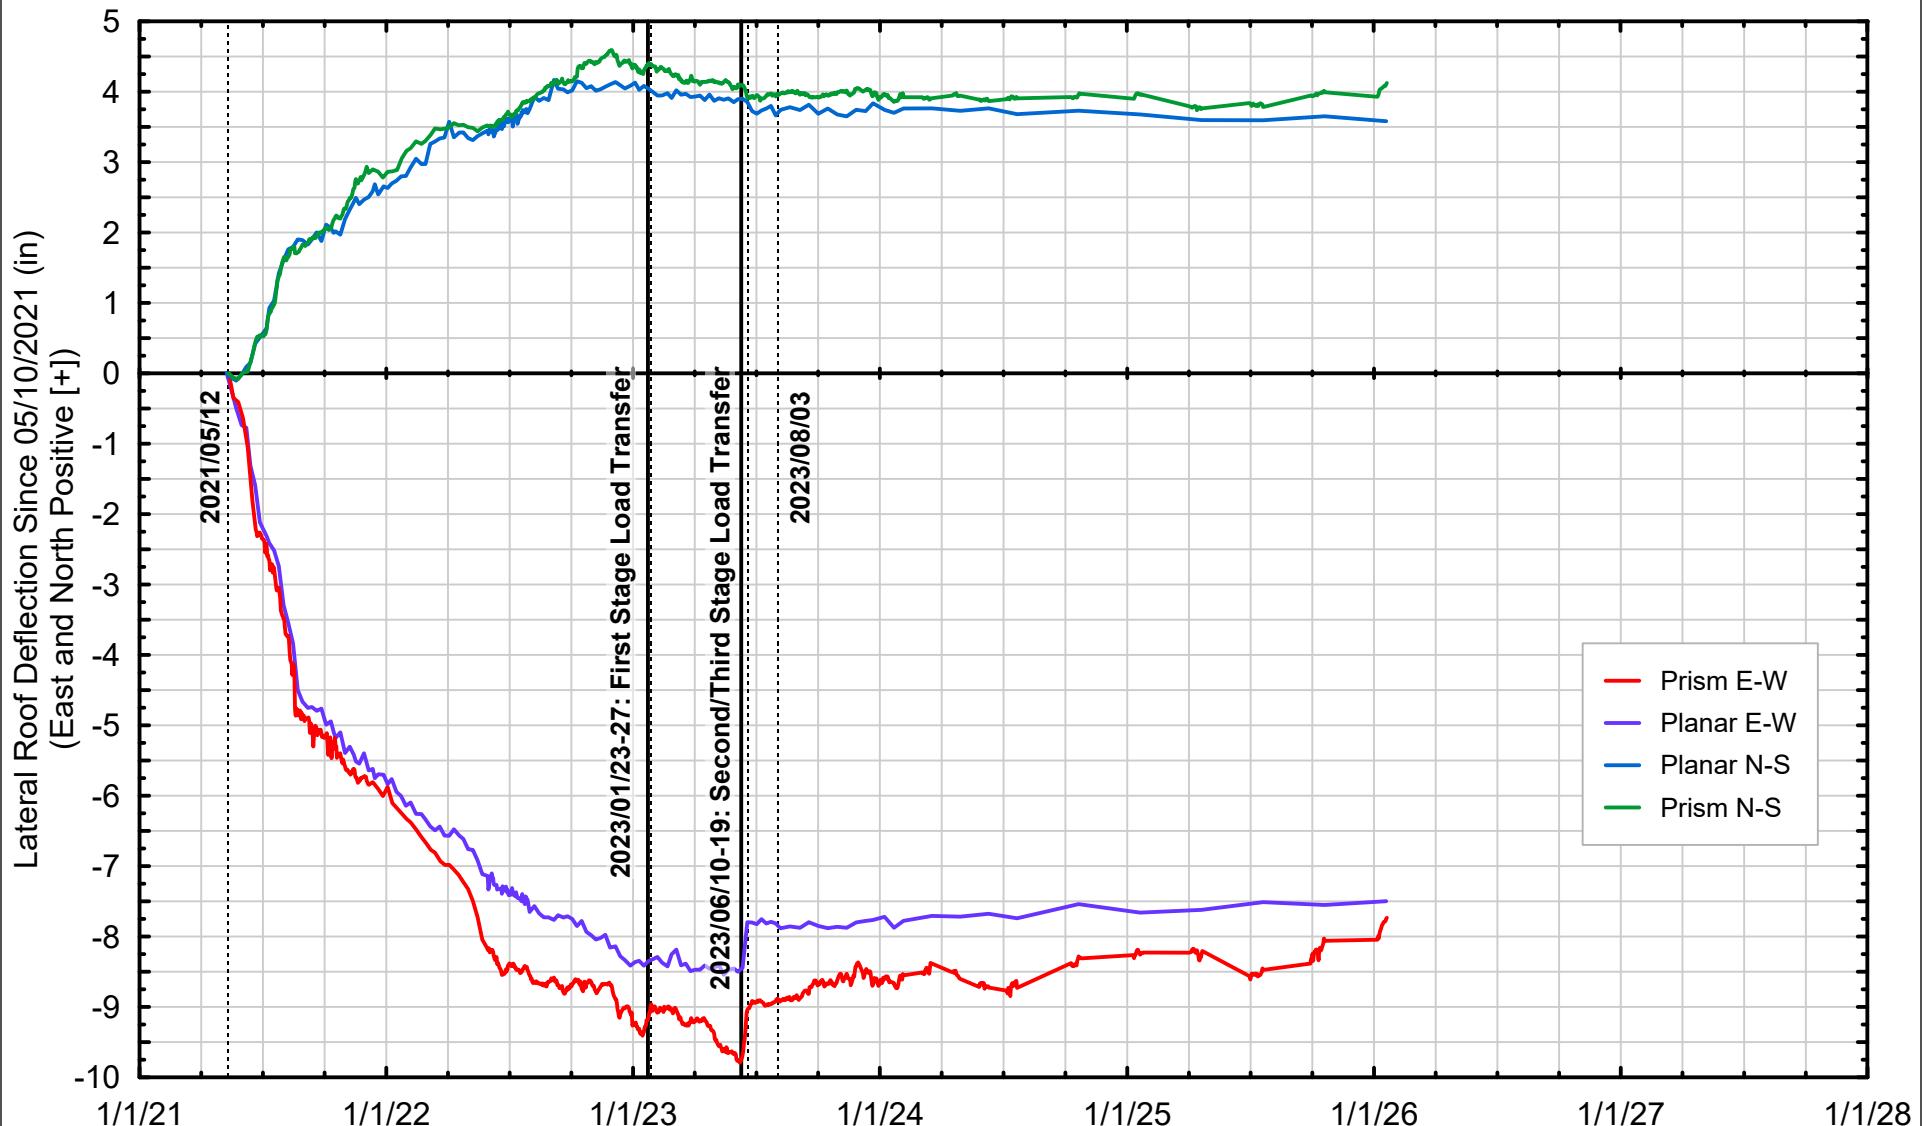
Figure No: 141-06

LATERAL ROOF DEFLECTION DATA
SINCE 05/10/2021 THROUGH 01/20/2026

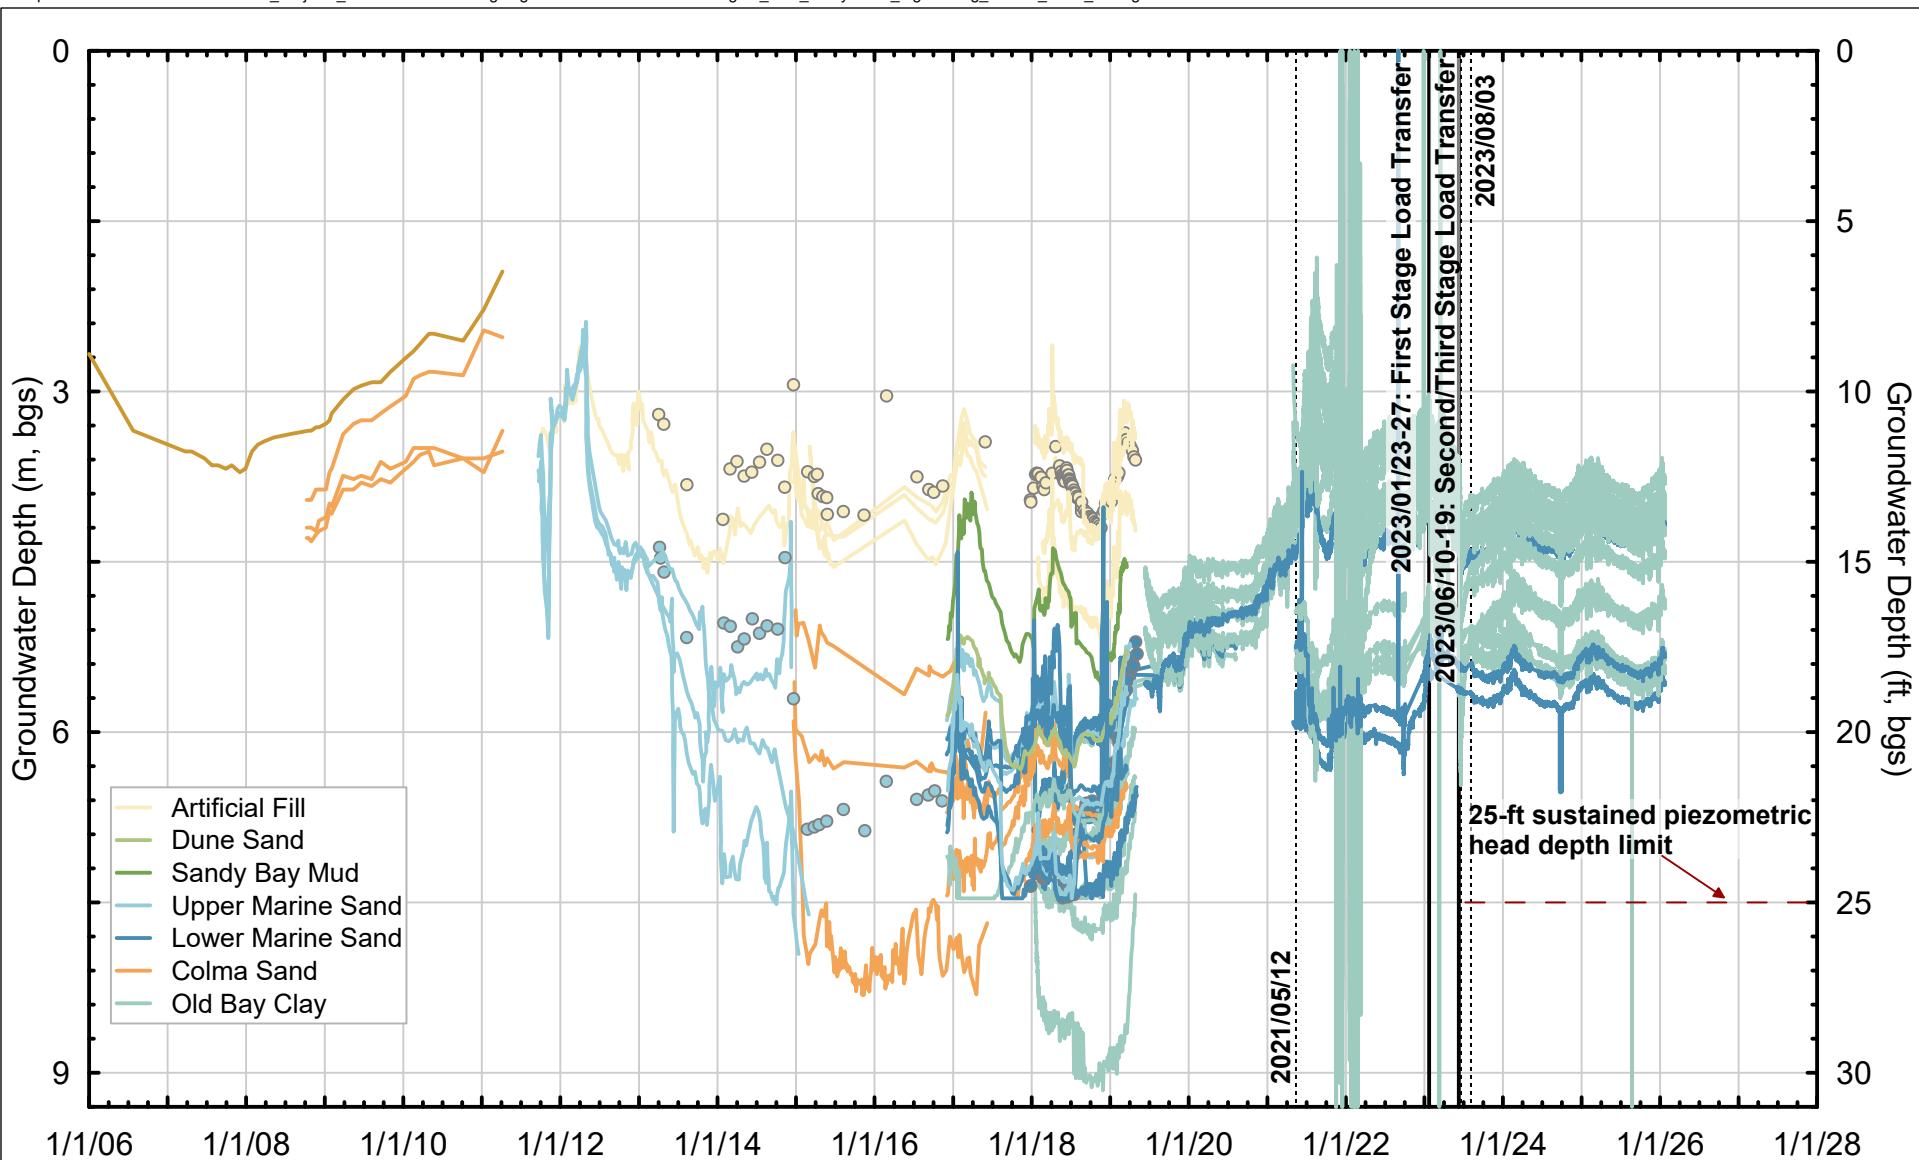
Project No: 23-018-01	Date: 1/27/2026	Created By: TB	Checked By: DGM	Figure No: 141-07
-----------------------	-----------------	----------------	-----------------	-------------------

Figure 07 presents the historical groundwater elevation interpreted from piezometer readings at locations near 301 Mission. In addition, data from piezometers installed to monitor groundwater elevation during the retrofit are included. Figures 08 and 09 present groundwater elevation interpreted from piezometer readings

HISTORICAL GROUNDWATER ELEVATION MEASUREMENTS AT LOCATIONS NEAR 301 MISSION

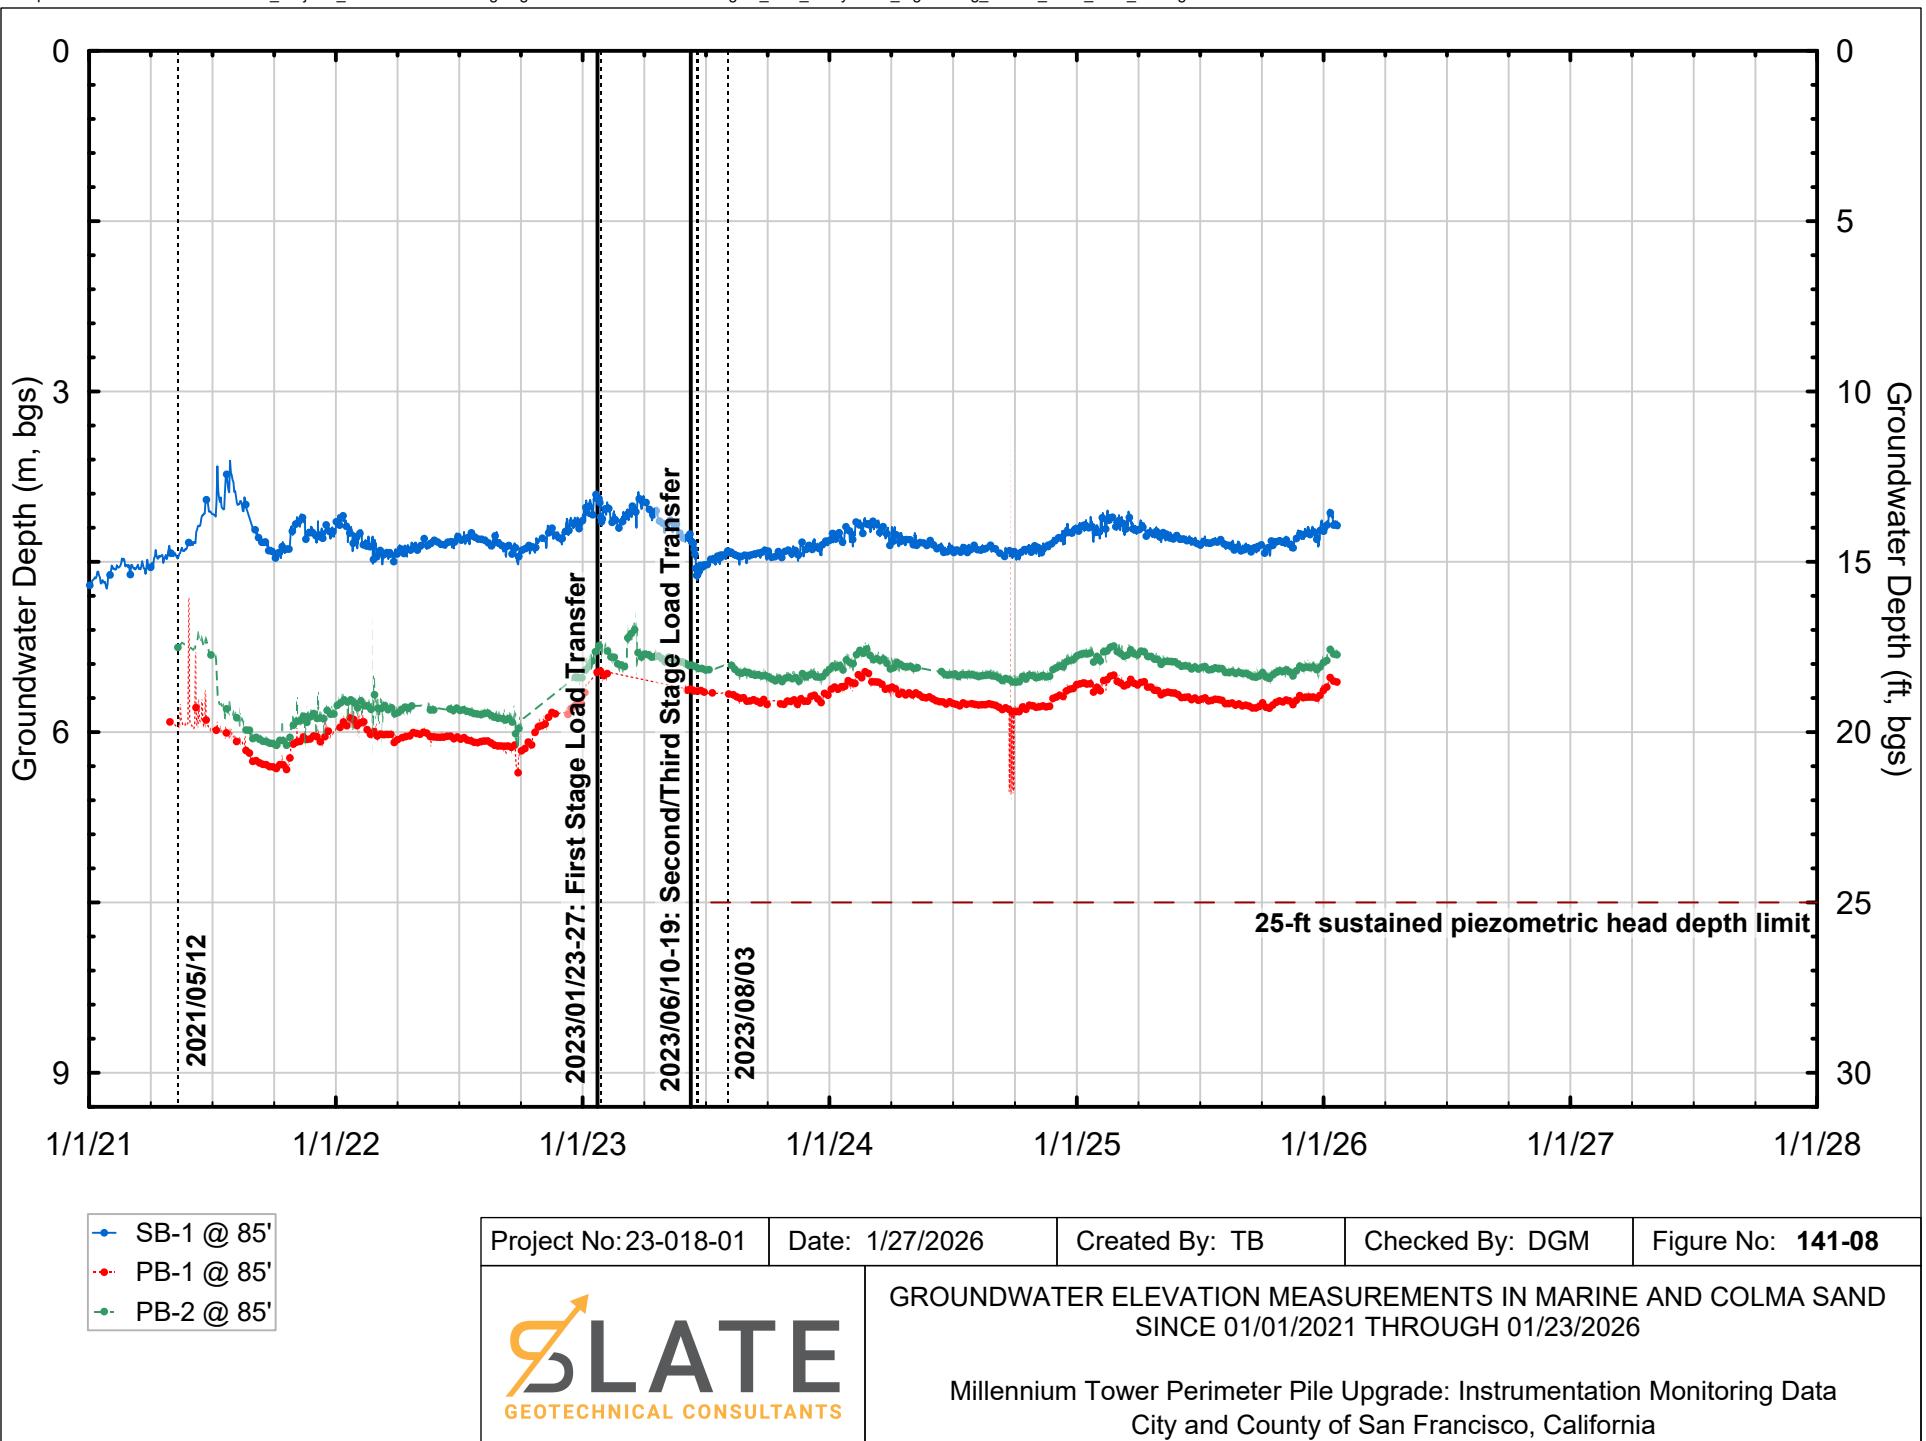
in the Marine/Colma Sand and the Old Bay Clay, respectively, for the time period prior to the start of production pile installation (January 1, 2021) through January 23, 2026.

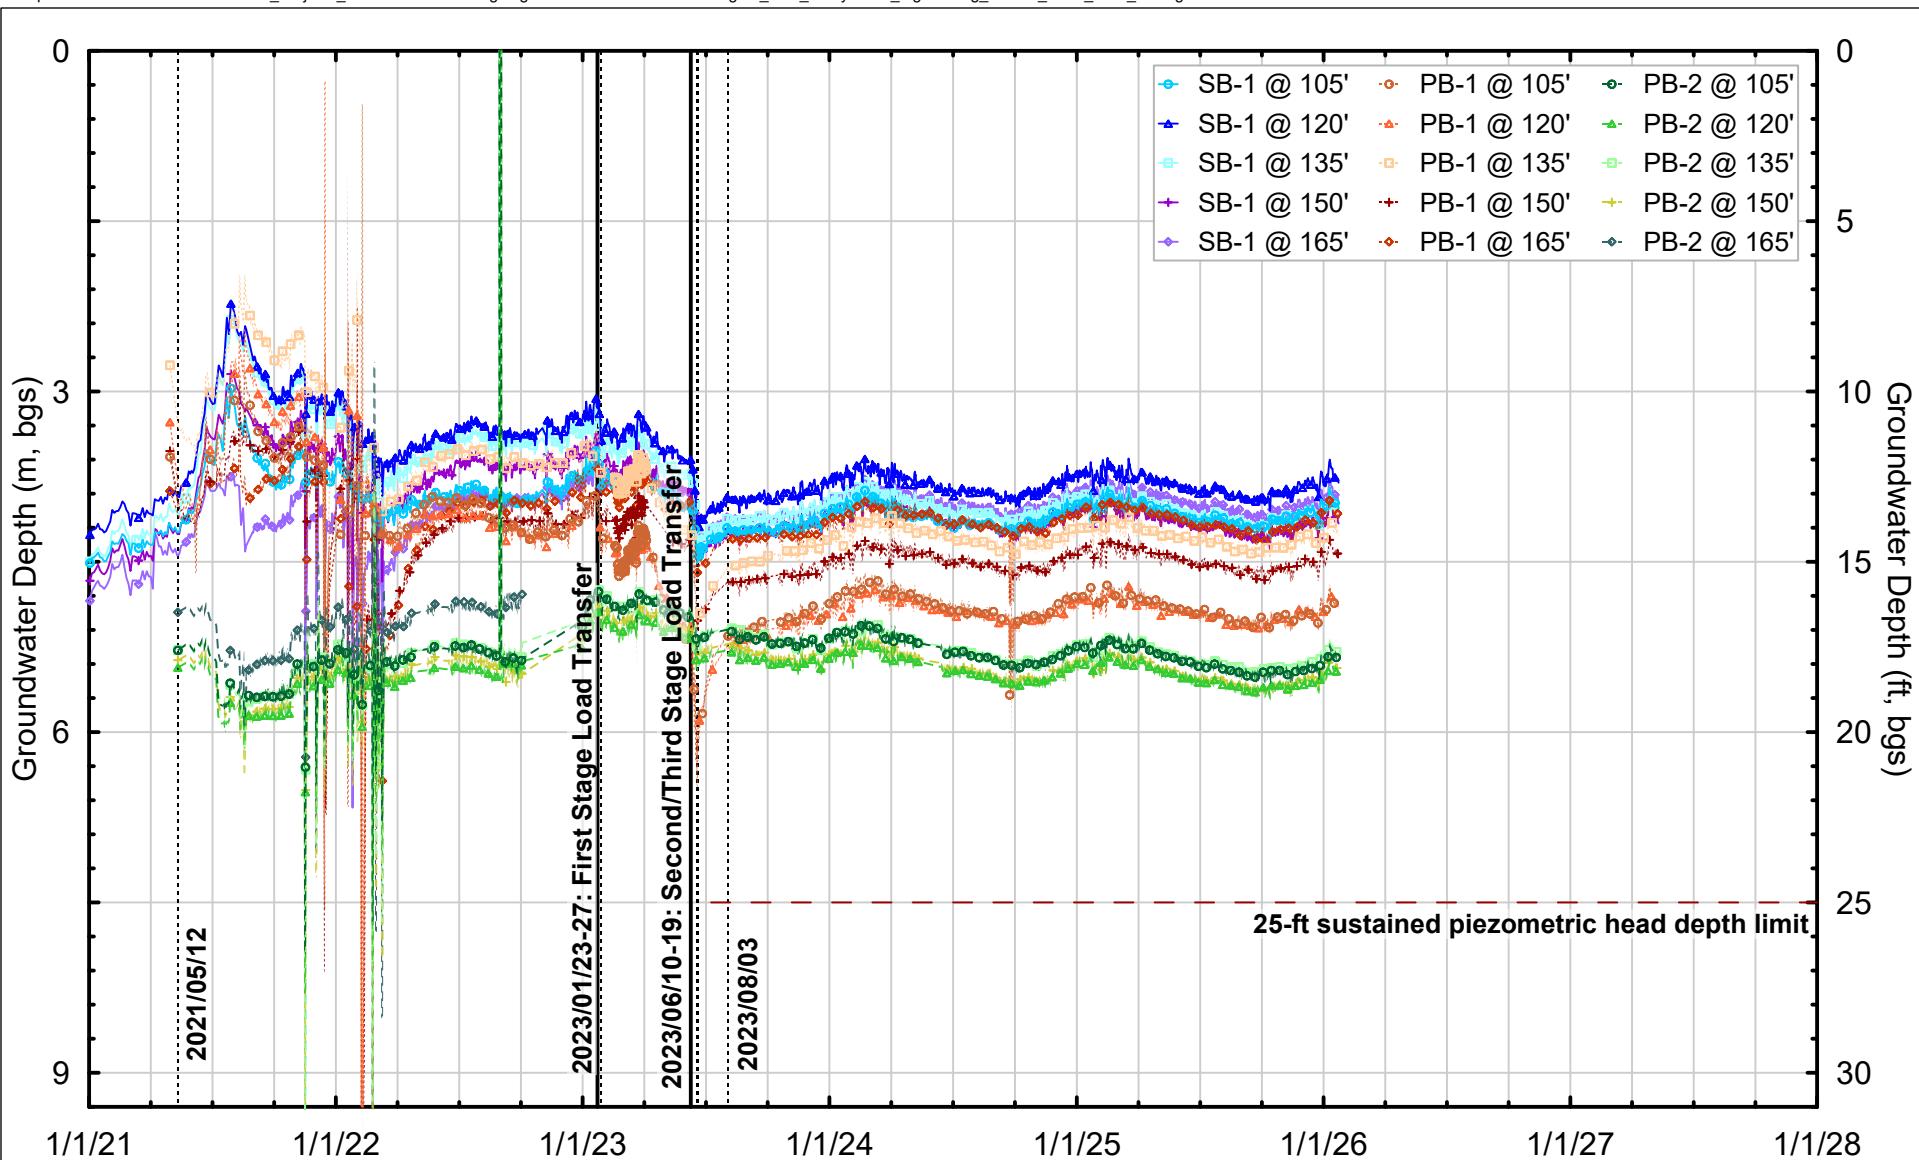
Figure No: 141-09

GROUNDWATER ELEVATION MEASUREMENTS IN OLD BAY CLAY
SINCE 01/01/2021 THROUGH 01/23/2026
