To: Millennium Tower Association

Project Number: 23-018-01

Subject: 301 Mission Retrofit Monitoring Report 141: Results as of January 23, 2026

Millennium Tower Perimeter Pile Upgrade: Instrumentation Monitoring Data
City and County of San Francisco, California

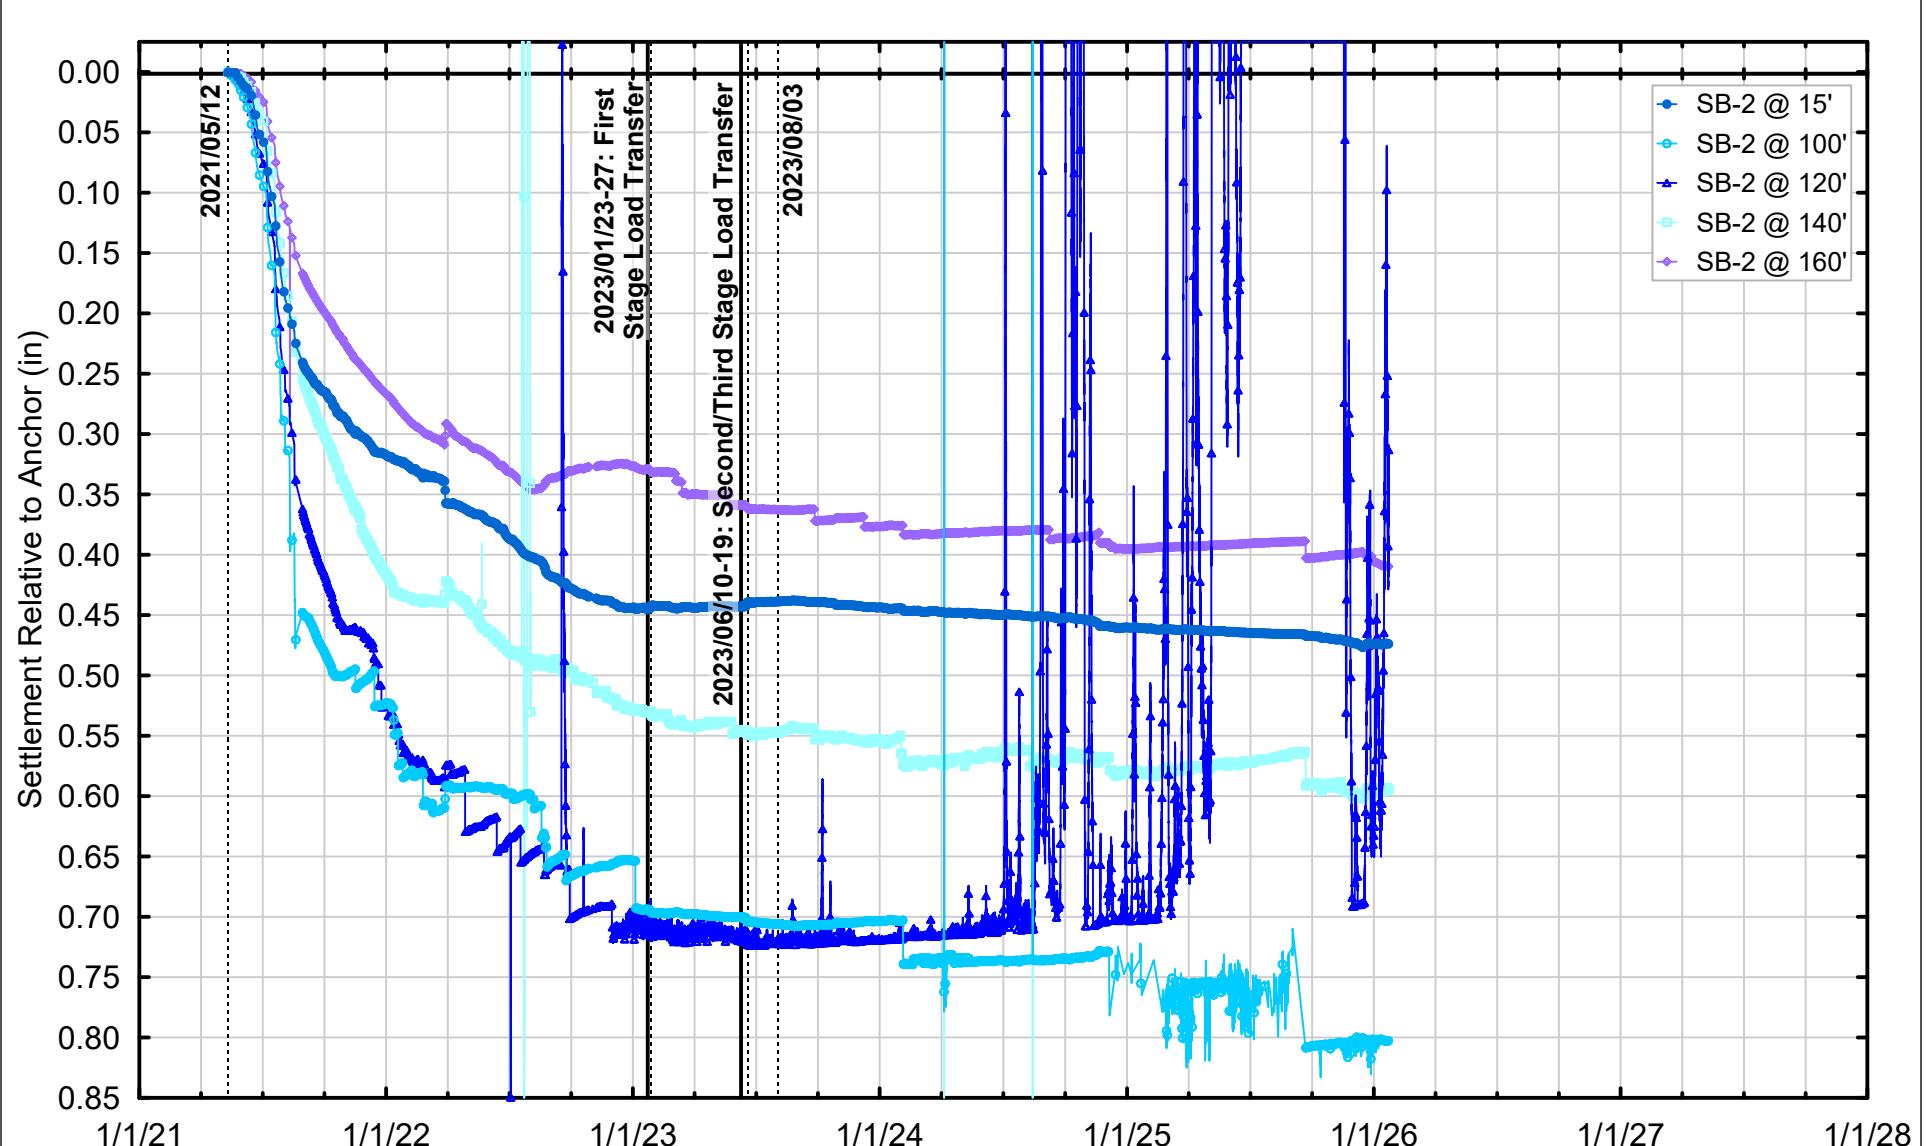
Figure No: 141-10

Figure 10 presents extensometer data from within the Tower basement since the start of production pile installation (May 12, 2021) through January 23, 2026. Figure 11 presents extensometer data from Fremont Street since the start of production pile installation (May 12, 2021) through May 16, 2023, and from the restart after fixing the extensometer (May 30, 2023) through January 23, 2026. Figure 12 presents extensometer data from Mission Street since the start of production pile installation (May 12, 2021) through January 23, 2026.

EXTENSOMETER DATA FROM WITHIN TOWER BASEMENT
SINCE 01/01/2021 THROUGH 01/23/2026

Exterior extensometer EB-2 is offline since August 9, 2025; work to correct this is currently ongoing.

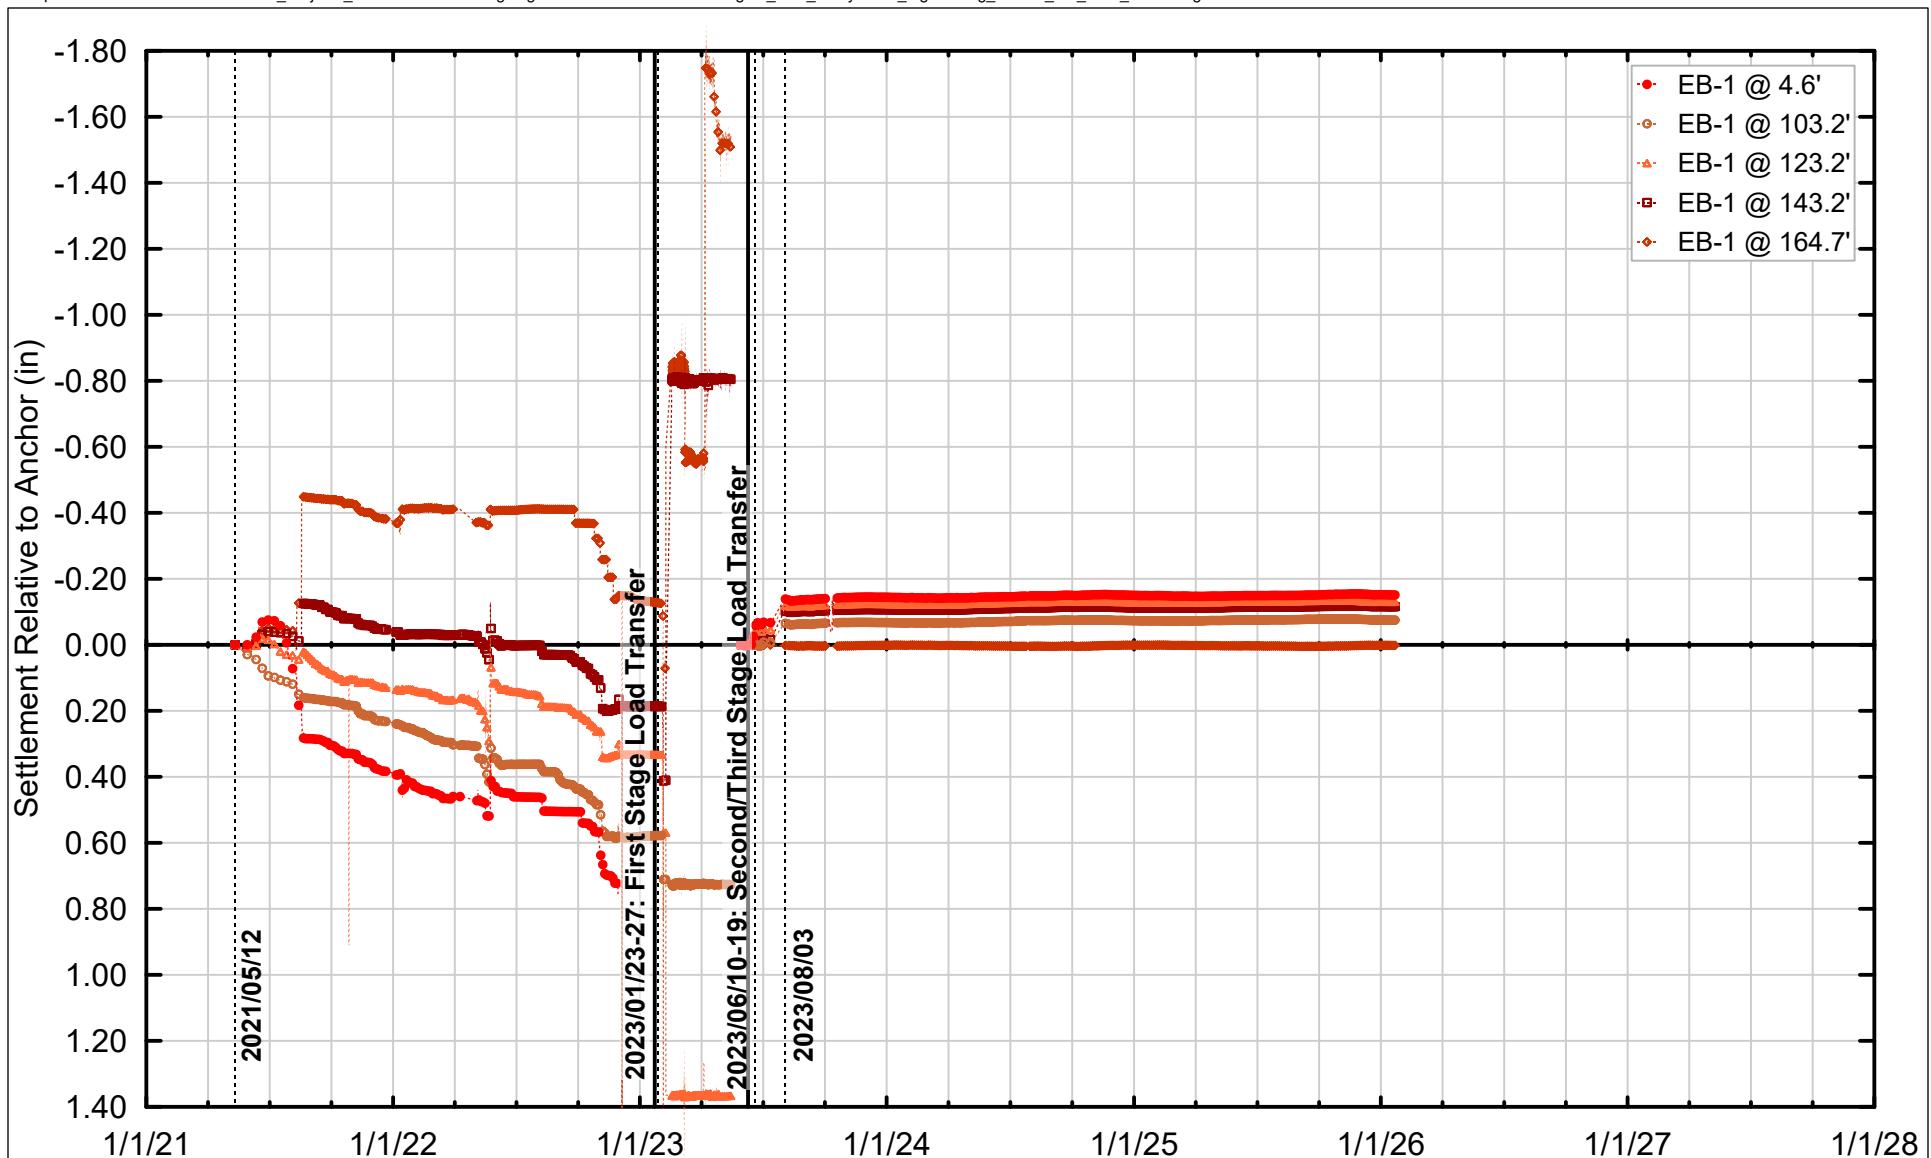
Project No: 23-018-01	Date: 1/27/2026	Created By: TB	Checked By: DGM	Figure No: 141-11
-----------------------	-----------------	----------------	-----------------	-------------------

Note: EB-1 was repaired and reset on 2023/05/30

EXTENSOMETER DATA FROM FREMONT STREET
SINCE 05/10/2021 THROUGH 05/16/2023
SINCE 05/30/2023 THROUGH 01/23/2025

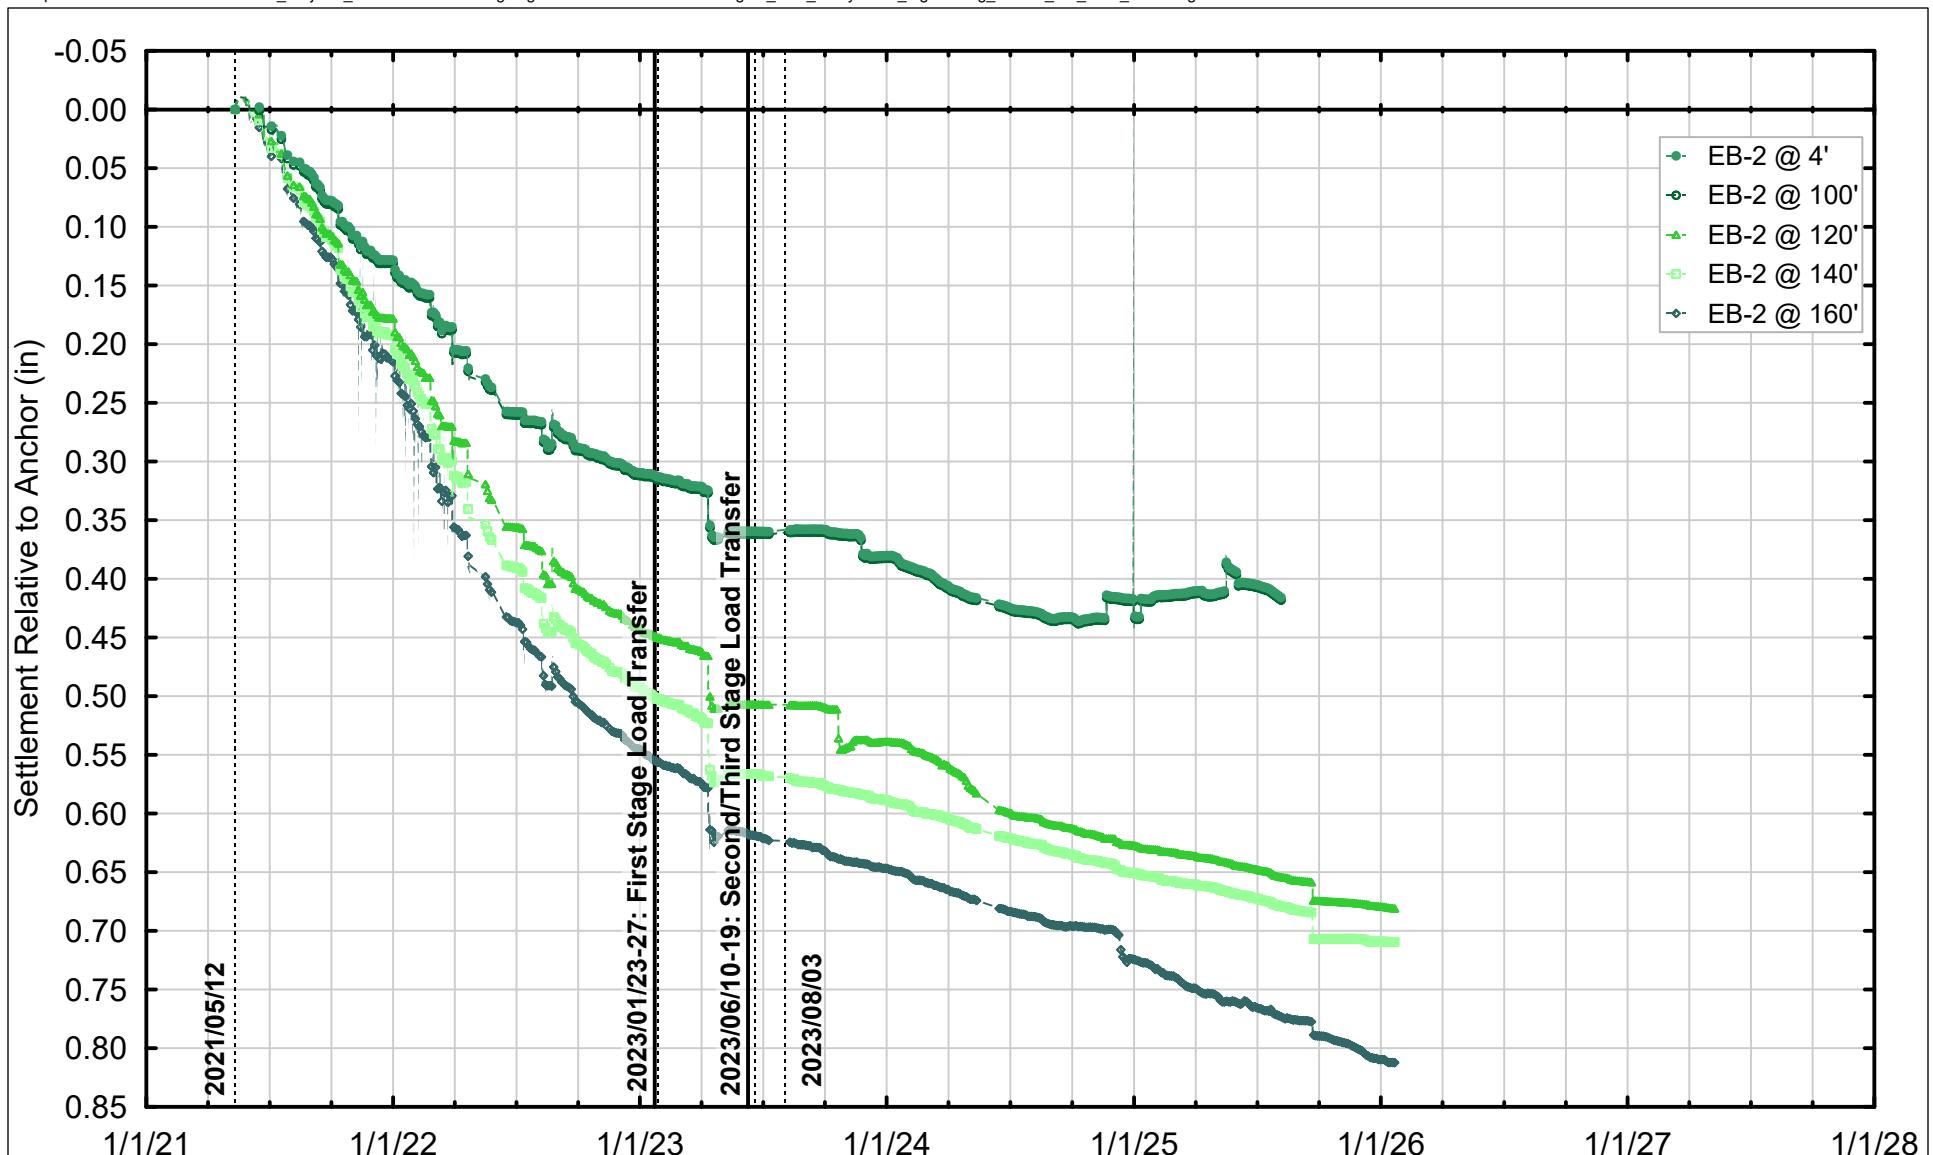
Figure No: 141-12

EXTENSOMETER DATA FROM MISSION STREET
SINCE 01/01/2021 THROUGH 01/23/2026

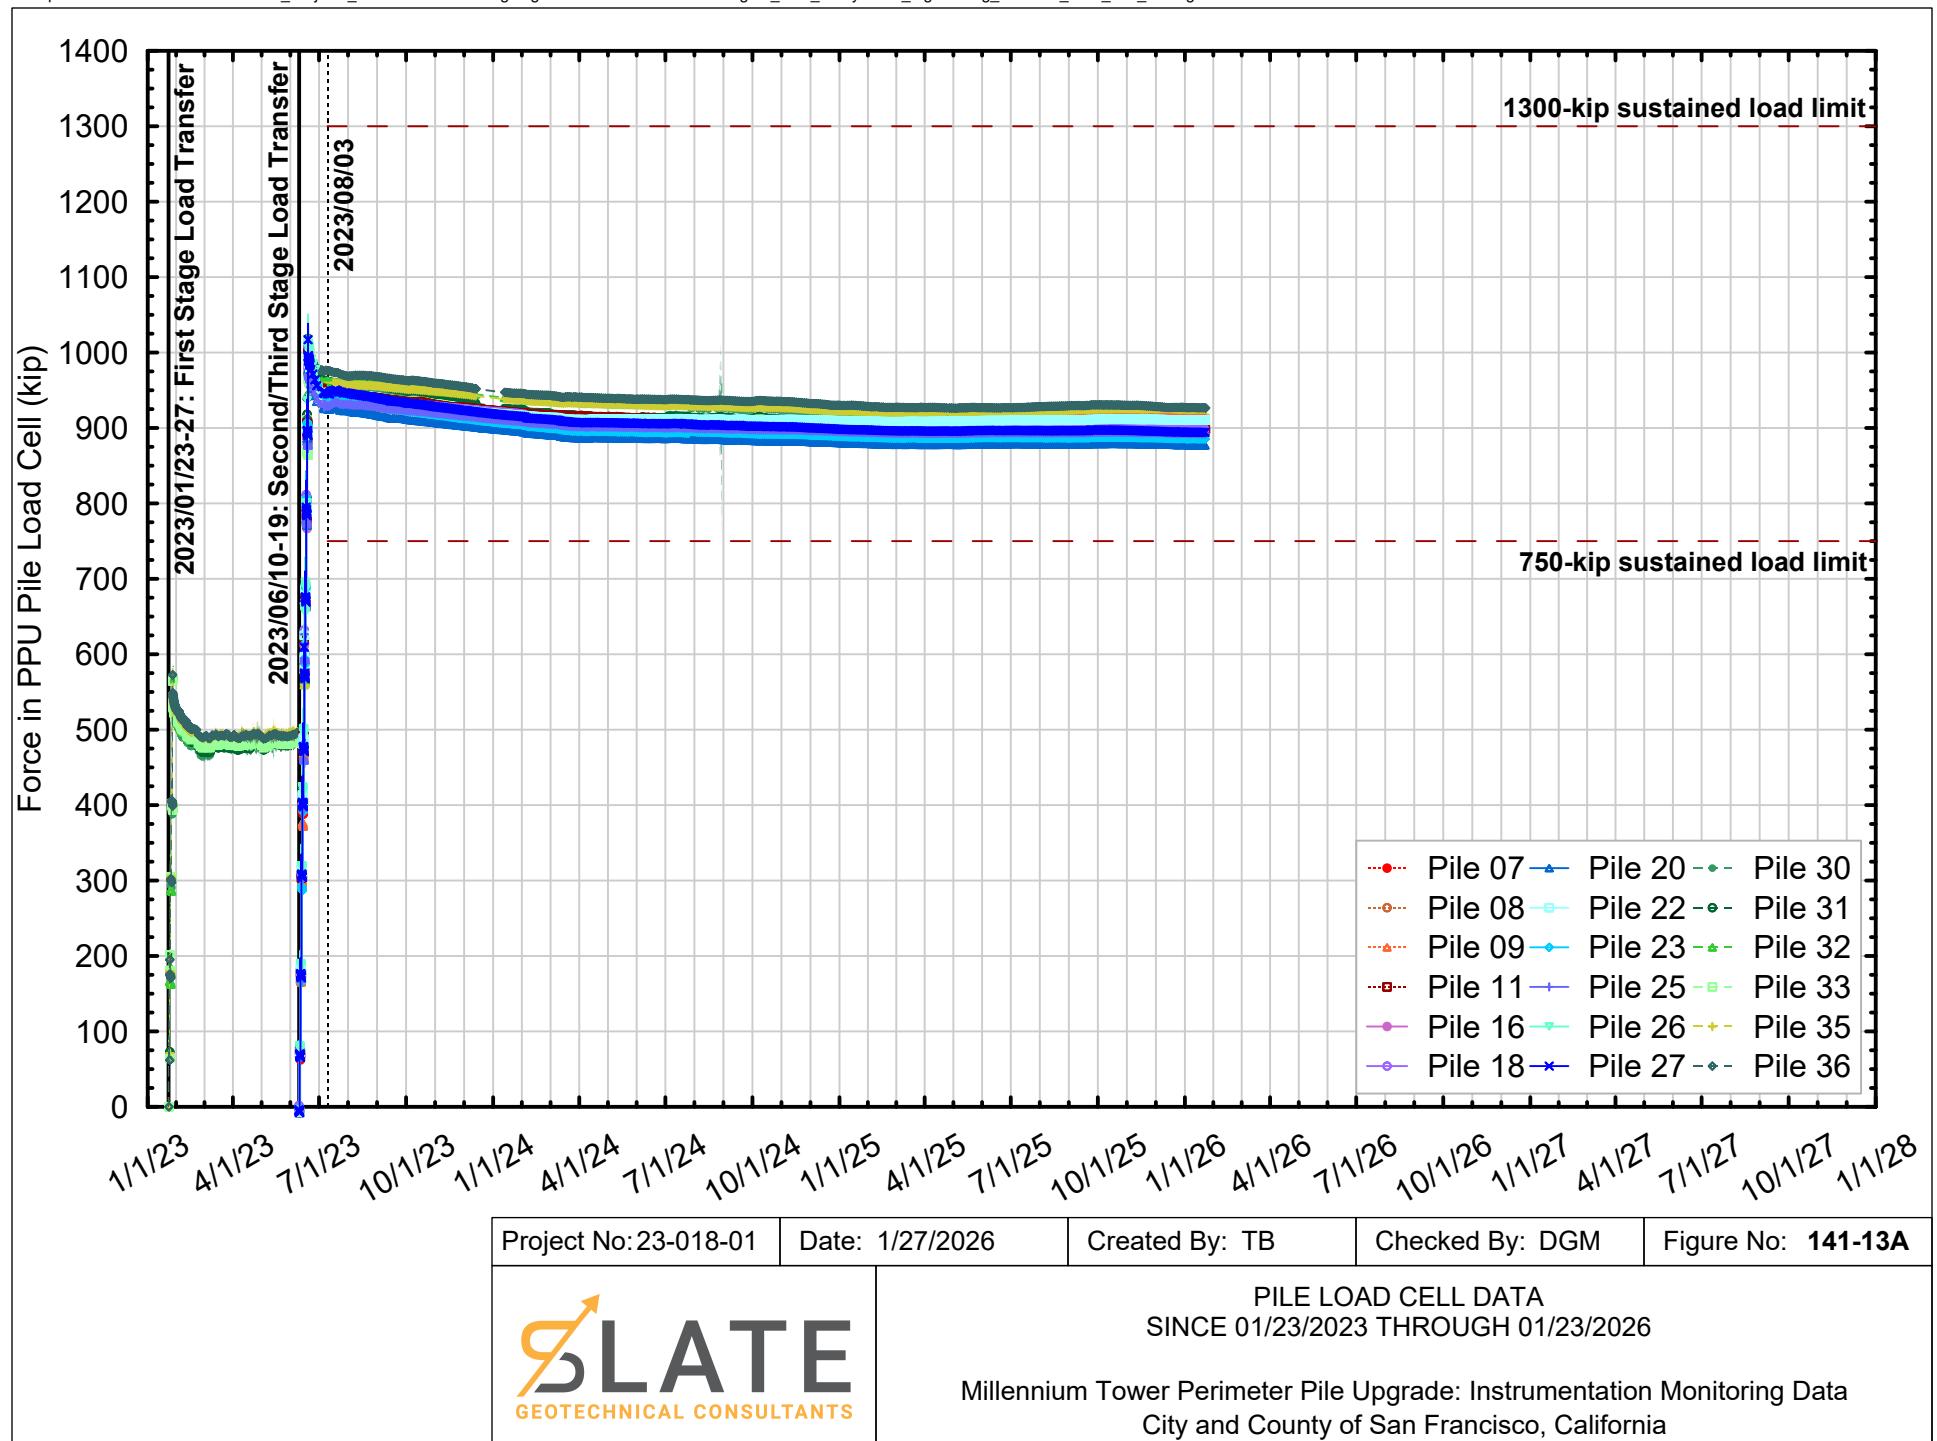
Figure 13A presents pile load cell data since the start of the First Stage Load Transfer (January 23, 2023) through January 23, 2026. Figure 13B presents the total pile load cell data since July 15, 2023, through January 23, 2026.

⁴ The load transfer rods have a maximum safe loading of 375 kips per rod, or 1,500 kips per pile. The 1,300-kip threshold is set to allow sufficient time to evaluate building behavior, should excessive load develop in one or more piles.

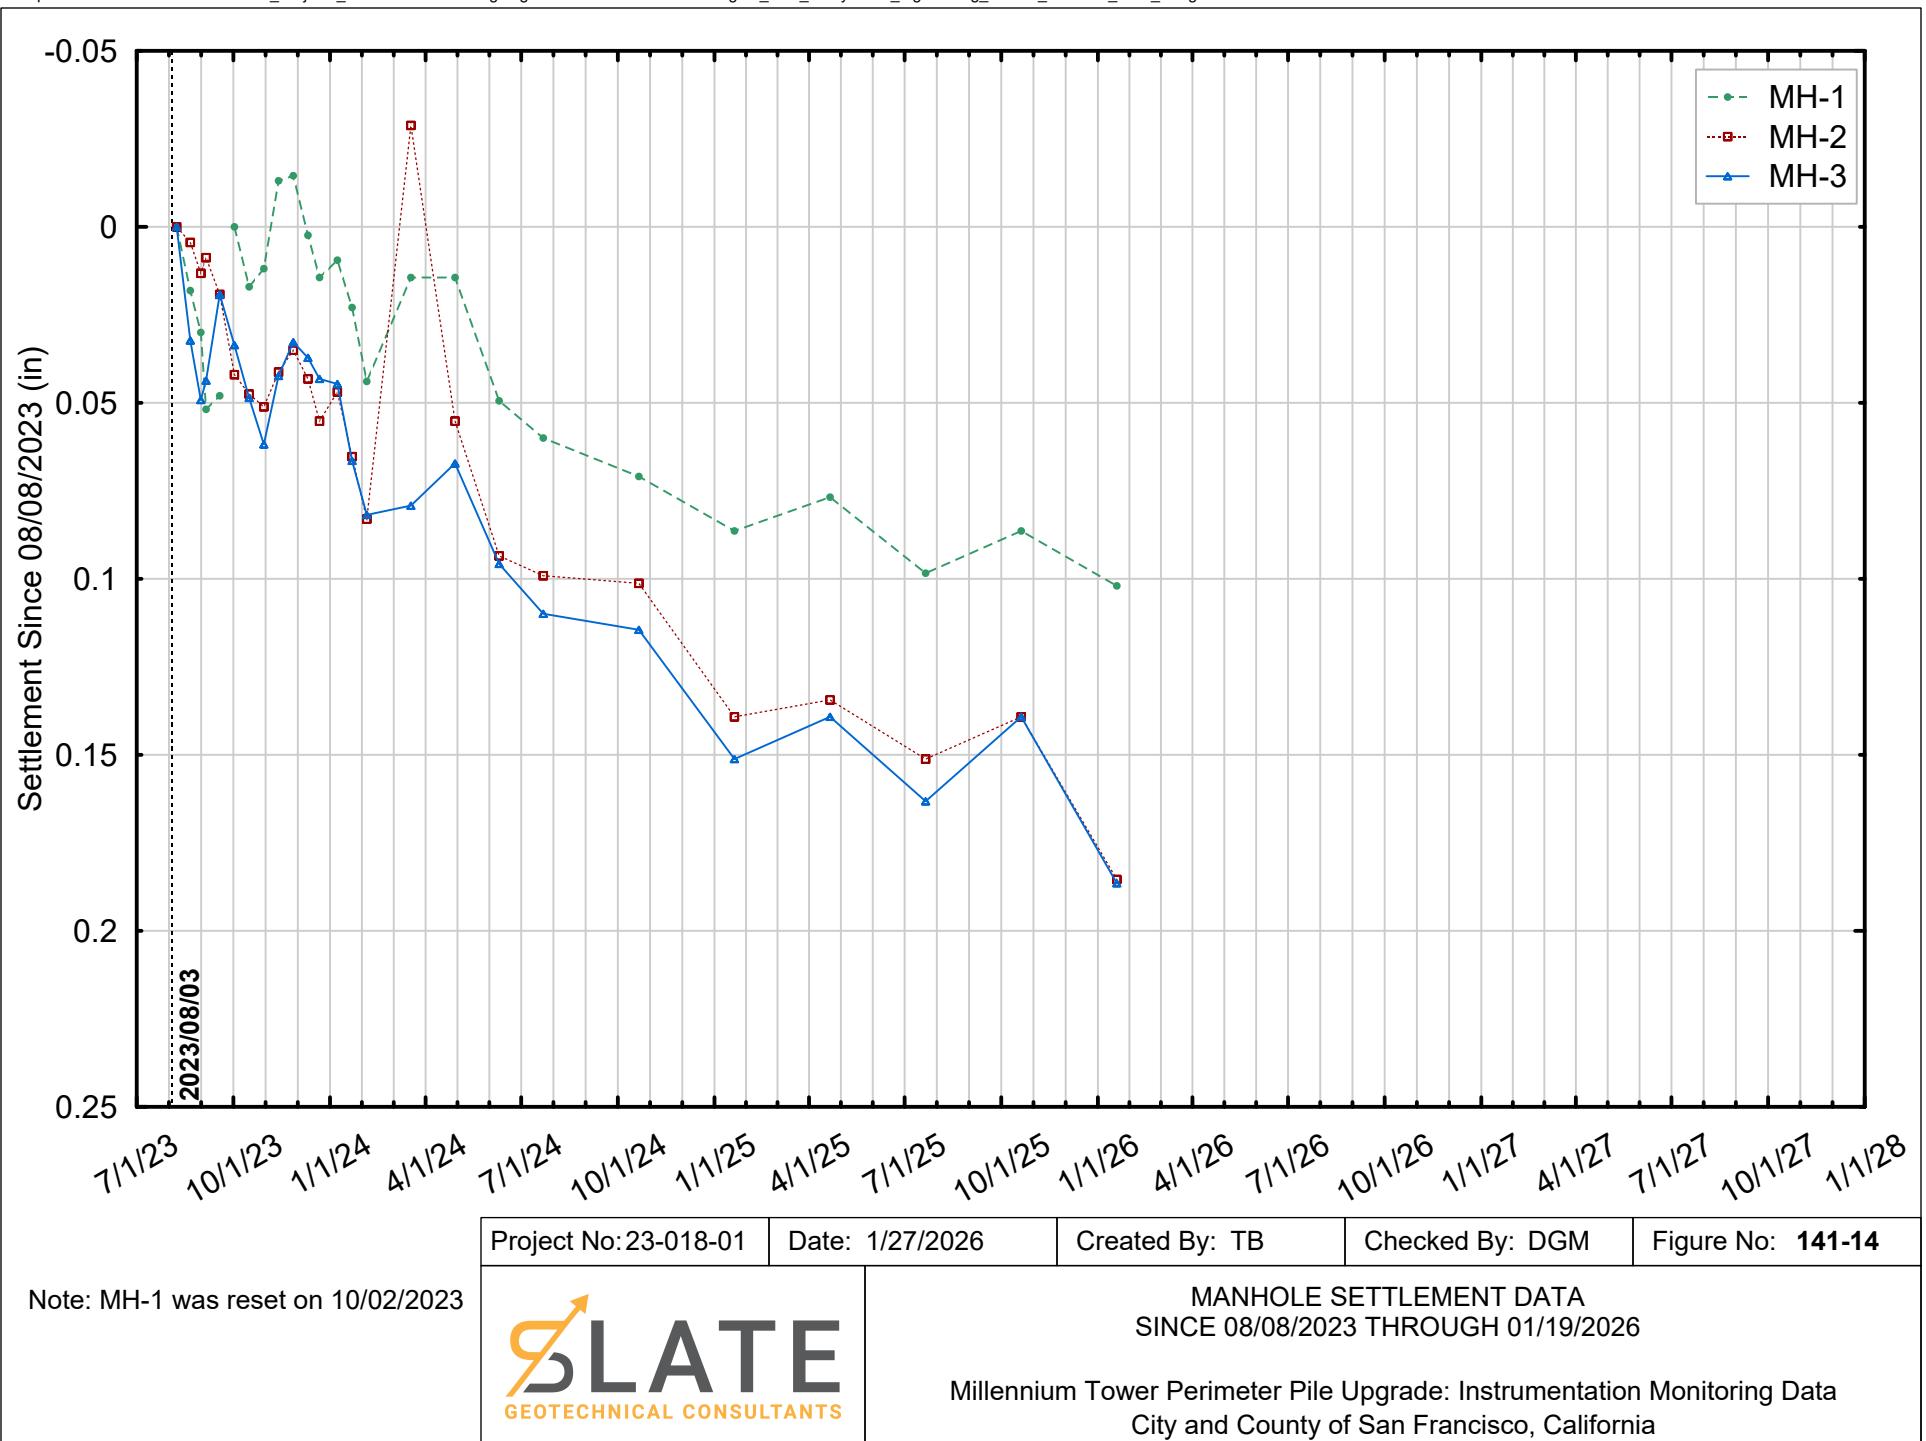
Figure 14 presents settlement data interpreted from survey points located on manholes around the Tower since August 8, 2023, through January 19, 2026.
