To: Millennium Tower Association

Subject: 301 Mission Retrofit Monitoring Report 140: Results as of October 20, 2025

301 Mission Retrofit Monitoring: Results as of October 20, 2025 Project No. 23-018-01

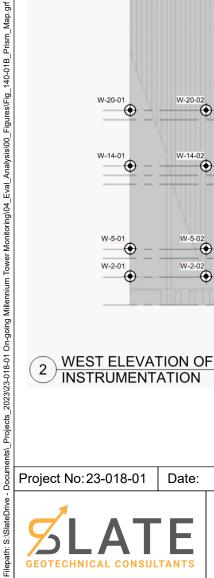
Project No: 23-018-01 7/26/2021 Date: Created By: NBW Checked By: DGM Figure No: **140-01B**

TOWER SURVEY PRISM LOCATION SCHEMATIC

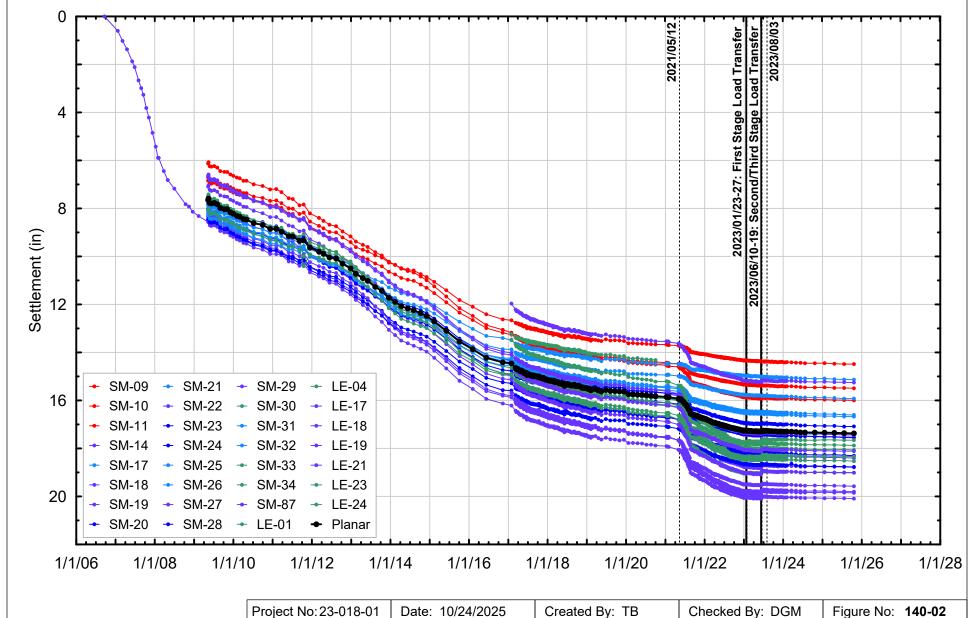
Figure 02 - Historical Settlement Marker Data

HISTORICAL SETTLEMENT MARKER DATA

Figure 02 presents the historical settlement data interpreted from settlement markers installed on the B-1 Level of 301 Mission Tower. In addition, data from surveys performed during the retrofit are included. Figure 03 presents settlement data since the start of production pile installation (May 12, 2021; baseline readings on May 10, 2021) through October 20, 2025. Figure 04 presents current settlement contours (in inches) on October 20, 2025.

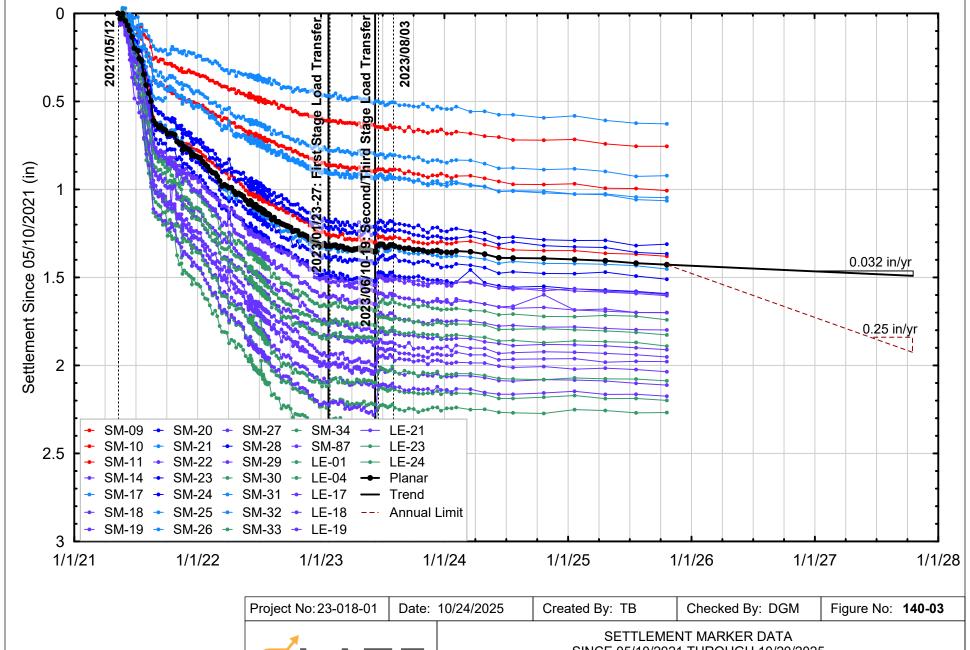
Figure 03 –Settlement Marker Data since 05/10/2021 through 10/20/2025

SINCE 05/10/2021 THROUGH 10/20/2025

⁵ As plotted on Figure 03. The annual rate is calculated starting on the settlement monitoring date closest to one year prior to the current date or on June 19, 2023 (the settlement monitoring date corresponding to the last day of jacking load application), whichever is later, and ending on the current date.

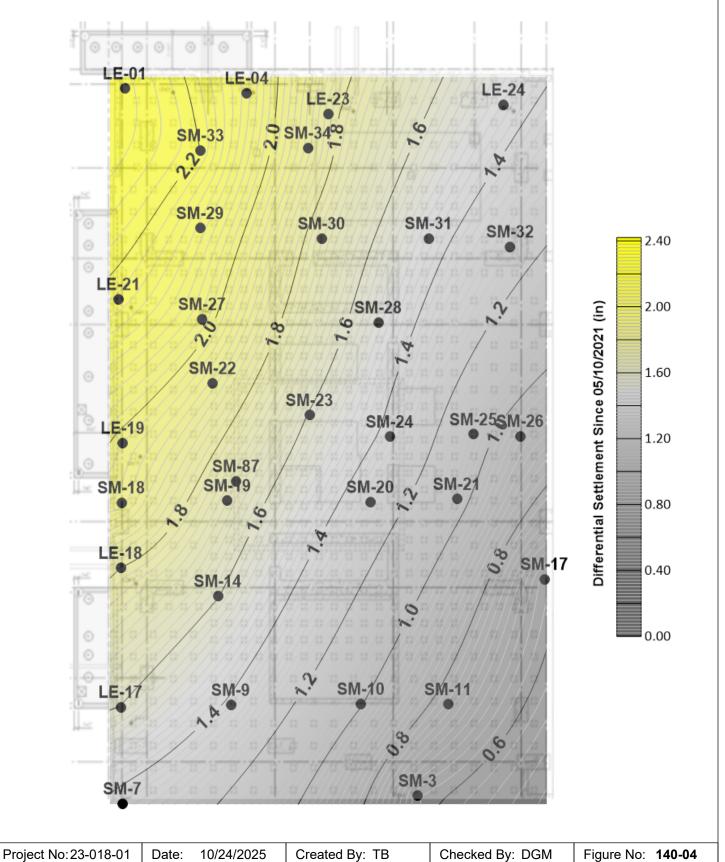
Figure 04 – Settlement Contours since 05/10/2021 through 10/20/2025

SETTLEMENT CONTOURS

SINCE 05/10/2021 THROUGH 10/20/2025

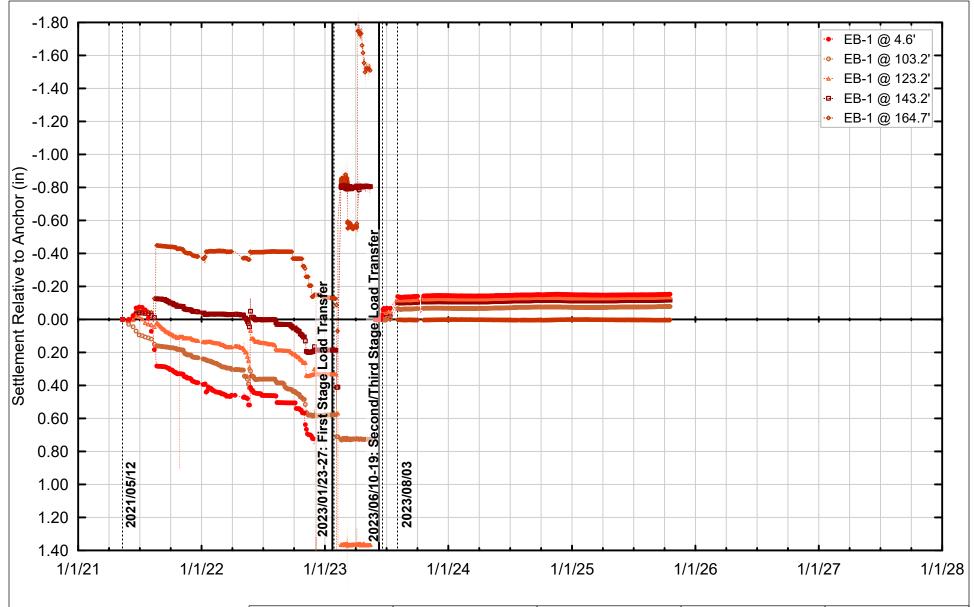
Figure No: **140-11**

Figure 11 – Extensometer Data from Fremont Street since 01/01/2021 through 05/16/2023, since 05/30/2023 through 10/20/2025

Note: EB-1 was repaired and reset on 2023/05/30

EXTENSOMETER DATA FROM FREMONT STREET SINCE 05/10/2021 THROUGH 05/16/2023 SINCE 05/30/2023 THROUGH 7/23/2025

Figure 10 presents extensometer data from within the Tower basement since the start of production pile installation (May 12, 2021) through October 20, 2025. Figure 11 presents extensometer data from Fremont Street since the start of production pile installation (May 12, 2021) through May 16, 2023, and from the restart after fixing the extensometer (May 30, 2023) through October 20, 2025. Figure 12 presents extensometer data from Mission Street since the start of production pile installation (May 12, 2021) through October 20, 2025.
