Subject: 301 Mission Retrofit Monitoring Report 142: Results as of April 20, 2026

This memorandum summarizes results from the monitoring plan implemented at the 301 Mission property. Instrumentation to monitor the structure prior to, during and after the retrofit was installed in January 2021, including piezometers and extensometers. Settlement markers installed in April 2009 and January 2017, survey prisms mounted on the exterior of the structure in December 2016, and crack gauges installed in April 2009 have also been monitored. Pile load cells were installed on the Mission Street piles in January 2023, and on the Fremont Street piles in June 2023. Survey points were established on the manhole covers around the Tower and a baseline reading was performed on August 8, 2023. This memorandum is for review only. It only contains ongoing monitoring information. This memorandum does not contain recommendations based upon the ongoing monitoring information.

Millennium Tower Perimeter Pile Upgrade: Instrumentation Monitoring Data
City and County of San Francisco, California

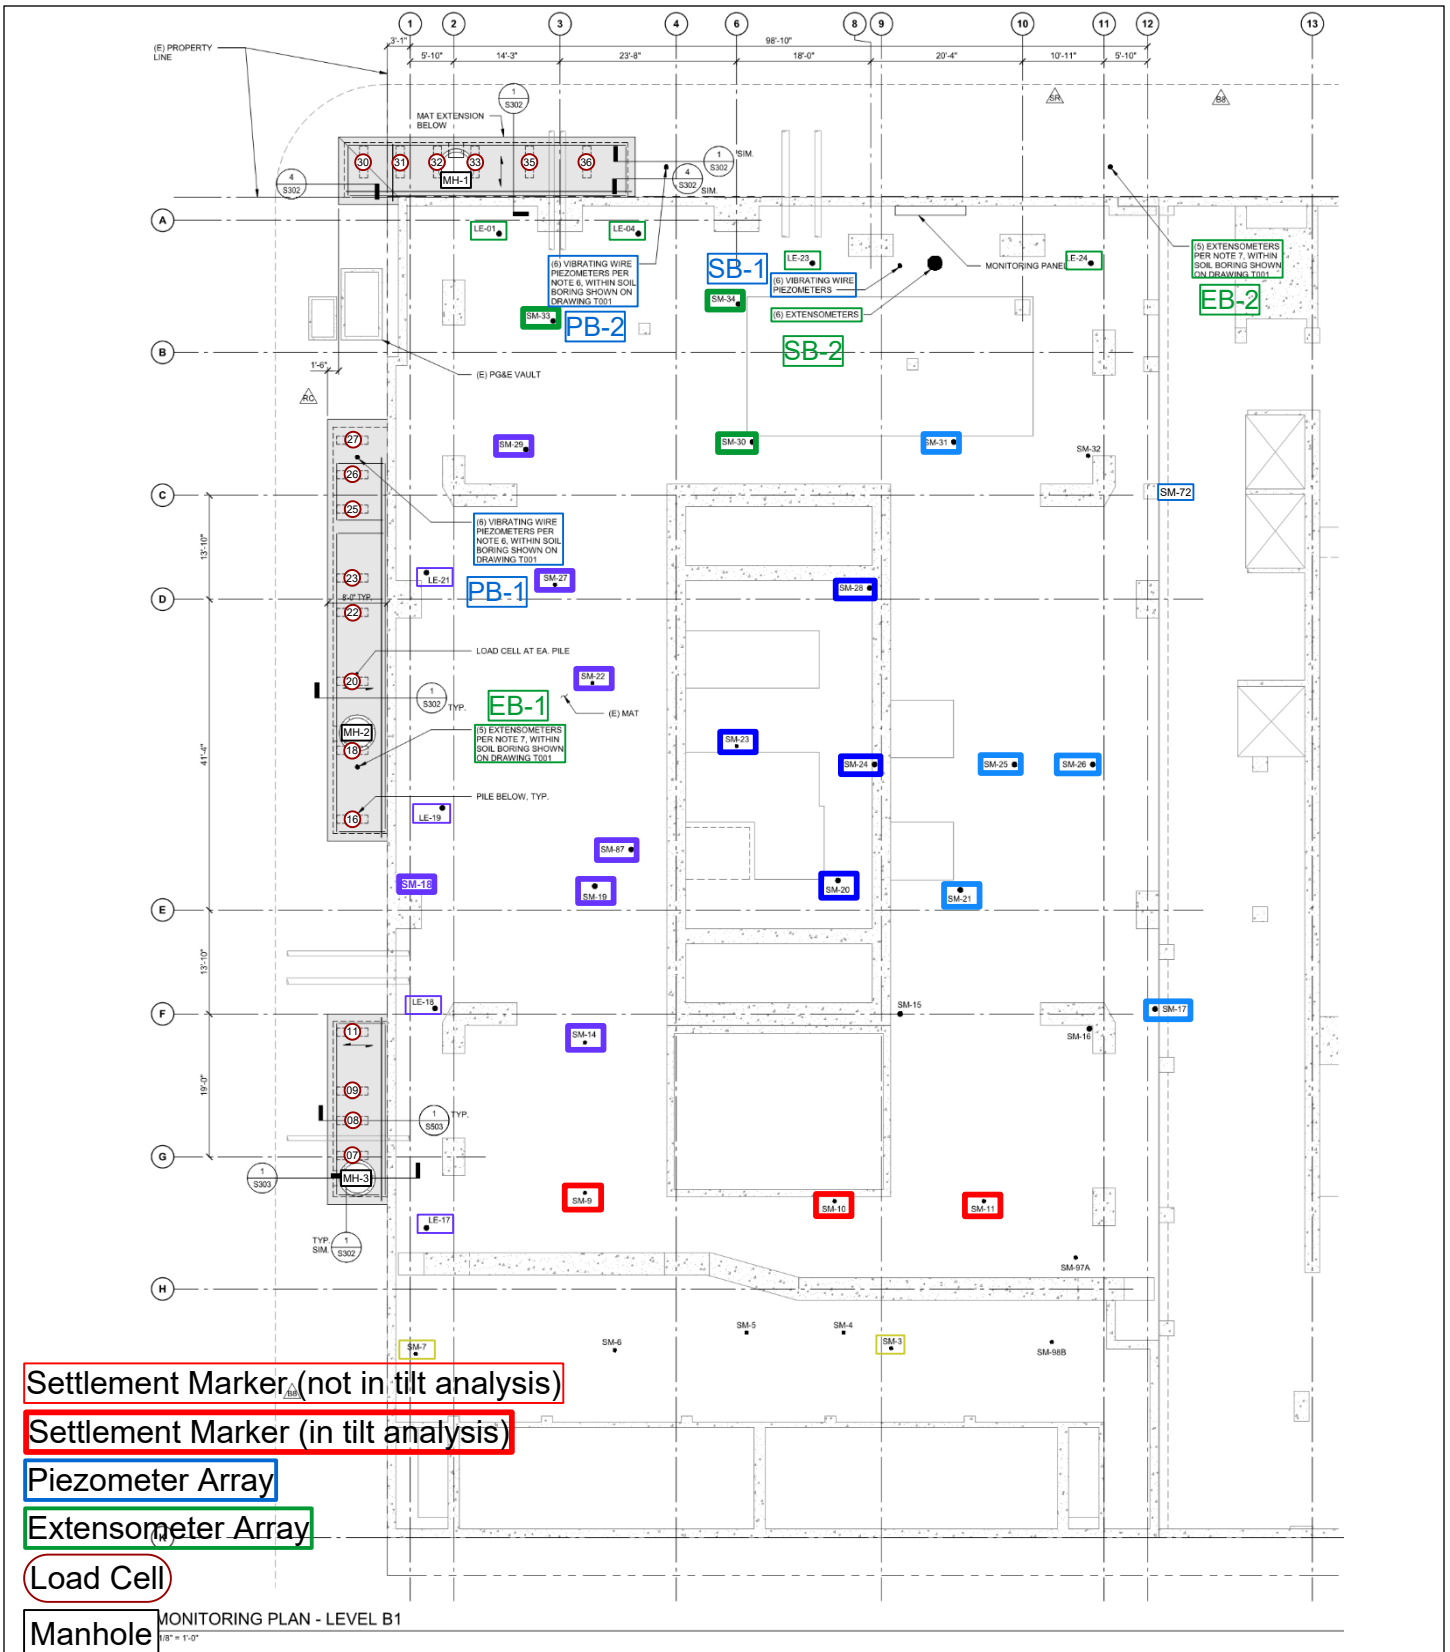
Project No: 23-018-01	Date: 8/22/2023	Created By: NBW	Checked By: DGM	Figure No: 142-01A
-----------------------	-----------------	-----------------	-----------------	--------------------

Figure 01 presents the instrument locations as referenced in later figures.

- Settlement Marker (not in tilt analysis)
- Settlement Marker (in tilt analysis)
- Piezometer Array
- Extensometer Array
- Load Cell
- Manhole

**INSTRUMENT LOCATION MAP
SETTLEMENT MARKERS, PIEZOMETERS, EXTENSOMETERS, LOAD CELLS**

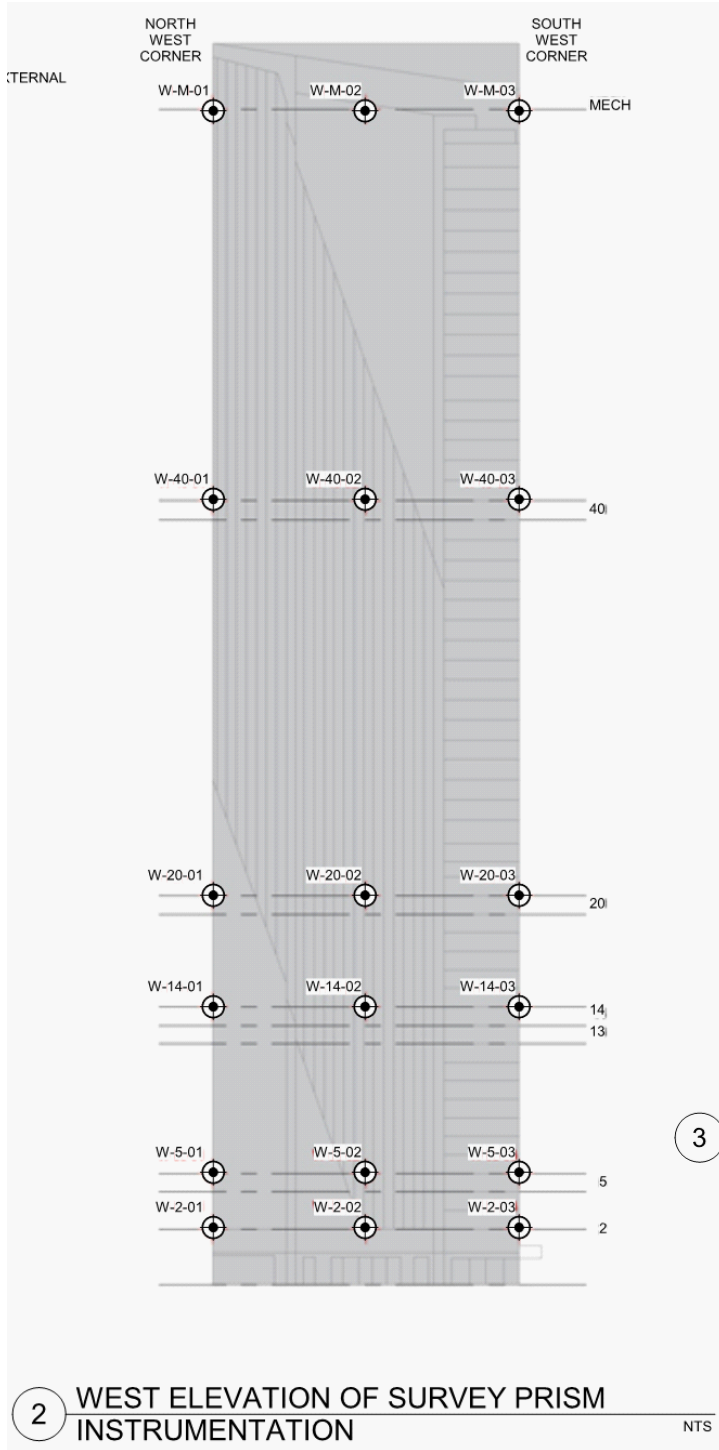
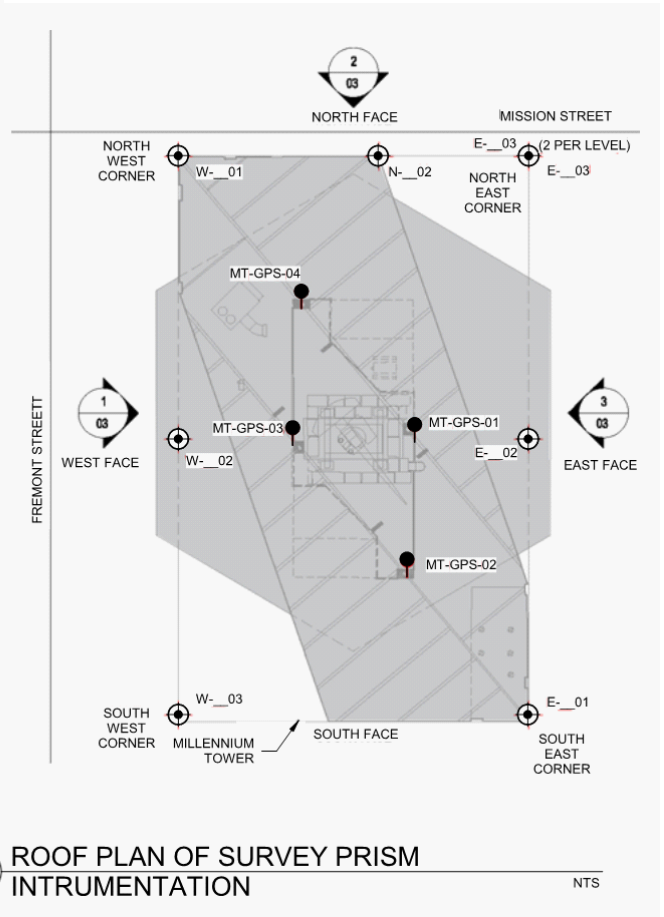
Project No: 23-018-01	Date: 7/26/2021	Created By: NBW	Checked By: DGM	Figure No: 142-01B
-----------------------	-----------------	-----------------	-----------------	---------------------------

TOWER SURVEY PRISM LOCATION SCHEMATIC

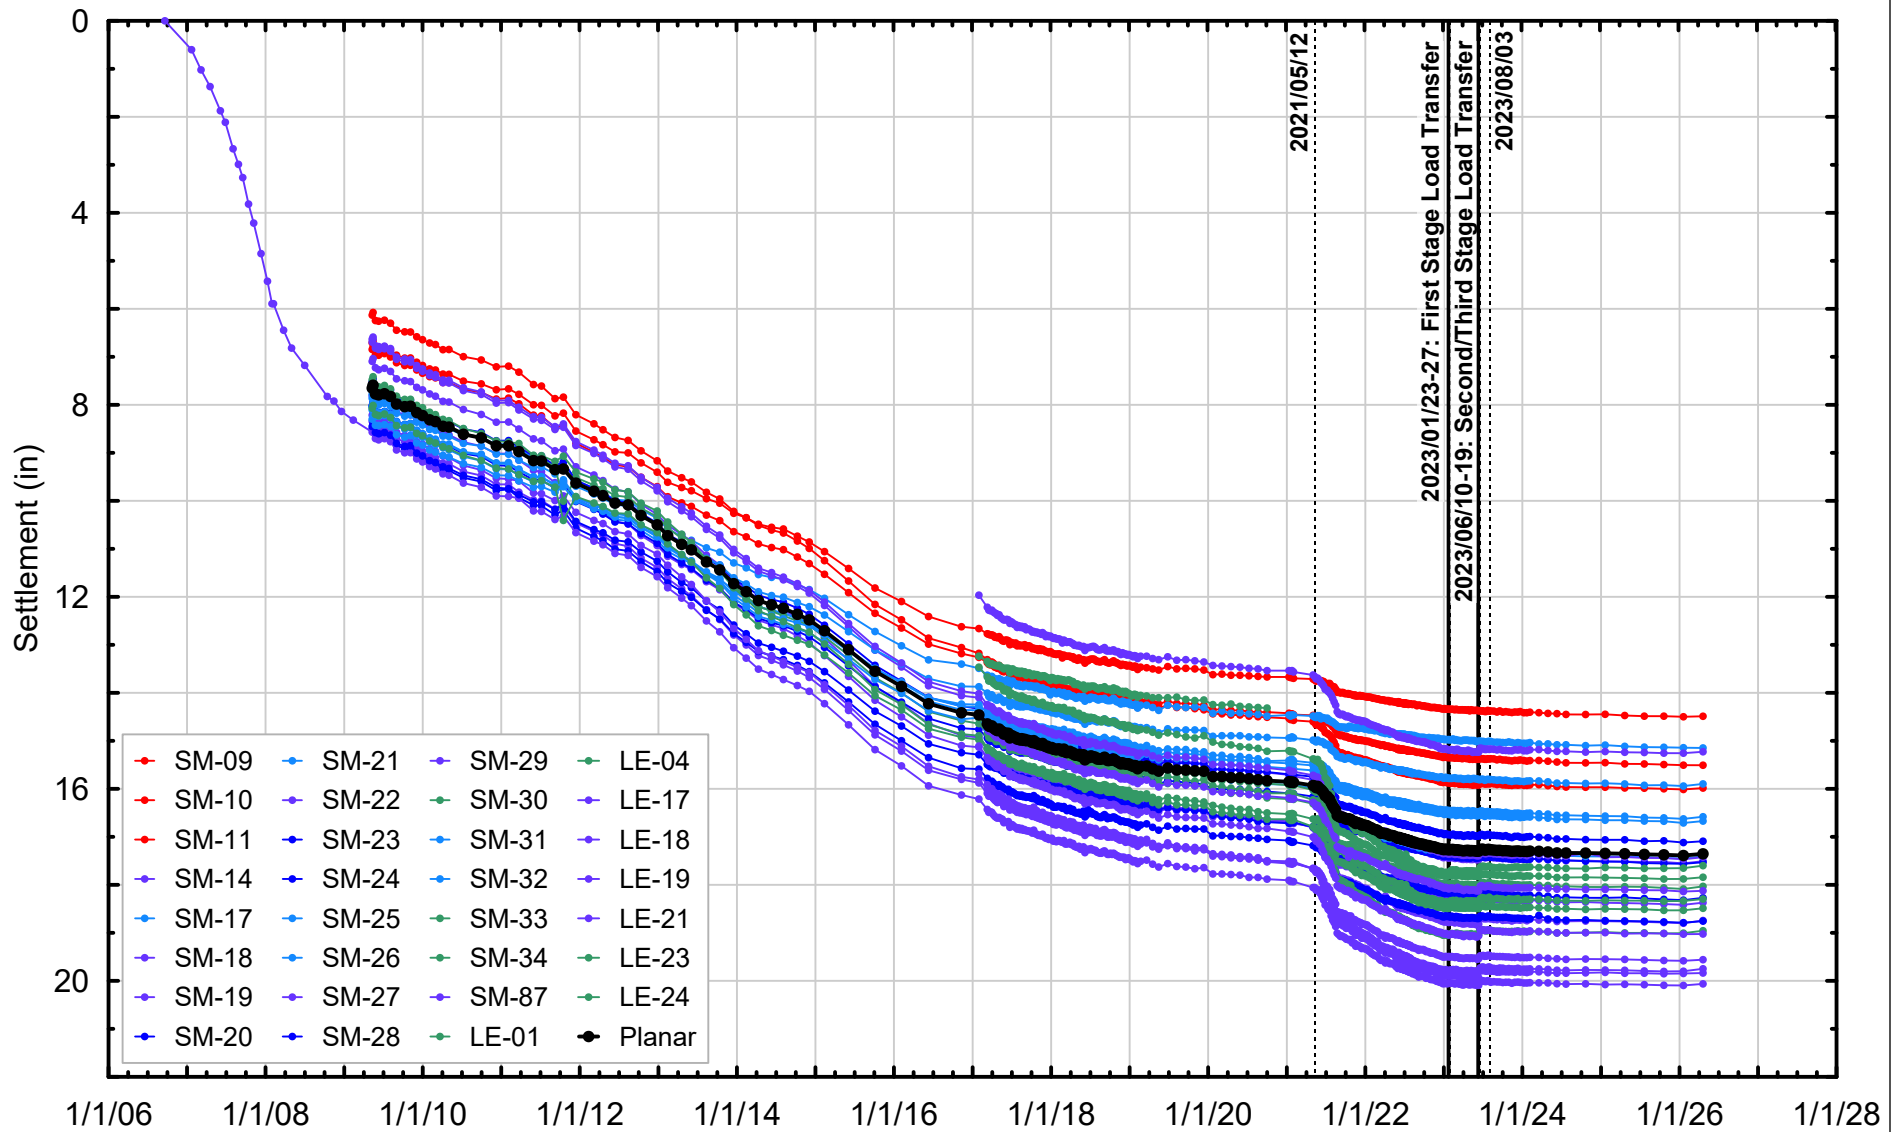
Project No: 23-018-01	Date: 4/29/2026	Created By: LR	Checked By: DGM	Figure No: 142-02

Figure 02 presents the historical settlement data interpreted from settlement markers installed on the B-1 Level of 301 Mission Tower. In addition, data from surveys performed during the retrofit are included. Figure 03 presents settlement data since the start of production pile installation (May 12, 2021; baseline readings on May 10, 2021) through April 20, 2026. Figure 04 presents current settlement contours (in inches) on April 20, 2026.

HISTORICAL SETTLEMENT MARKER DATA		
		Millennium Tower Perimeter Pile Upgrade: Instrumentation Monitoring Data City and County of San Francisco, California

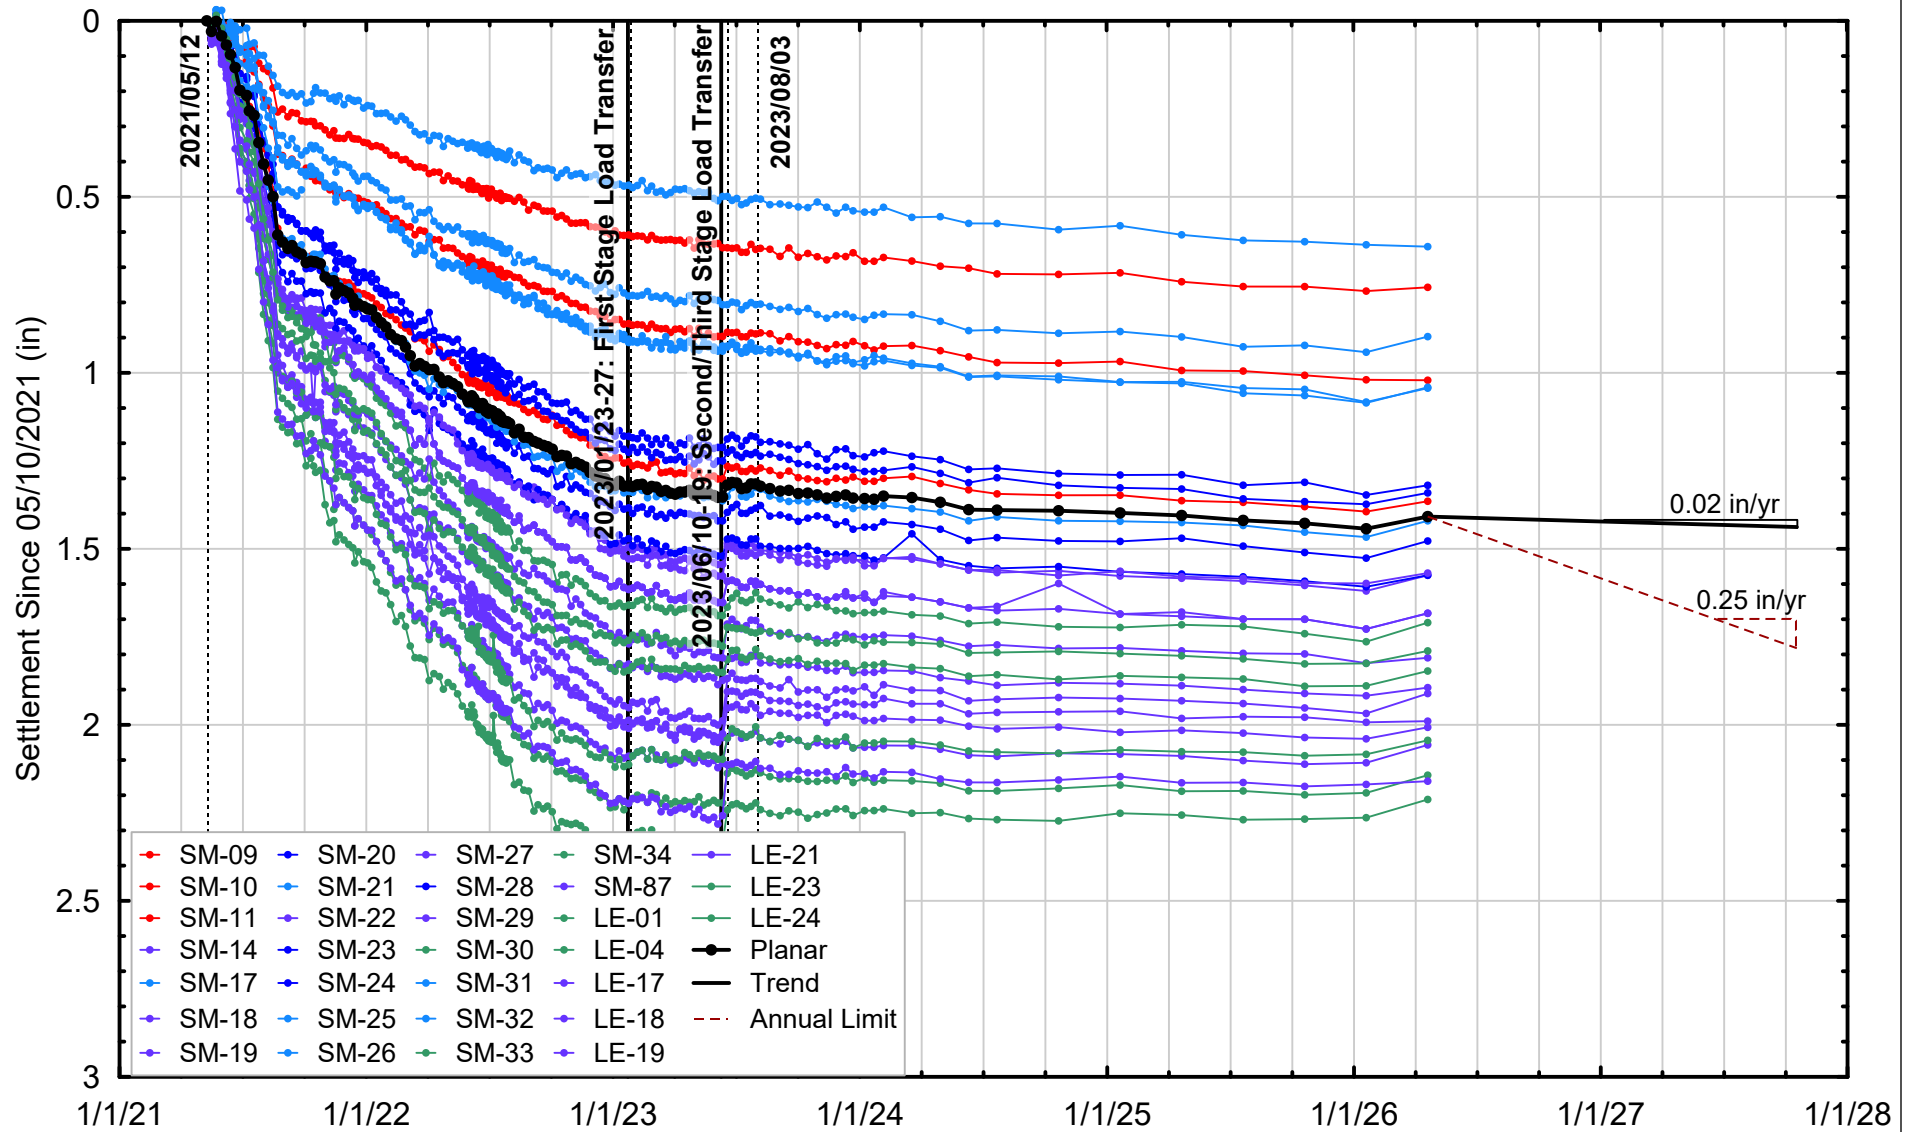
Project No: 23-018-01	Date: 4/29/2026	Created By: LR	Checked By: DGM	Figure No: 142-03

⁵ As plotted on Figure 03. The annual rate is calculated starting on the settlement monitoring date closest to one year prior to the current date or on June 19, 2023 (the settlement monitoring date corresponding to the last day of jacking load application), whichever is later, and ending on the current date.

SETTLEMENT MARKER DATA SINCE 05/10/2021 THROUGH 04/20/2026		
		Millennium Tower Perimeter Pile Upgrade: Instrumentation Monitoring Data City and County of San Francisco, California

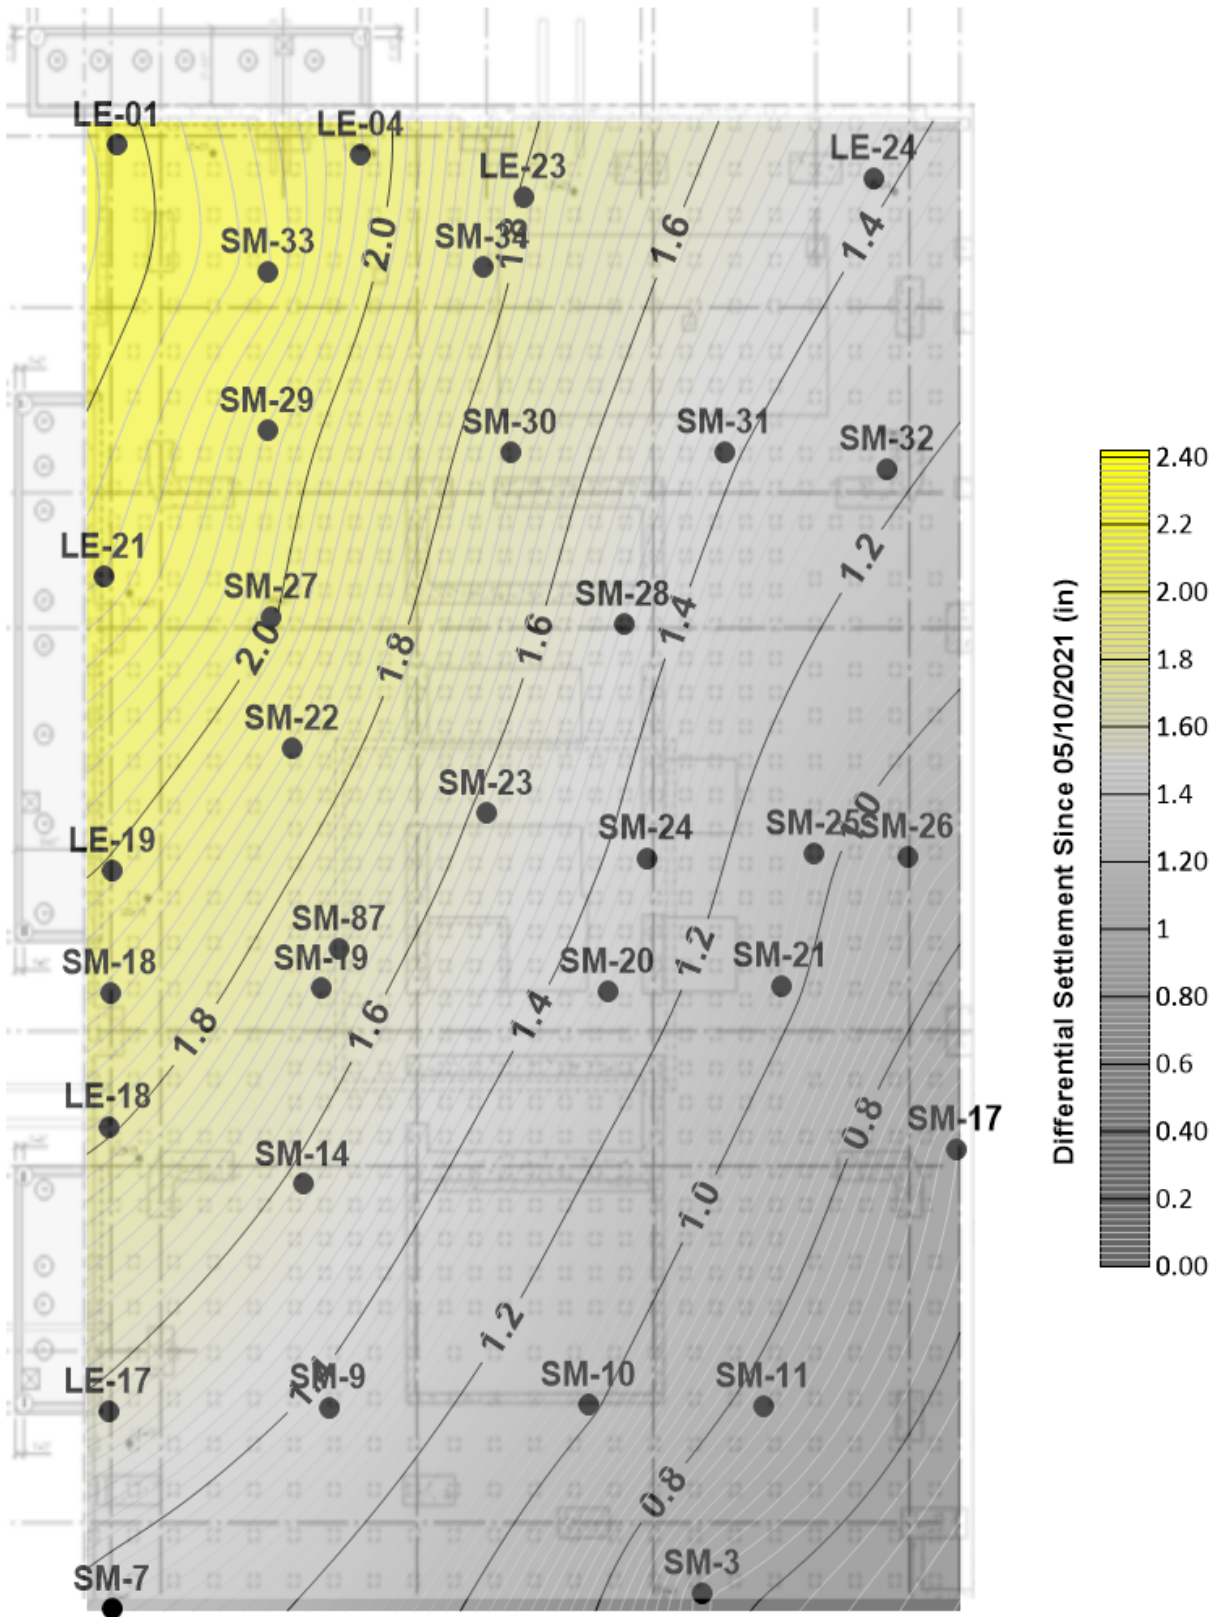
Project No: 23-018-01 Date: 4/29/2026 Created By: LR Checked By: DGM Figure No: **142-04**

SETTLEMENT CONTOURS
 SINCE 05/10/2021 THROUGH 04/20/2026
 Millennium Tower Perimeter Pile Upgrade: Instrumentation Monitoring Data
 City and County of San Francisco, California

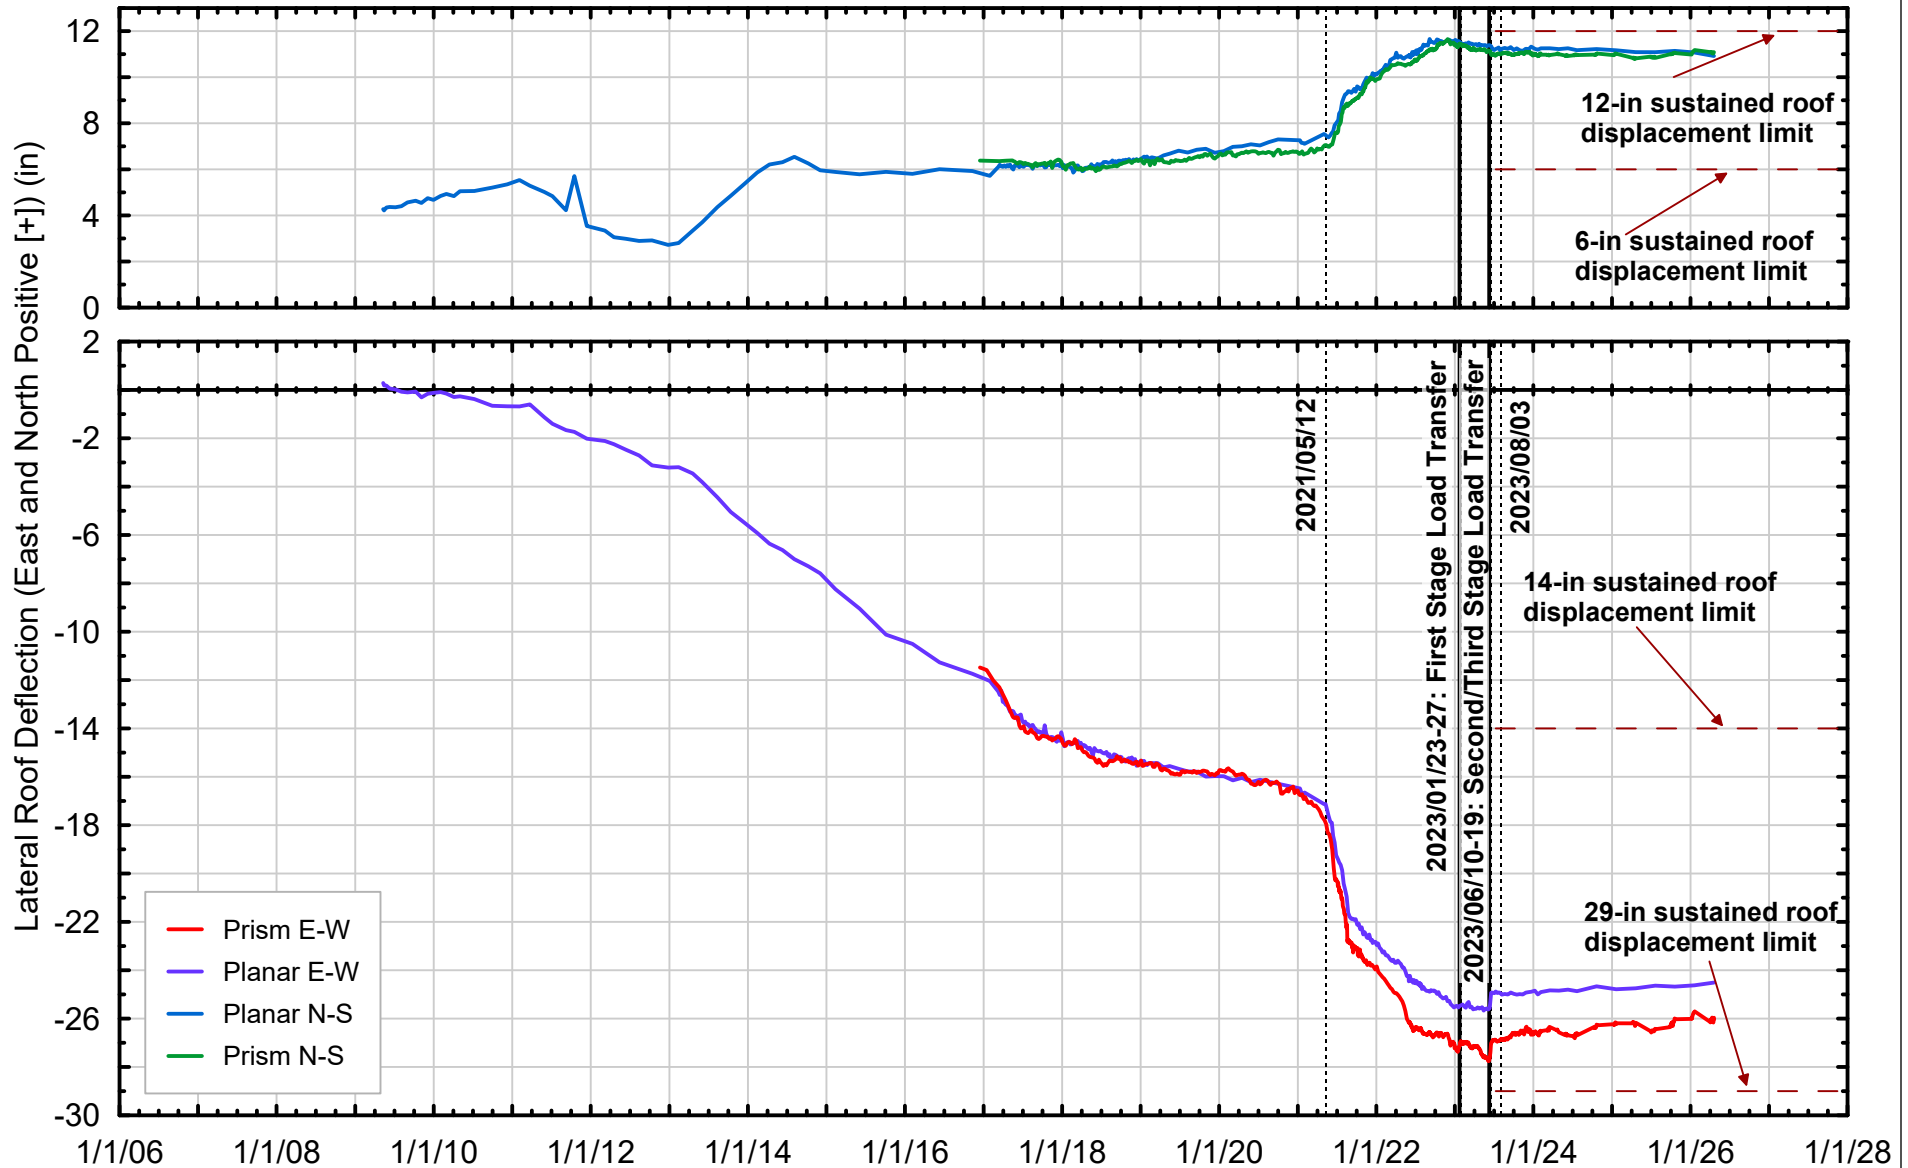
Project No: 23-018-01	Date: 4/29/2026	Created By: LR	Checked By: DGM	Figure No: 142-05
-----------------------	-----------------	----------------	-----------------	-------------------

Figure 05 presents historical lateral roof deflections in the project north-south and project east-west directions interpreted from survey prisms mounted on the exterior of the Tower, from InSAR data, and from a planar fit of the settlement marker data. In addition, data from surveys performed during the retrofit are included. Figure 06 presents lateral roof deflection data from a planar fit of the settlement marker data and from survey prisms mounted on the exterior of the Tower since the start of production pile installation (May 12, 2021; baseline readings on May 10 and 13, 2021, respectively) through April 20, 2026.

⁶ As plotted on Figure 05, relative to a plumb condition.

HISTORICAL LATERAL ROOF DEFLECTION DATA

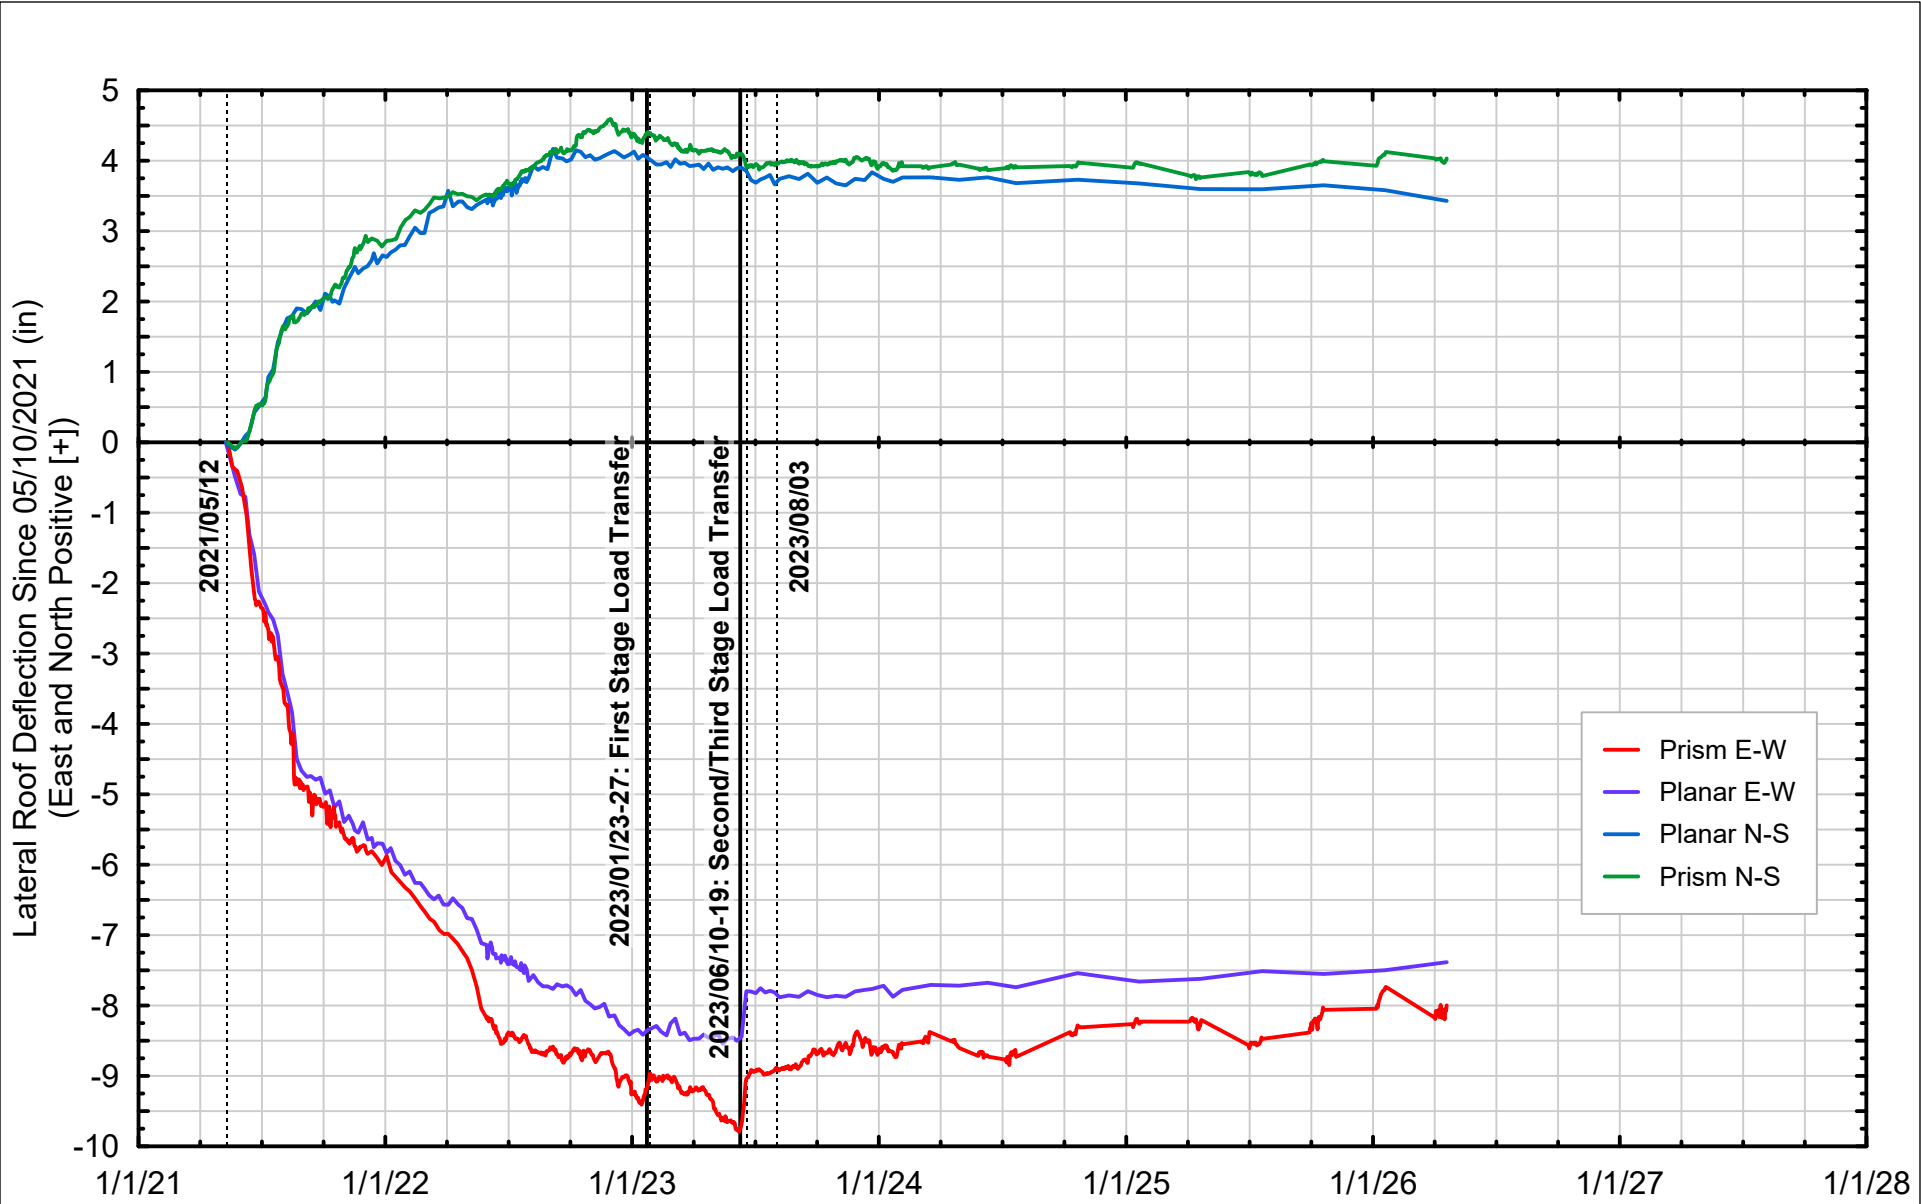
Project No: 23-018-01	Date: 4/29/2026	Created By: LR	Checked By: DGM	Figure No: 142-06
-----------------------	-----------------	----------------	-----------------	-------------------

LATERAL ROOF DEFLECTION DATA
SINCE 05/10/2021 THROUGH 04/20/2026

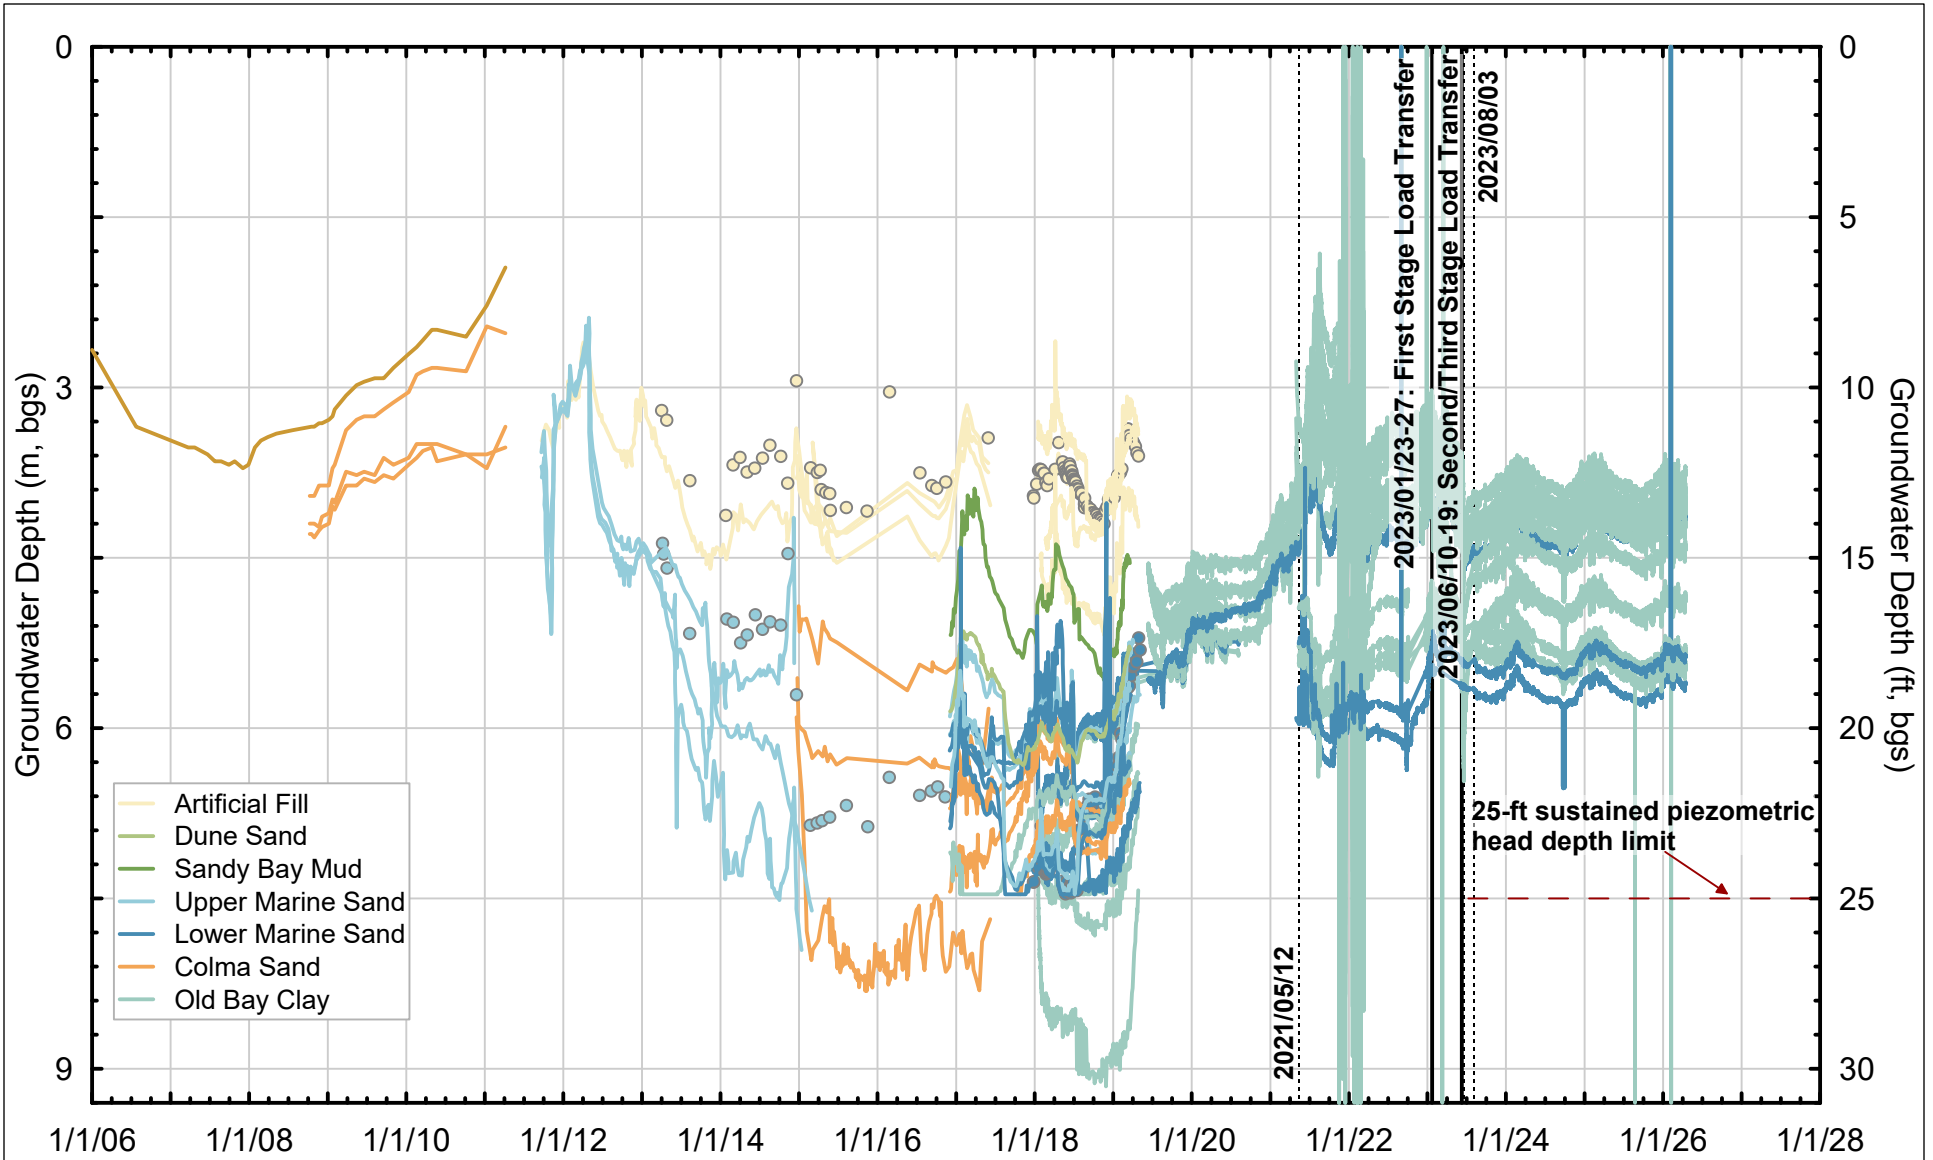
Project No: 23-018-01	Date: 4/29/2026	Created By: LR	Checked By: DGM	Figure No: 142-07
-----------------------	-----------------	----------------	-----------------	-------------------

Figure 07 presents the historical groundwater elevation interpreted from piezometer readings at locations near 301 Mission. In addition, data from piezometers installed to monitor groundwater elevation during the retrofit are included. Figures 08 and 09 present groundwater elevation interpreted from piezometer readings in the Marine/Colma Sand and the Old Bay Clay, respectively, for the time period prior to the start of production pile installation (January 1, 2021) through April 16, 2026.

HISTORICAL GROUNDWATER ELEVATION MEASUREMENTS
 AT LOCATIONS NEAR 301 MISSION

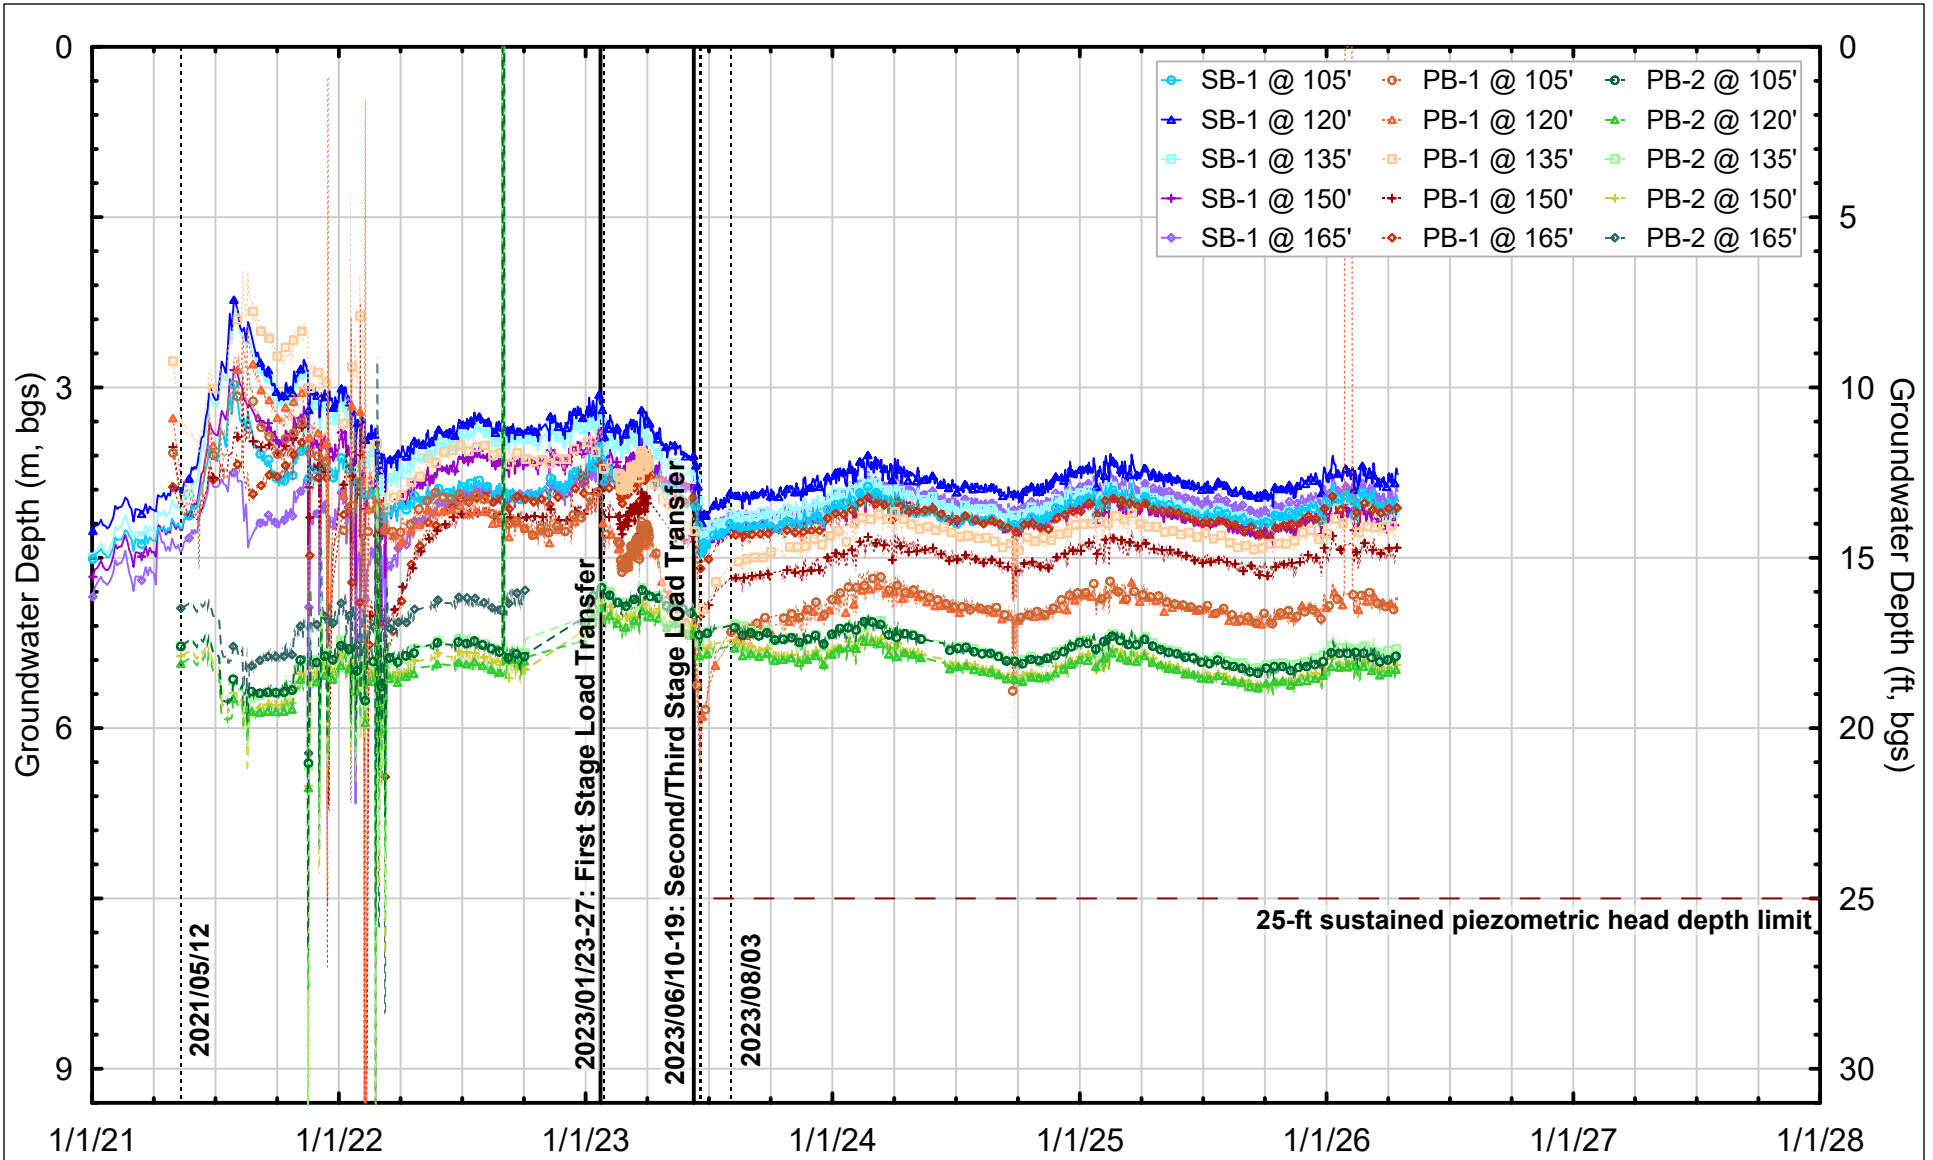
Project No: 23-018-01	Date: 4/29/2026	Created By: LR	Checked By: DGM	Figure No: 142-09
-----------------------	-----------------	----------------	-----------------	-------------------

GROUNDWATER ELEVATION MEASUREMENTS IN OLD BAY CLAY
 SINCE 01/01/2021 THROUGH 04/16/2026
