Subject: 301 Mission Retrofit Monitoring Report 142: Results as of April 20, 2026

This memorandum summarizes results from the monitoring plan implemented at the 301 Mission property. Instrumentation to monitor the structure prior to, during and after the retrofit was installed in January 2021, including piezometers and extensometers. Settlement markers installed in April 2009 and January 2017, survey prisms mounted on the exterior of the structure in December 2016, and crack gauges installed in April 2009 have also been monitored. Pile load cells were installed on the Mission Street piles in January 2023, and on the Fremont Street piles in June 2023. Survey points were established on the manhole covers around the Tower and a baseline reading was performed on August 8, 2023. This memorandum is for review only. It only contains ongoing monitoring information. This memorandum does not contain recommendations based upon the ongoing monitoring information.

Millennium Tower Perimeter Pile Upgrade: Instrumentation Monitoring Data
City and County of San Francisco, California

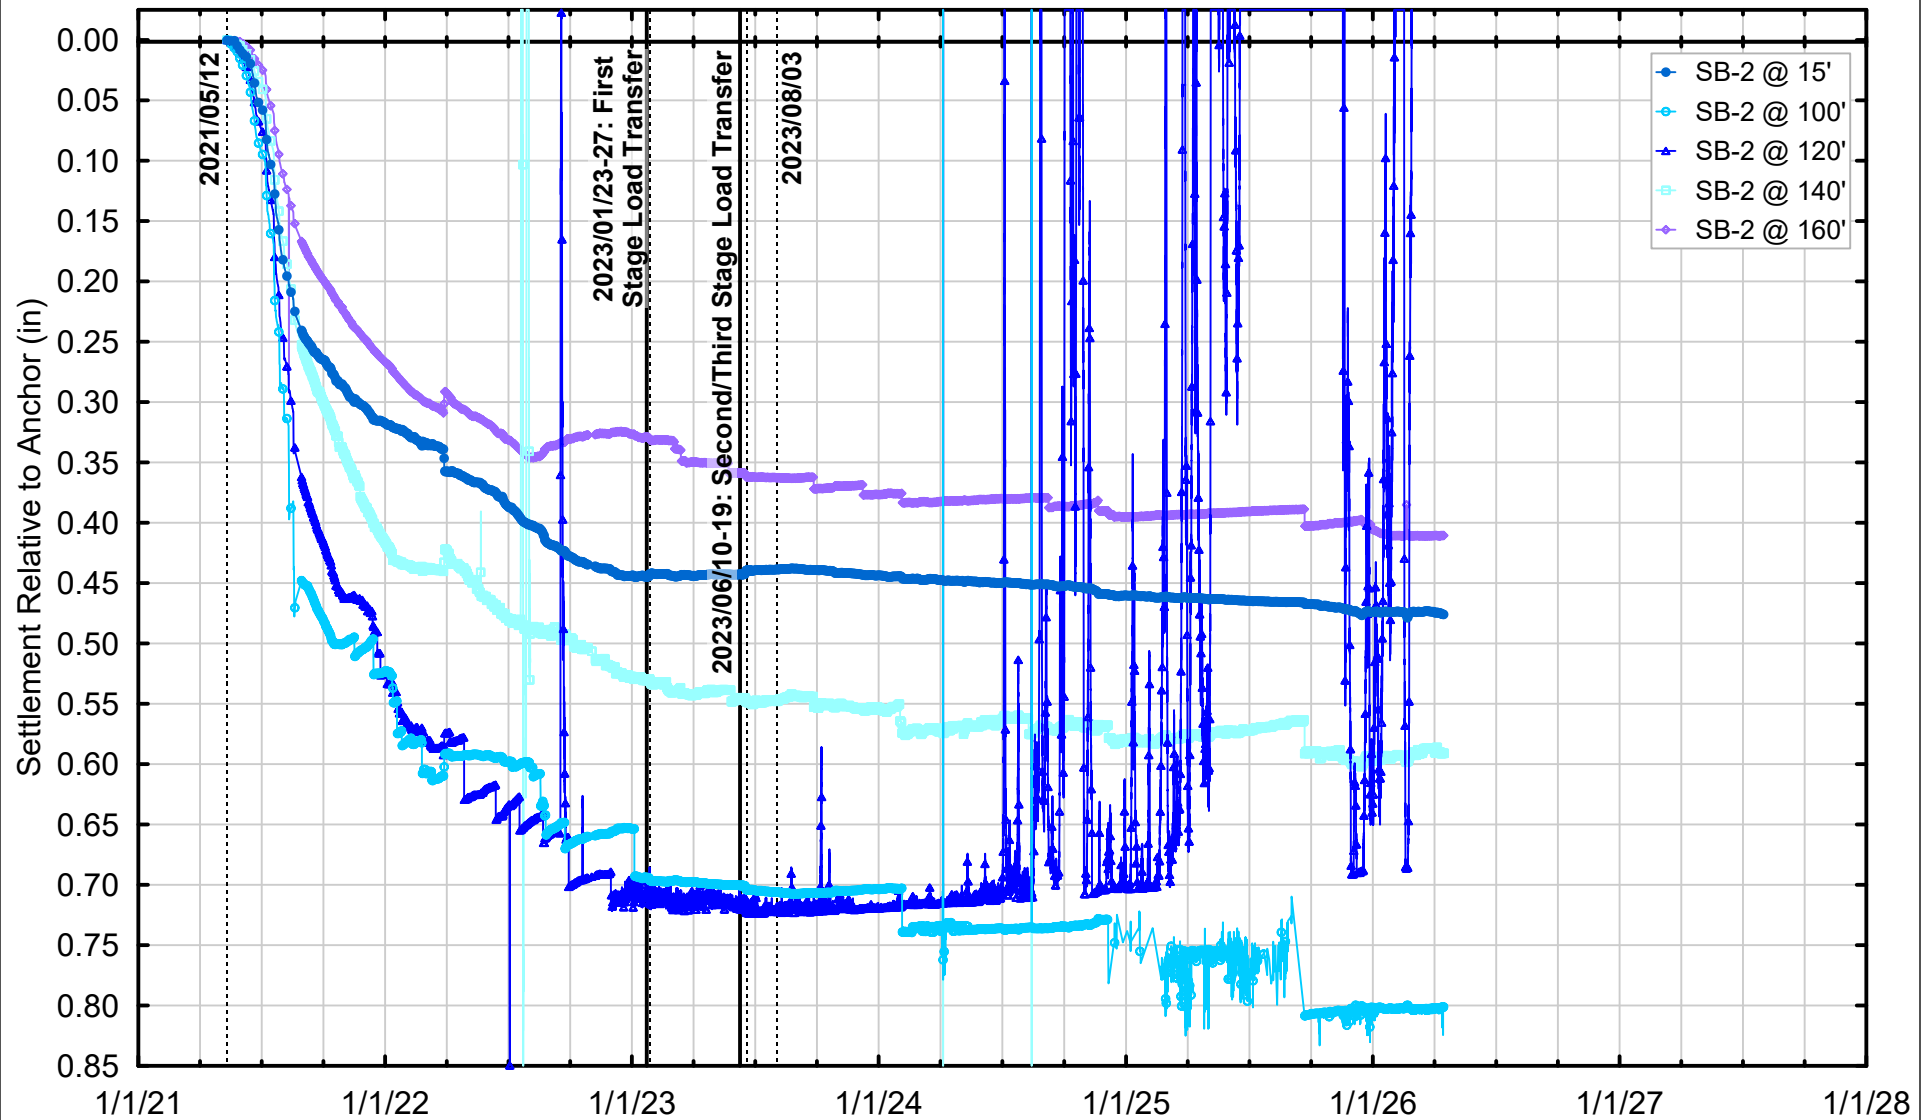
Project No: 23-018-01	Date: 4/29/2026	Created By: LR	Checked By: DGM	Figure No: 142-10

During data collection, potential damage was noticed on the data logger for the basement instruments. Work to correct this is underway, and the batteries have been removed as a precaution.

Figure 10 presents extensometer data from within the Tower basement since the start of production pile installation (May 12, 2021) through April 16, 2026. Figure 11 presents extensometer data from Fremont Street since the start of production pile installation (May 12, 2021) through May 16, 2023, and from the restart after fixing the extensometer (May 30, 2023) through April 16, 2026. Figure 12 presents extensometer data from Mission Street since the start of production pile installation (May 12, 2021) through April 16, 2026.

EXTENSOMETER DATA FROM WITHIN TOWER BASEMENT SINCE 01/01/2021 THROUGH 04/16/2026 Millennium Tower Perimeter Pile Upgrade: Instrumentation Monitoring Data City and County of San Francisco, California

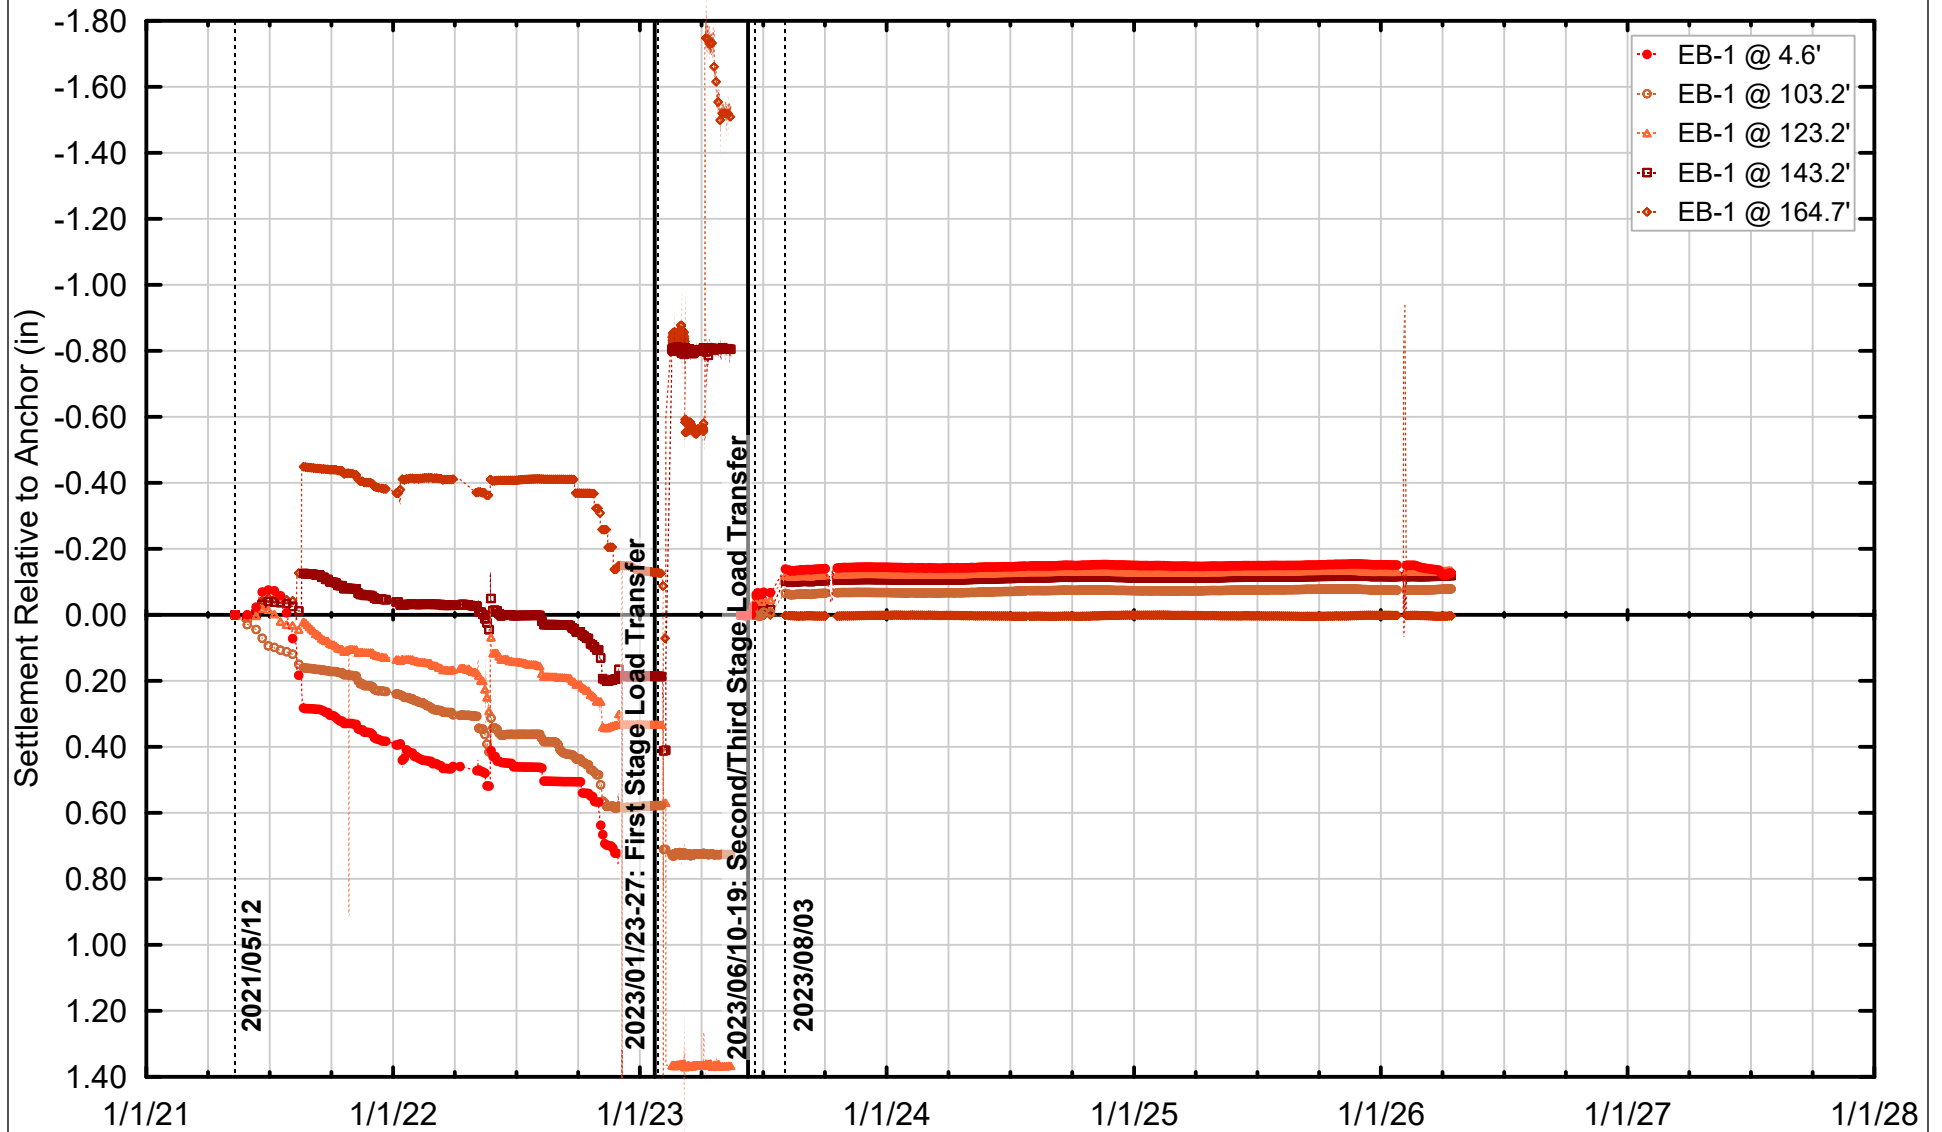
Figure No: 142-11

Exterior extensometer EB-2 is offline since August 9, 2025; work to correct this is currently ongoing.

Note: EB-1 was repaired and reset on 2023/05/30

EXTENSOMETER DATA FROM FREMONT STREET
 SINCE 05/10/2021 THROUGH 05/16/2023
 SINCE 05/30/2023 THROUGH 04/16/2025
 Millennium Tower Perimeter Pile Upgrade: Instrumentation Monitoring Data
 City and County of San Francisco, California

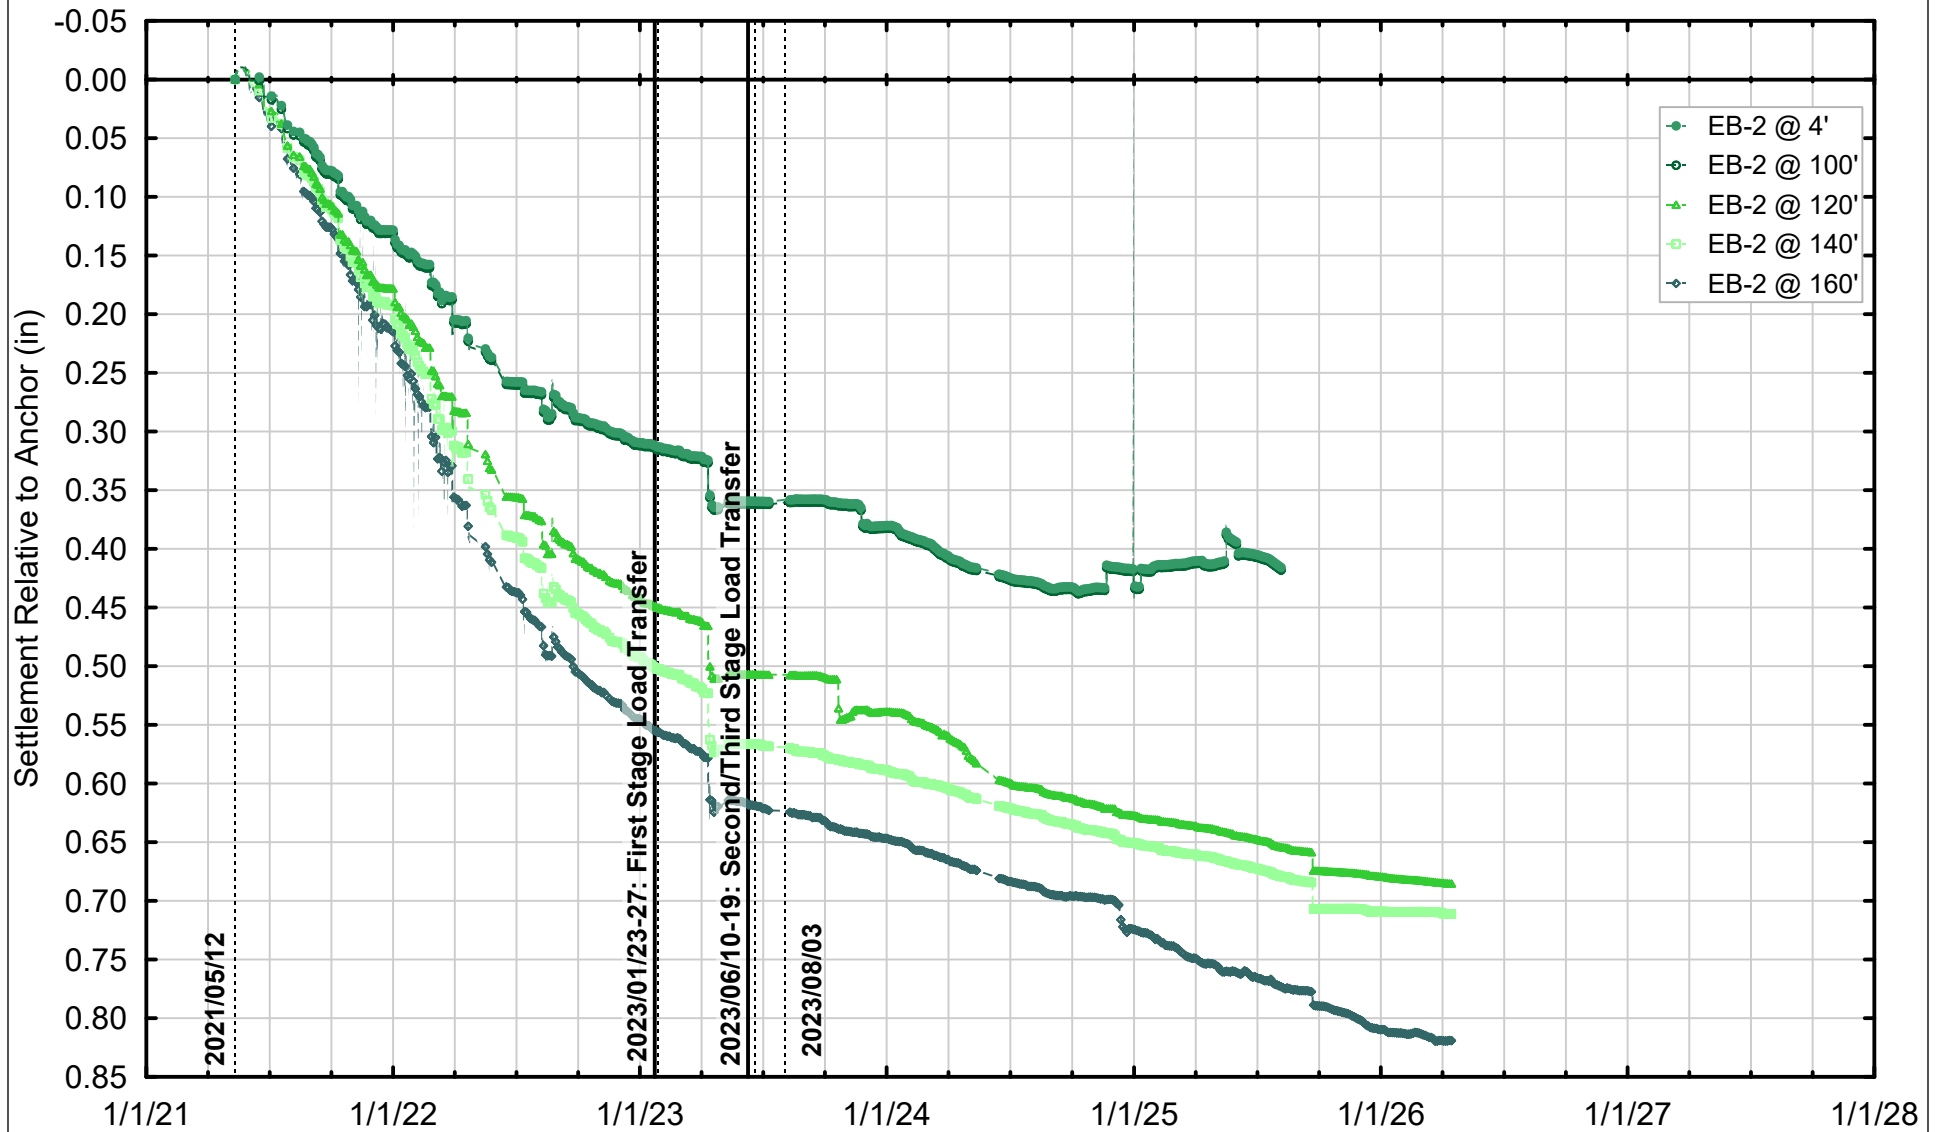
Project No: 23-018-01	Date: 4/29/2026	Created By: LR	Checked By: DGM	Figure No: 142-12
-----------------------	-----------------	----------------	-----------------	-------------------

EXTENSOMETER DATA FROM MISSION STREET
SINCE 01/01/2021 THROUGH 04/16/2026

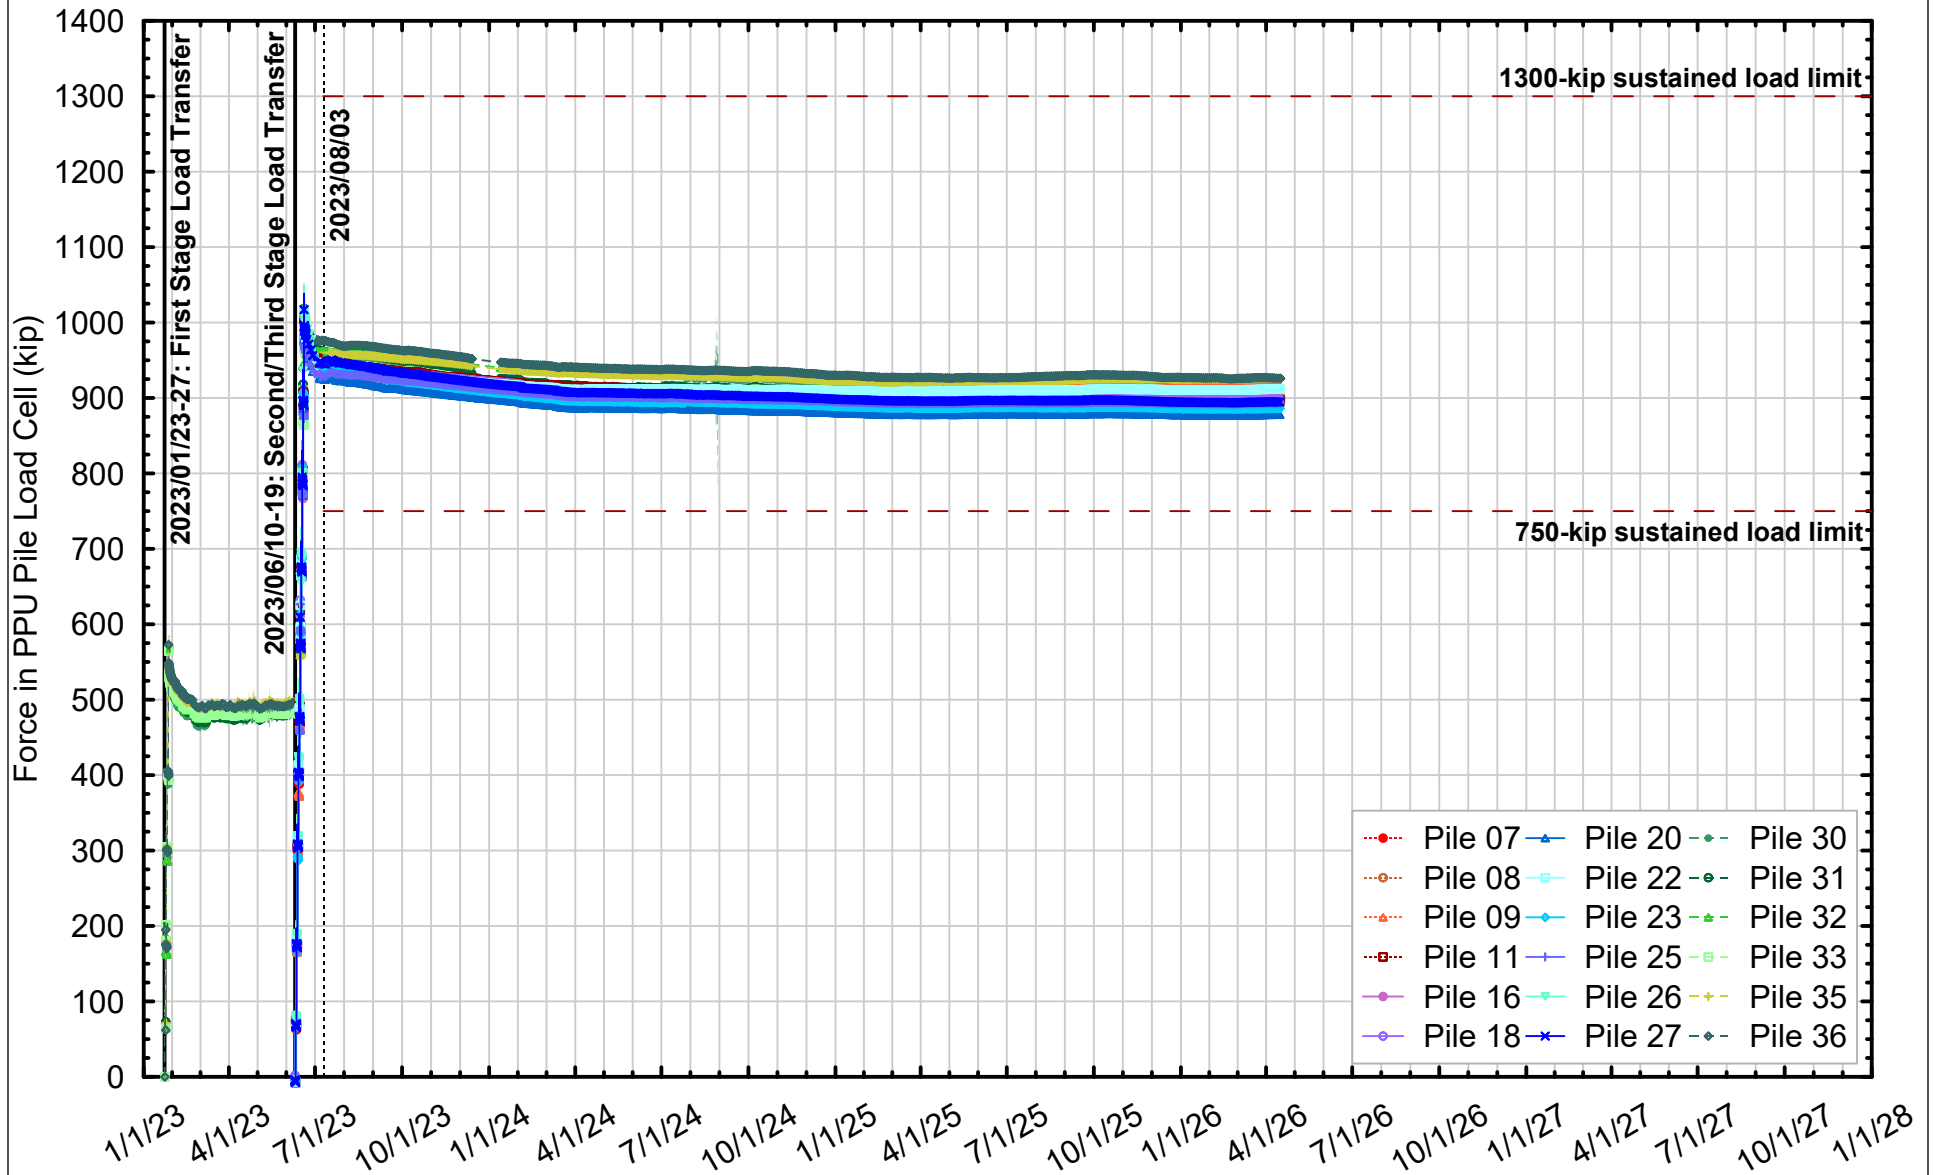
Project No: 23-018-01	Date: 4/29/2026	Created By: LR	Checked By: DGM	Figure No: 142-13A
-----------------------	-----------------	----------------	-----------------	--------------------

Figure 13A presents pile load cell data since the start of the First Stage Load Transfer (January 23, 2023) through April 16, 2026. Figure 13B presents the total pile load cell data since July 15, 2023, through April 16, 2026.

⁴ The load transfer rods have a maximum safe loading of 375 kips per rod, or 1,500 kips per pile. The 1,300-kip threshold is set to allow sufficient time to evaluate building behavior, should excessive load develop in one or more piles.

PILE LOAD CELL DATA
SINCE 01/23/2023 THROUGH 04/16/2026

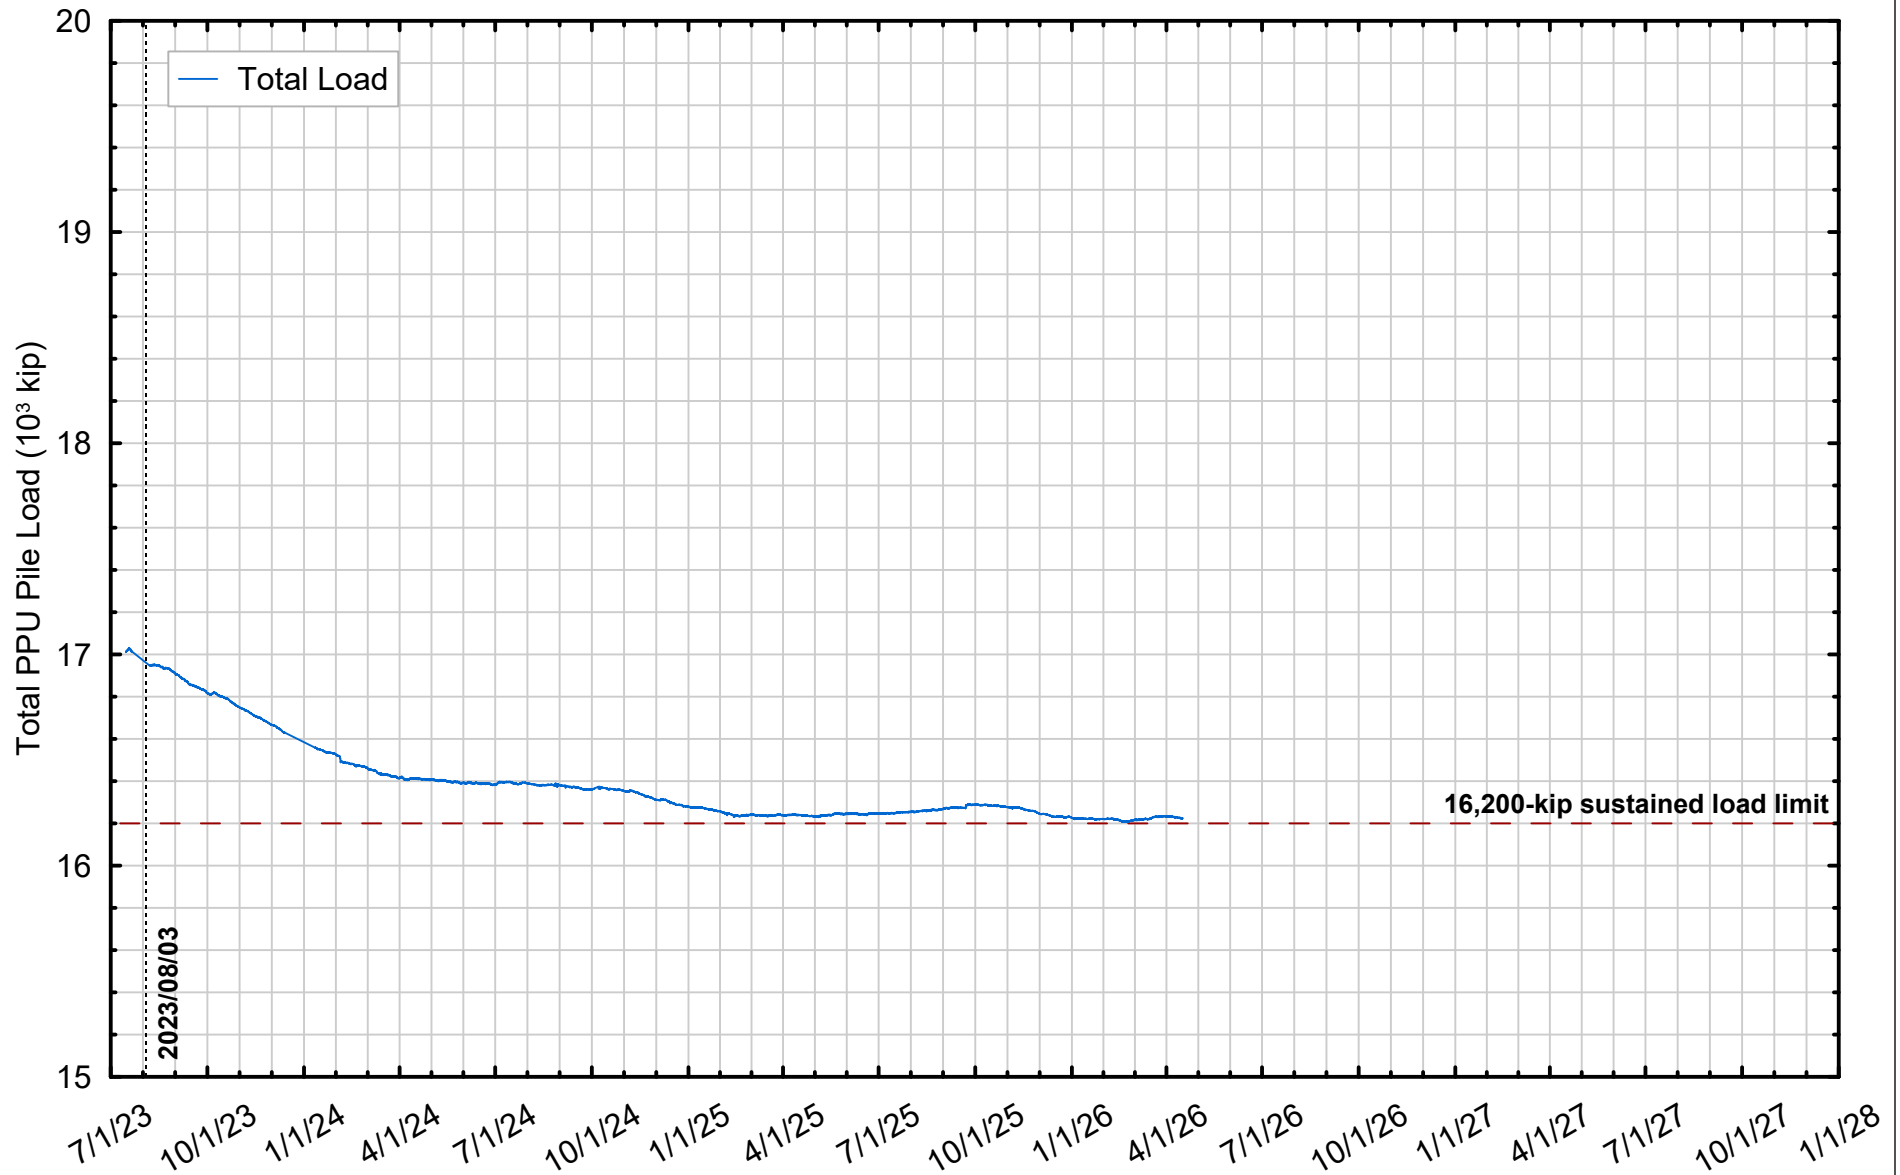
Project No: 23-018-01	Date: 4/29/2026	Created By: LR	Checked By: DGM	Figure No: 142-13B
-----------------------	-----------------	----------------	-----------------	--------------------

TOTAL PILE LOAD CELL DATA
SINCE 07/15/2023 THROUGH 04/16/2026

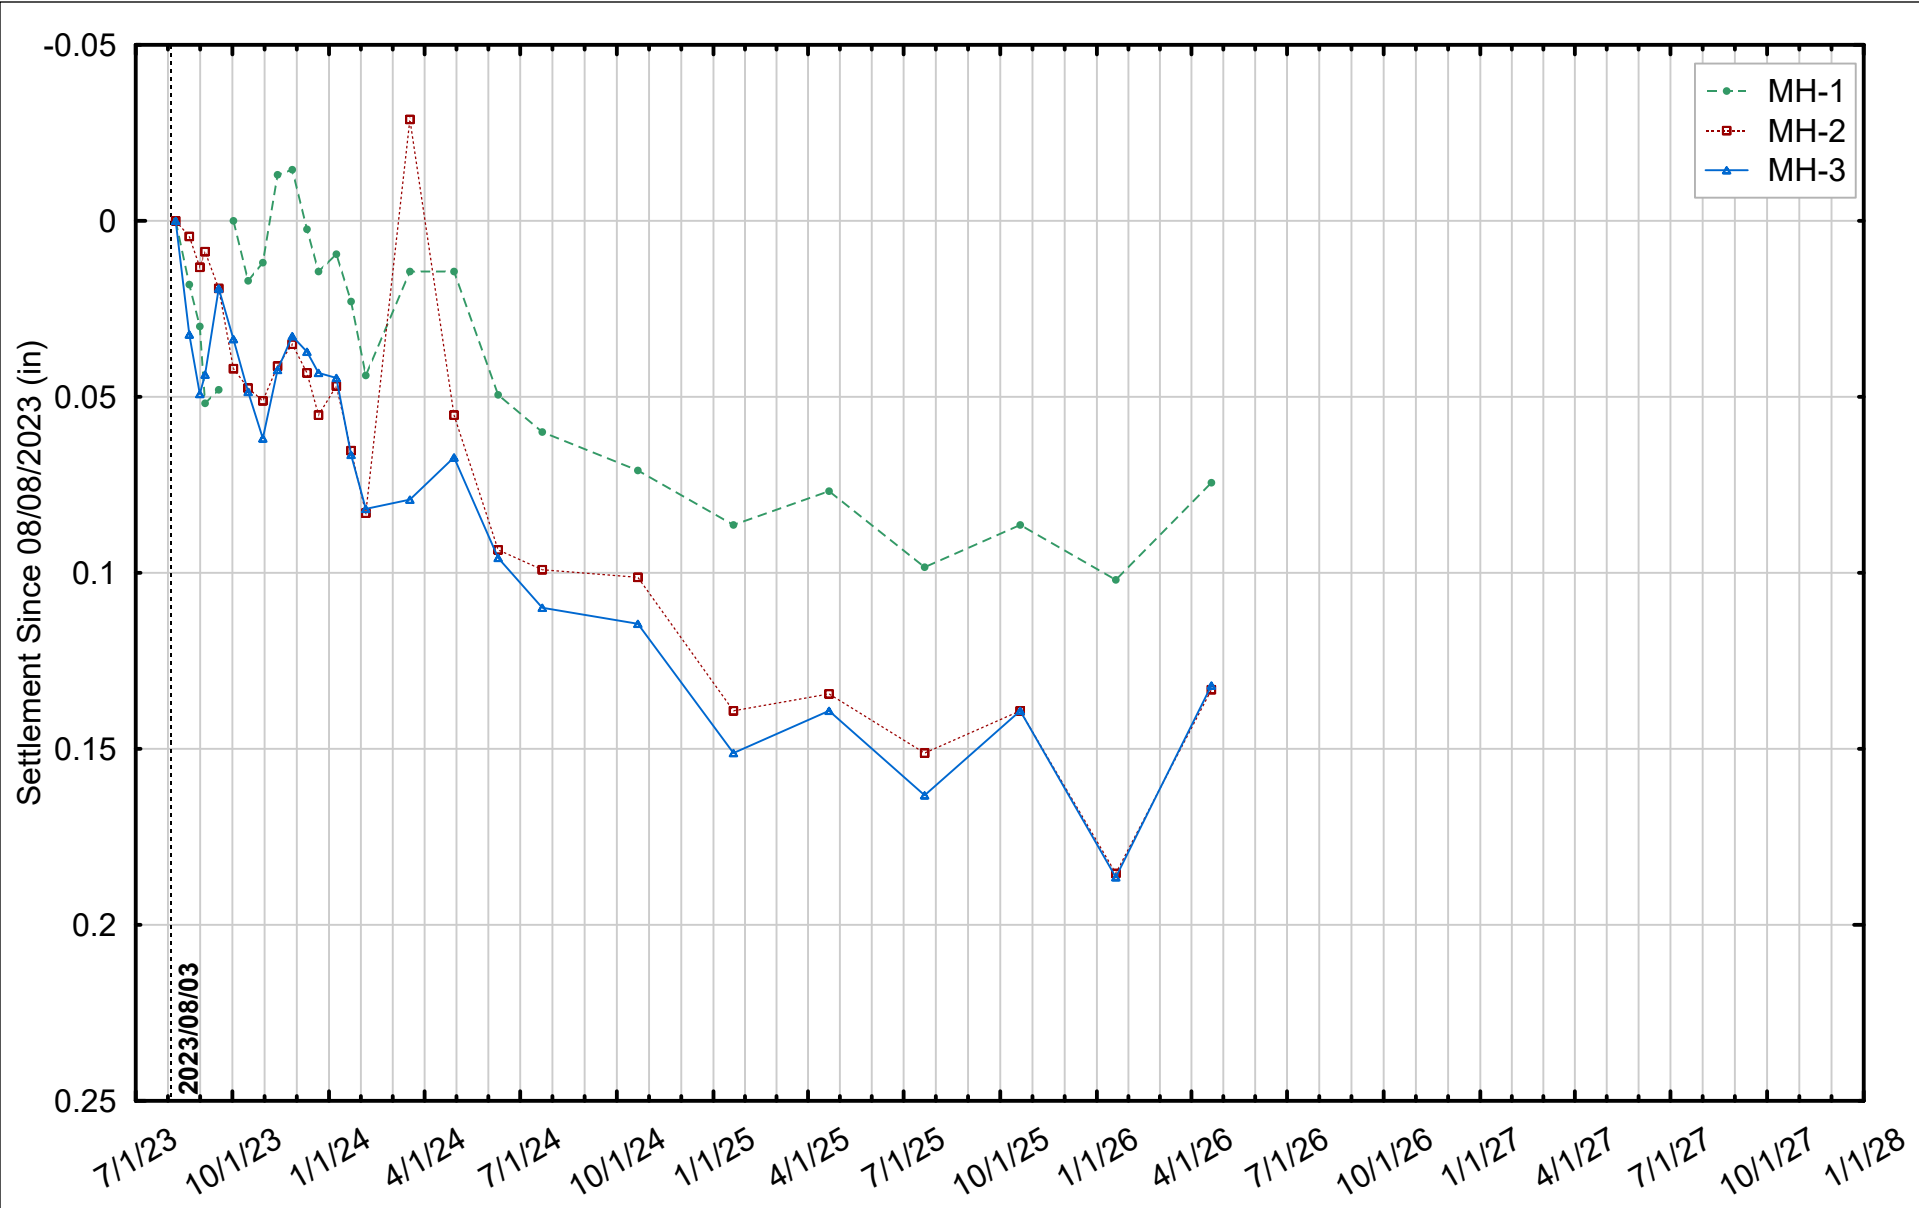
Project No: 23-018-01	Date: 4/29/2026	Created By: LR	Checked By: DGM	Figure No: 142-14
-----------------------	-----------------	----------------	-----------------	-------------------

Figure 14 presents settlement data interpreted from survey points located on manholes around the Tower since August 8, 2023, through April 20, 2026.

Note: MH-1 was reset on 10/02/2023

MANHOLE SETTLEMENT DATA
 SINCE 08/08/2023 THROUGH 04/20/2026
 Millennium Tower Perimeter Pile Upgrade: Instrumentation Monitoring Data
 City and County of San Francisco, California
