***Regular Meeting
of the
Building Inspection Commission***

APPENDIX A – MODIFICATIONS TO FEMA 352 FOR APPLICATION OF THIS BULLETIN

Recommended Postearthquake Evaluation and Repair Criteria for Welded Steel Moment-Frame Buildings

SAC Joint Venture

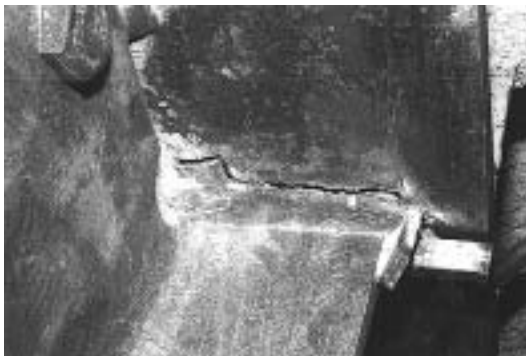
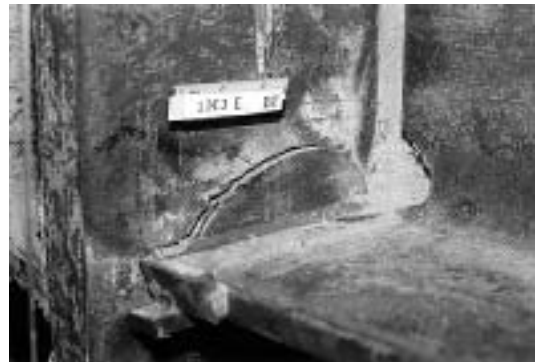
a. Fracture at Fused Zone

b. Column Flange "Divot" Fracture

Figure 1-3 Fractures of Beam to Column Joints

In some cases, the fractures progressed completely through the thickness of the weld, and when fire protective finishes were removed, the fractures were evident as a crack through exposed faces of the weld, or the metal just behind the weld (Figure 1-3a). Other fracture patterns also developed. In some cases, the fracture developed into a crack of the column flange material behind the CJP weld (Figure 1-3b). In these cases, a portion of the column flange remained bonded to the beam flange, but pulled free from the remainder of the column. This fracture pattern has sometimes been termed a “divot” or “nugget” failure.

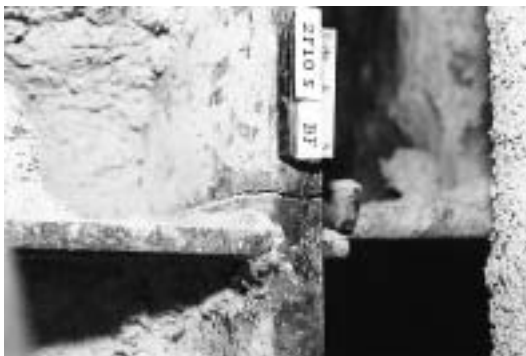
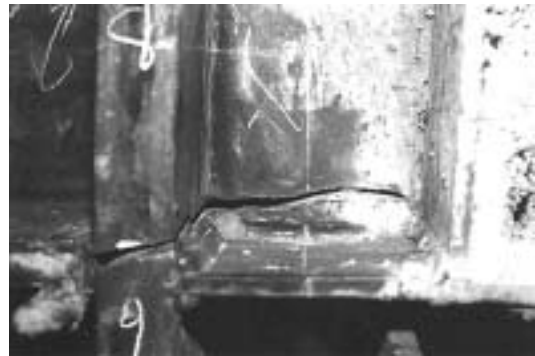
a. Fractures through Column Flange

b. Fracture Progresses into Column Web

Figure 1-4 Column Fractures

A number of fractures progressed completely through the column flange, along a near-horizontal plane that aligns approximately with the beam lower flange (Figure 1-4a). In some cases, these fractures extended into the column web and progressed across the panel zone (Figure 1-4b). Investigators have reported some instances where columns fractured entirely across the section.

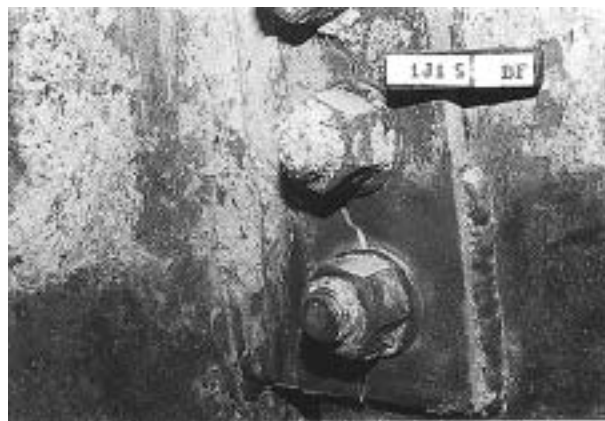
Figure 1-5 Vertical Fracture through Beam Shear Plate Connection

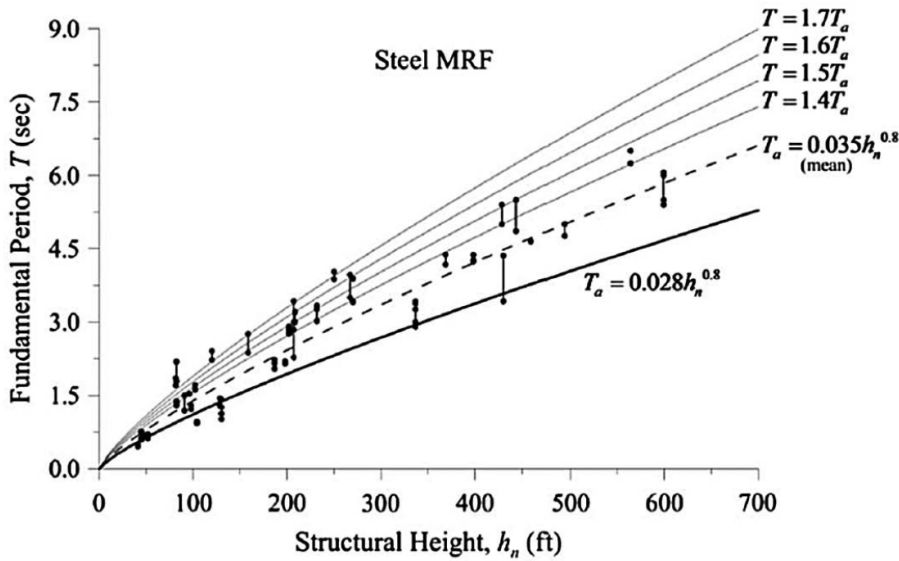
Figure 1 – Approximate Period formula and measured SMF building period from ASCE 7-22 Figure C12.8-2, based on work by Chopra, et. al.

Commentary: For steel moment-frame structures, ASCE 7-22 specifies a formula to approximate the lower-bound period to conservatively determine the seismic response coefficient for design. As illustrated in Figure 1, Equation 1 is an adaptation of the ASCE 7-22 equation to approximate the mean (expected) period of steel frame structures. The period given by Equation 1 has also been shown to provide a reasonable approximation to first-mode periods from frame analysis models of a set of steel moment-frame models representative of tall steel buildings in San Francisco (Valois et al. 2025).
