BOARD OF APPEALS, CITY & COUNTY OF SAN FRANCISCO

Appeal No. **25-049**

NOTICE OF APPEAL

PRELIMINARY STATEMENT FOR APPEAL NO. 25-049

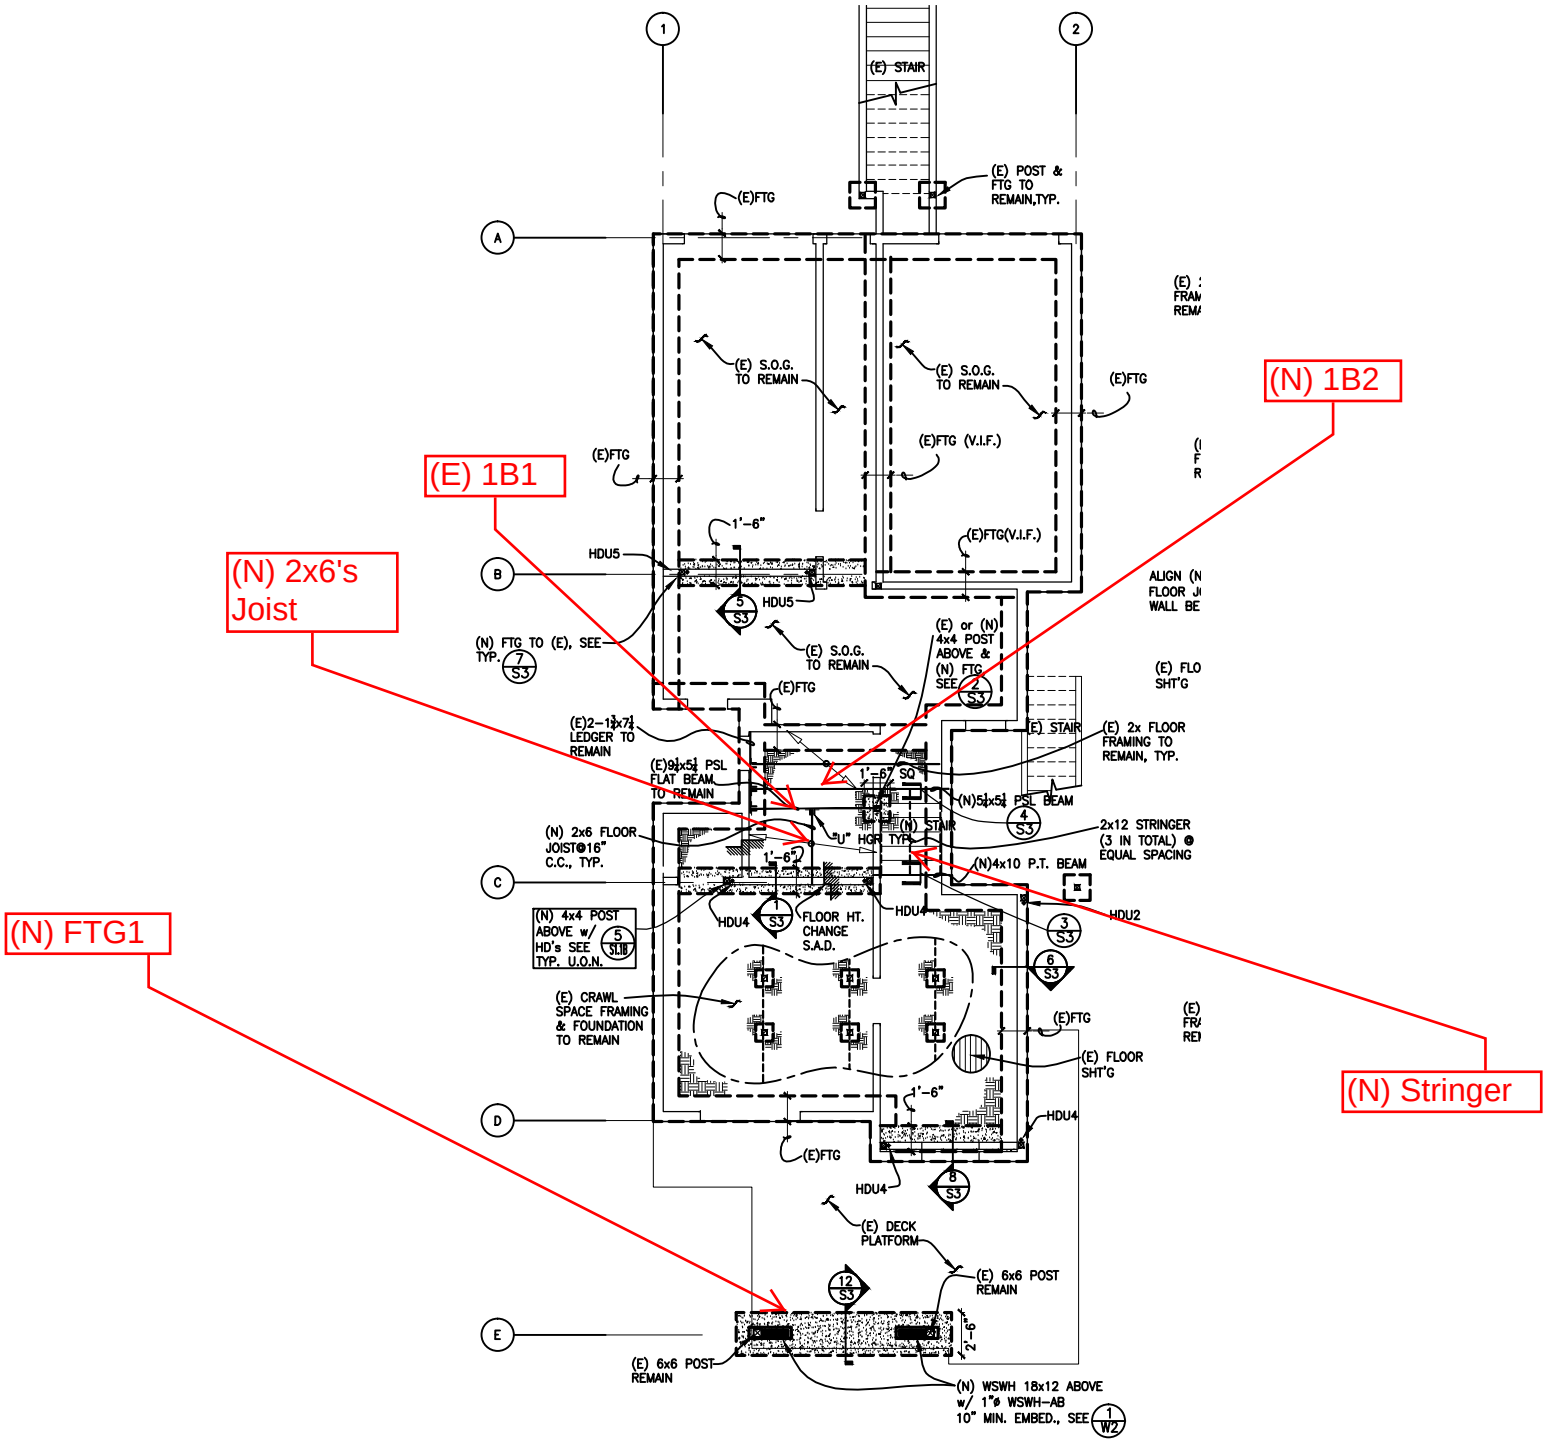
FIRST FLOOR / FOUNDATION PLAN

4'-0" LONG SHEARWALL ALONG LINE A IS MISSING

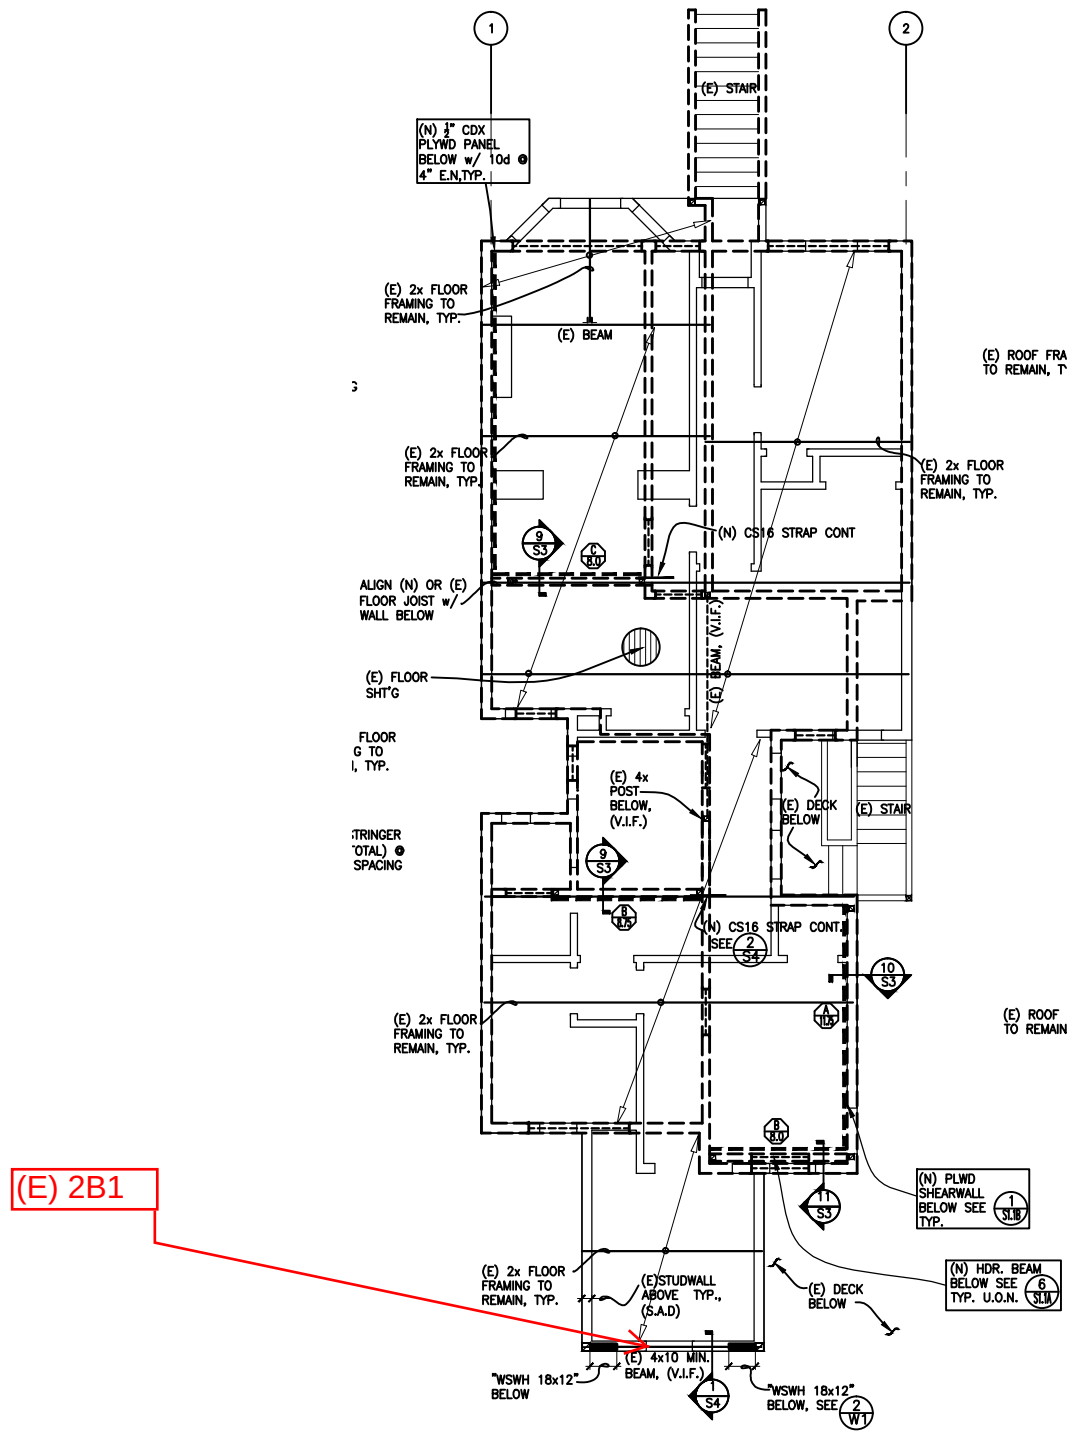
IT SEEMS LIKE POST HAS BEEN RELOCATED TO MISS BRICK FOUNDATIONADJUST SECOND FLOOR FRAMING PLAN AS REQUIRED

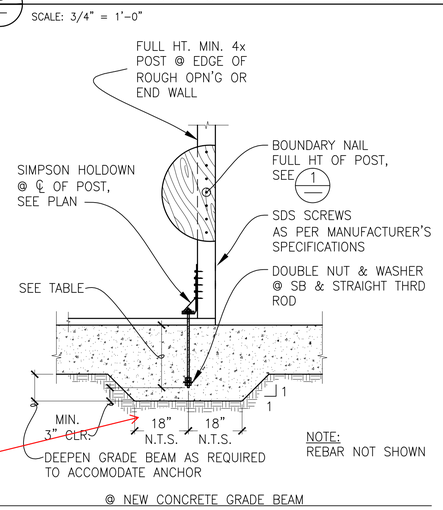
@ NEW CONCRETE GRADE BEAM

NEW FOUNDATION ON PLAN IS NOT IN ON EITHER SIDE OF HOLDOWN ANCHOR

THIS DETAIL IS SHOWING FOUNDATION TO BE 18" WIDE ON EACH SIDE OF HOLDOWN ANCHOR

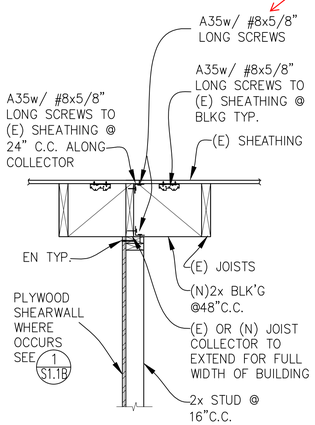
9 — SCALE: 3/4" = 1'-0"

CONFIRM SCREW SIZE SIMPSON USES PH612I #6 x 1/2" SCREWS

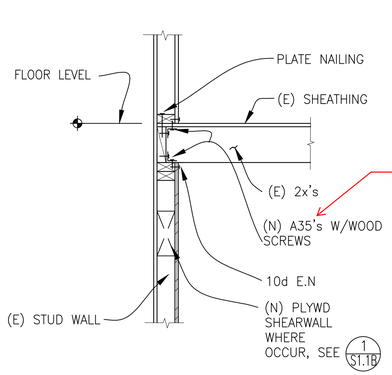
10 — SCALE: 3/4" = 1'-0"

CLARIFY THE AMOUNT OF CLIPS

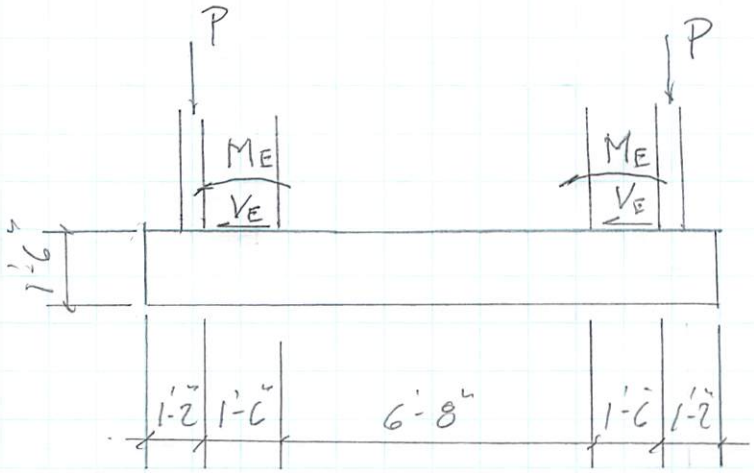
Line E Foundation check - FTG1

7. My calculations show that with earthquake forces included, the newly constructed footing will fail during a code level earthquake (**See Exhibit 7 Fn 6-15**). To make the new footing comply with code, it would need to be 16 ft long instead of the 12 ft provided. This footing should be modified to satisfy the code requirements.

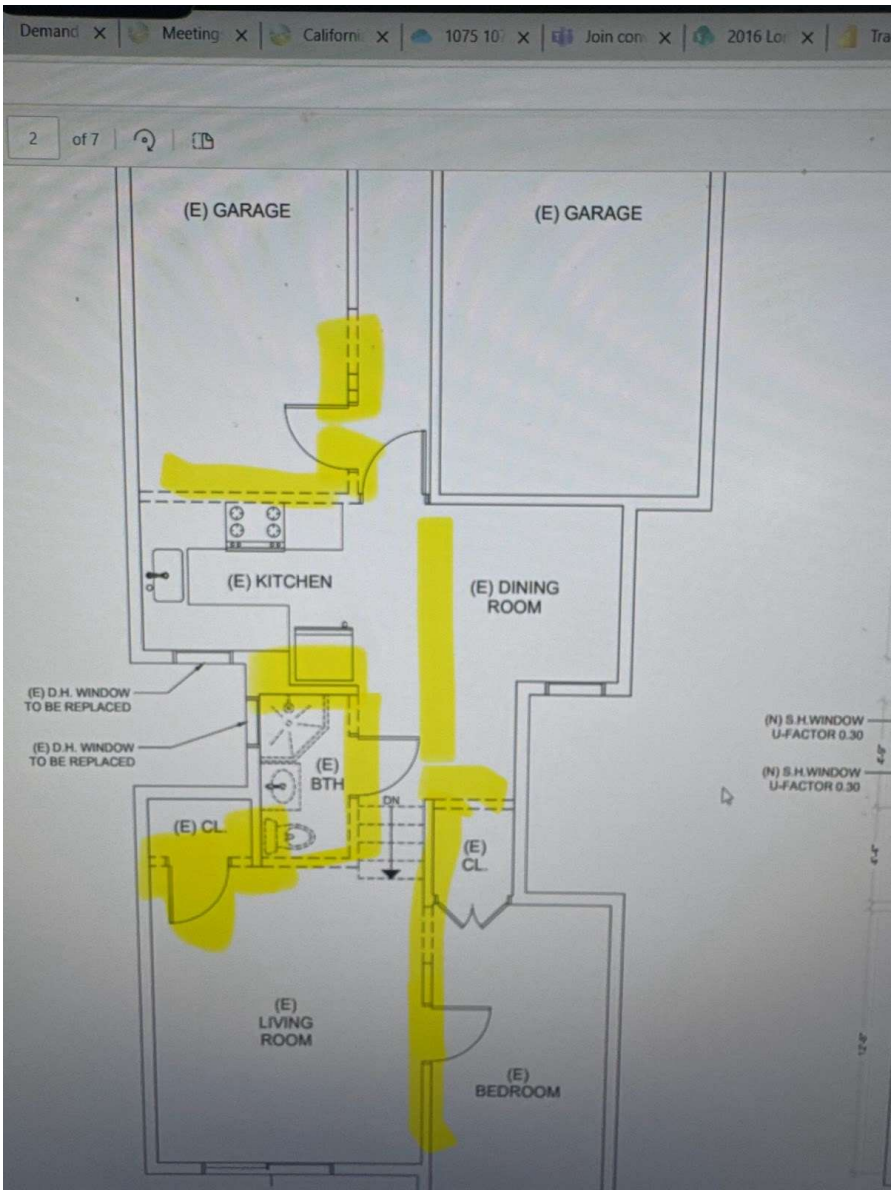
2. **Walls that were removed and left removed for over one year as part of 1077 remodel. Highlight between kitchen and dining room shows the structural beam changed. Photos of these highlighted areas are below.**

3. **Down to the studs gutting- Walls in house interior removed, including walls not shown as being altered. Photo from December 2023.**

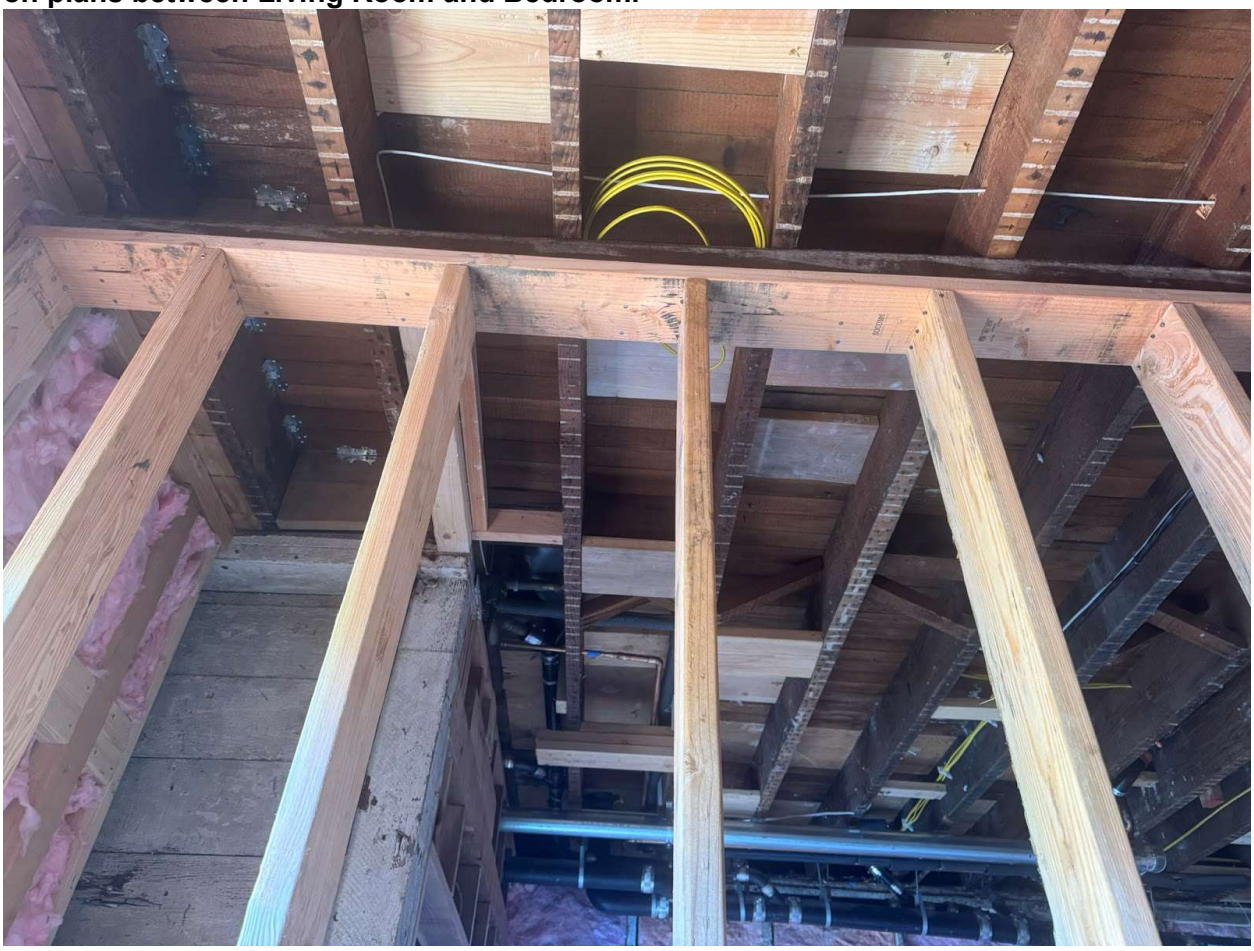
6. Photo taken 2025 shows newly reconstructed wall that was not indicated to be altered on plans between Living Room and Bedroom.

7 Photos taken May 2025 shows areas under 1077 Fell subfloor with new work or work that needs to be addressed

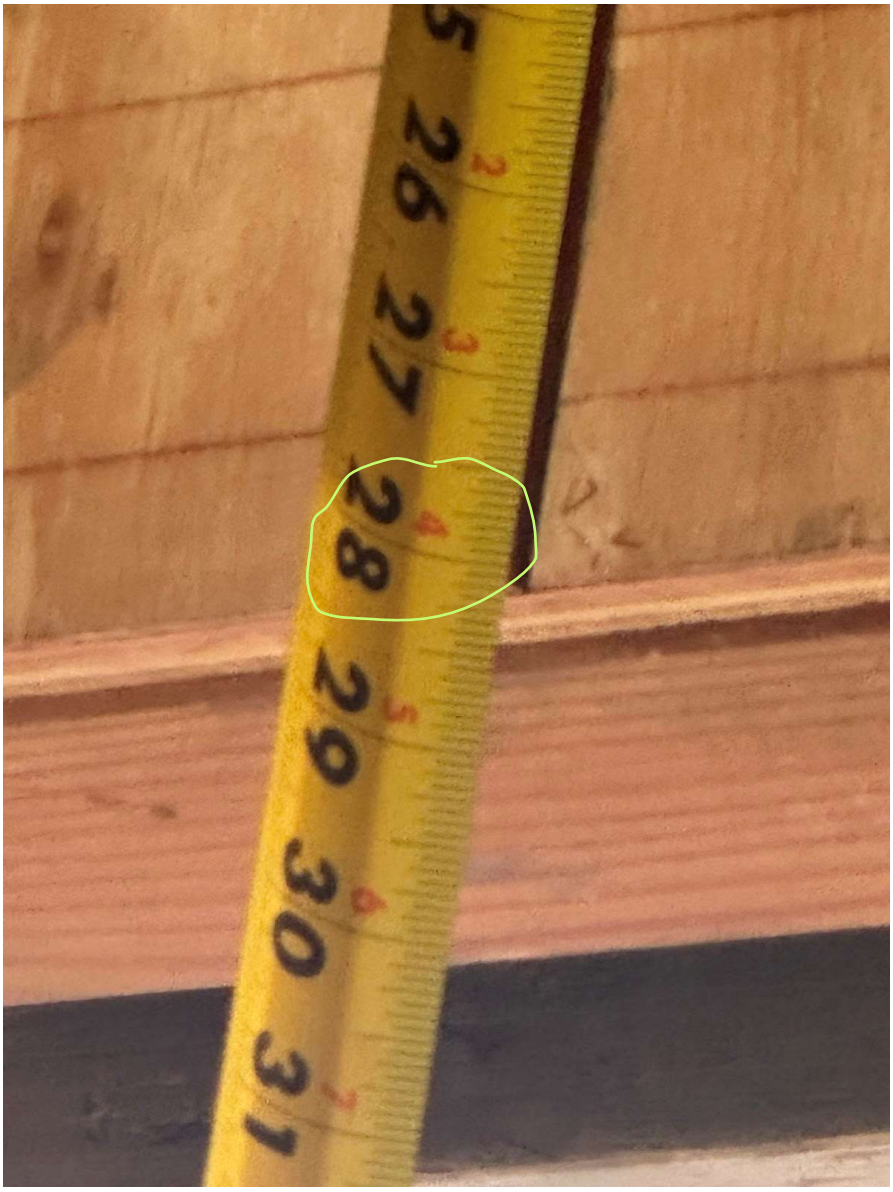
3. Shear wall height left above rough opening.

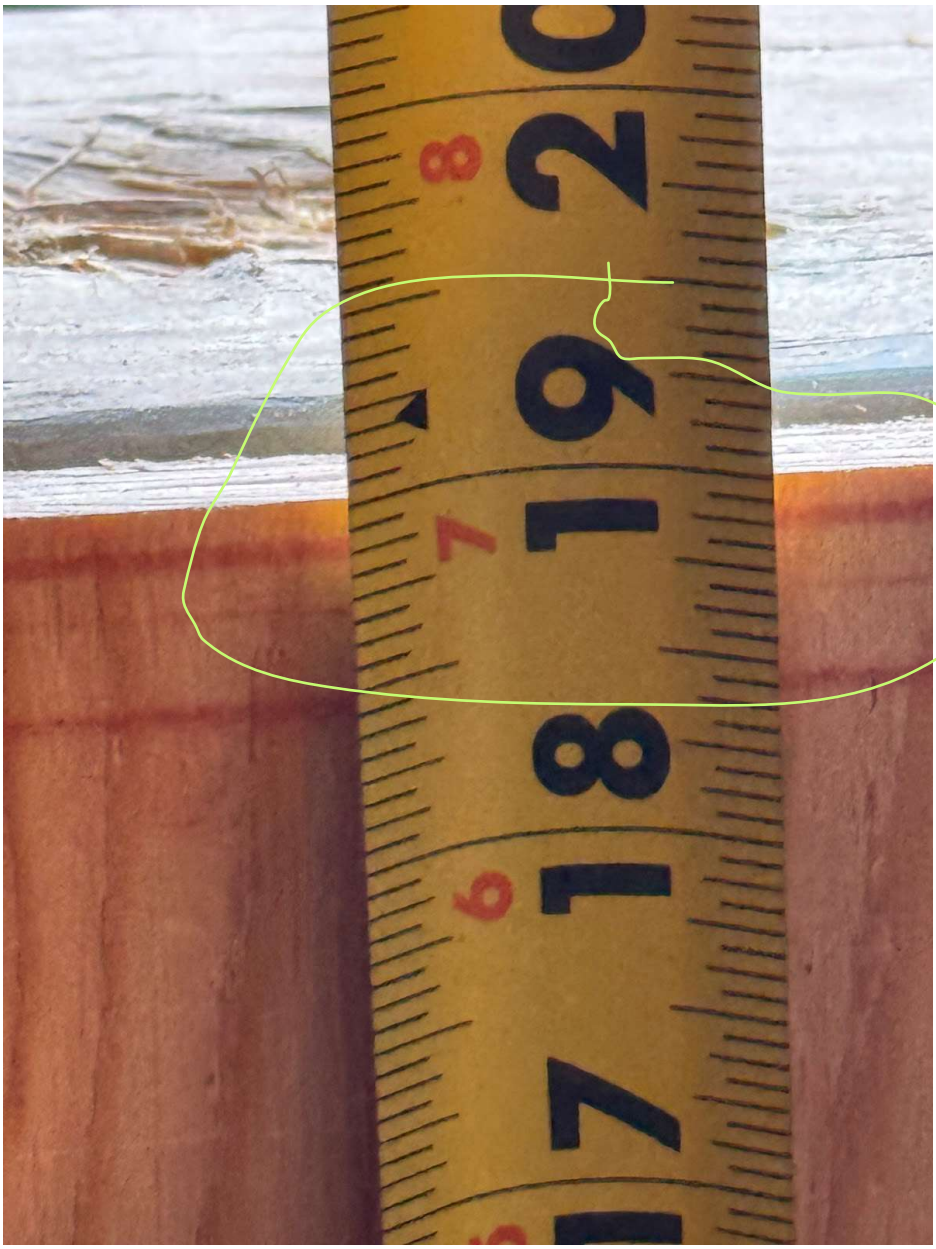
15. The section 8/S3 on Enertia's structural drawings do not show the correct conditions. The shear wall is shown to sit on the floor, but in reality it extends past the floor 15 inches or so and sits directly on the new footing. This makes the shear wall taller and changes the overturning forces. (See **Exhibit 6** Section 8 on S-3)

4. Shear wall extends below floor.

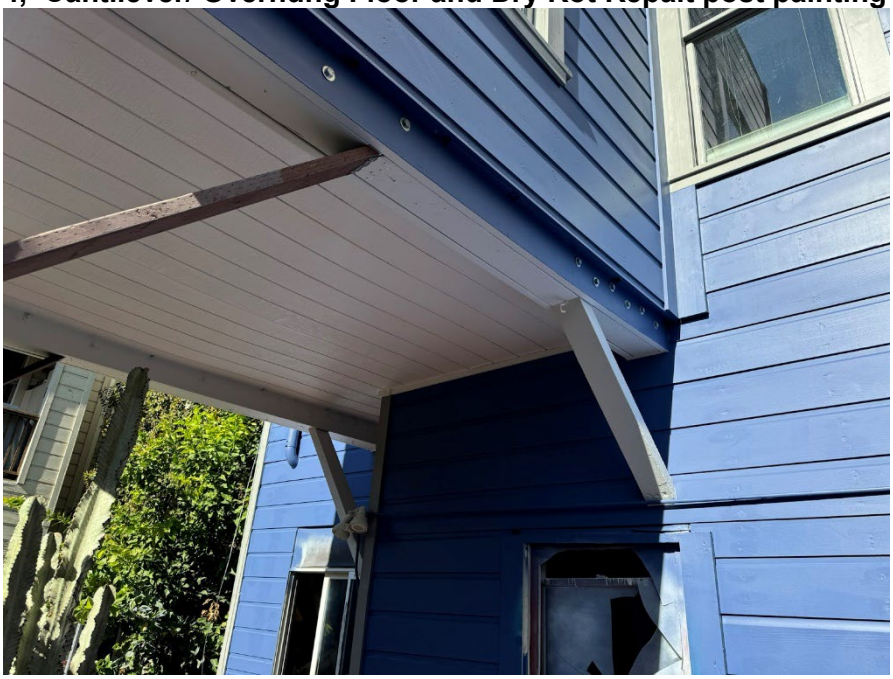
17. The 1075 Fell residence continues over a shared deck, protruding over and supported by the Simpson Strongwall at Line E. Based on conversations and pictures shared by Ms. Sastry, significant dry rot existed in beams supporting the elevated structure at the rear between Lines D and E, where this cantilevered floor joined the main building structure at Line D. I saw evidence of the dry rot repair during my site visit. (See true and correct copies of photos attached hereto in "**Exhibit 13.**") Ms. Sastry shared an Enertia field sketch of the repair with me (a true and correct copy is attached hereto in "**Exhibit 14**.") However, such repairs require calculations and details verifying their adequacy per CEBC 105.2.2 below.

4, Cantilever/ Overhung Floor and Dry Rot Repait post painting

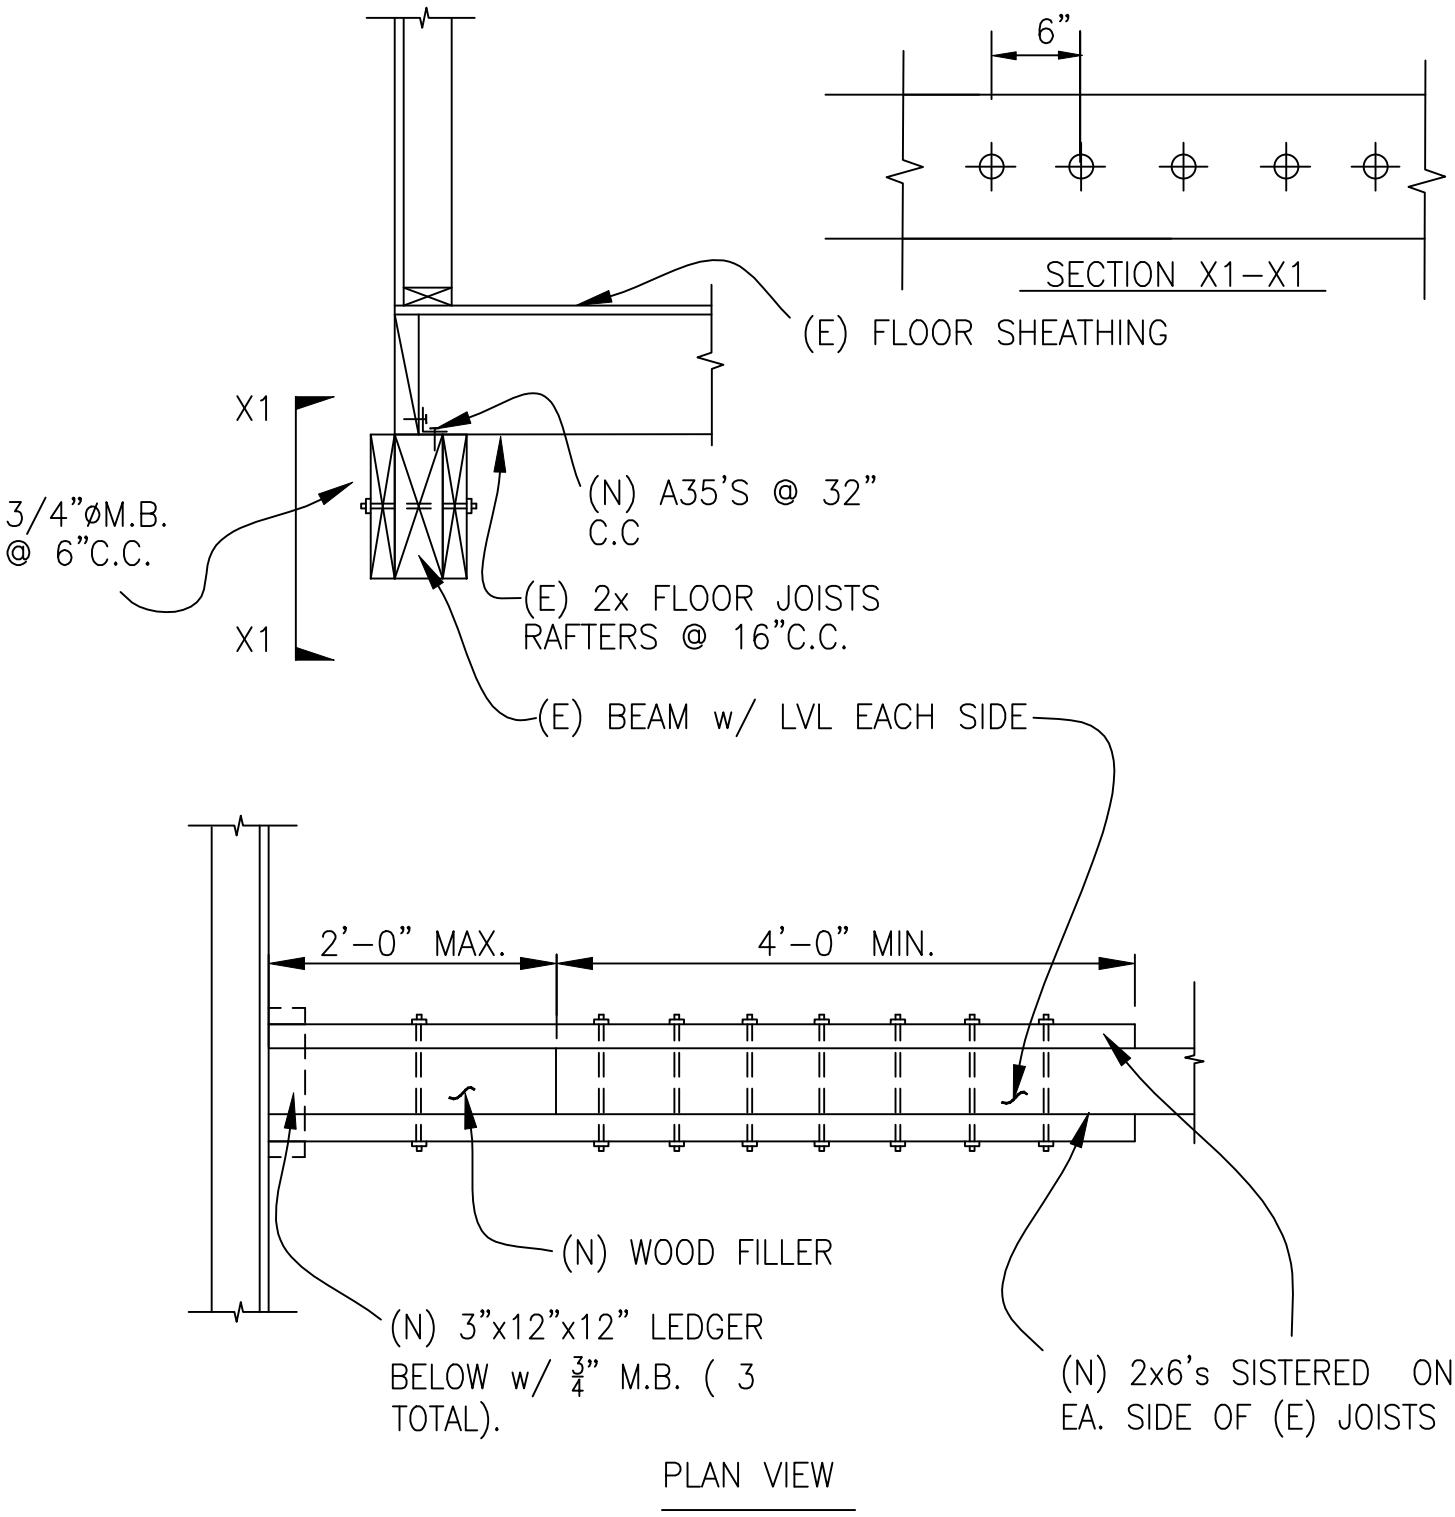
EXHIBIT 14

5. 2 by 6 cut during Construction- Enertia said was structural during onsite visit
