***Regular Meeting
of the
Building Inspection Commission***

Re: Post-Earthquake Inspection, Evaluation, Repair and Retrofit Requirements for Pre-Northridge Welded Moment Frame Buildings

NO. AB-0XX**DATE** : Effective Month, Day, 2026**SUBJECT** : Permit Review and Operations**TITLE** : **Post-Earthquake Inspection, Evaluation, Repair and Retrofit Requirements for Pre-Northridge Welded Steel Moment Frame Buildings**

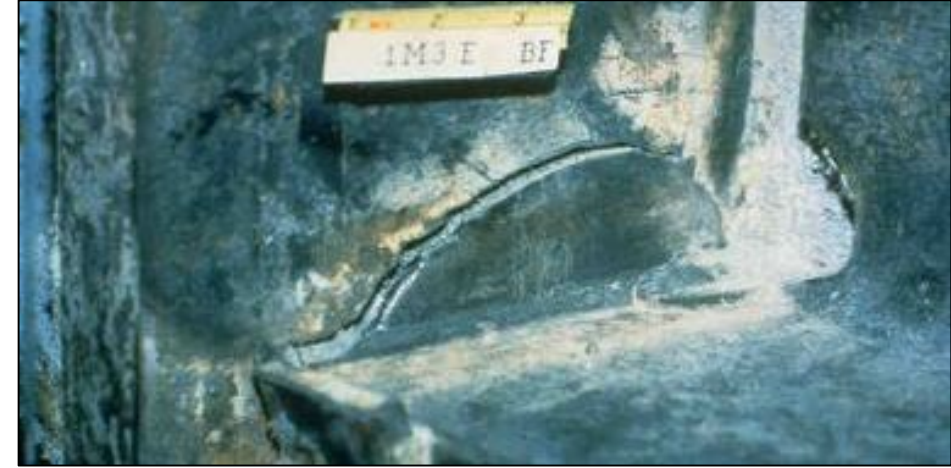
A cracked weld identified after the Northridge earthquake in 1994

Pre-Northridge Welded Steel Moment Frame Buildings:

- Risk of damage to welds after an earthquake
- Guidance document: FEMA 352
